FLOOD PROOFING PERFORMANCE

Successes
&
Failures

US Army Corps
of Engineers

December 1998

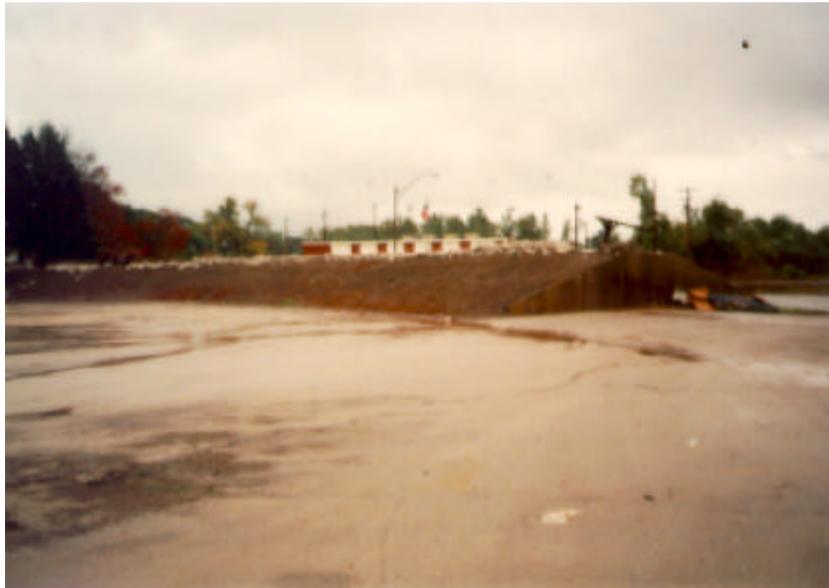
Looking at the portion of the partial ring levee with flatter sideslopes. Note the opening that was closed with a closure structure that was successful. Note the sandbag flood fight on top of the levee.

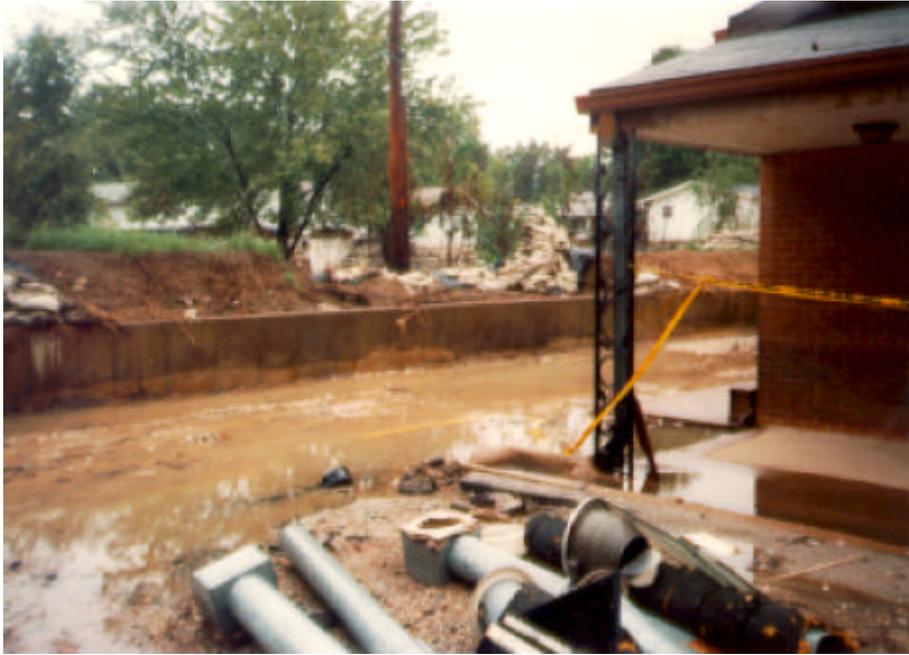
Lesson. In this case, all parts of the flood proofing system functioned as intended except that the levee was overtopped, leading to levee breaching. Obviously, the levee should have been higher for this event. The levee failed where the sideslopes were 1 vertical to 1 horizontal. Levee breaching may not have occurred if flatter sideslopes (1 vertical to 3 horizontal or flatter) had been used. Sideslopes of 1 vertical to 1 horizontal are without question too steep for reliable levee stability. Without levee breaching, a successful flood fight may have been possible. This flood proofing system had a definite weak point -- that portion of the levee with the 1 vertical to 1 horizontal sideslopes. If not enough area was present for a levee with flatter sideslopes, a floodwall should have been built in that location.

Looking at the portion of the partial ring levee with steep sideslopes that resulted in complete failure due to breaching.

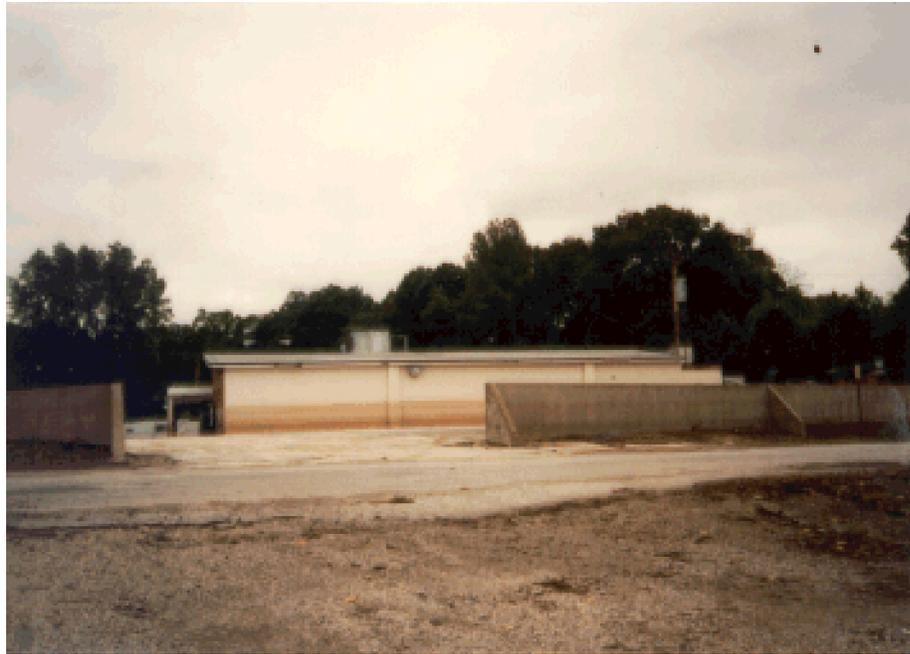
Lesson. This system apparently worked well until it was overtopped. Floodwall bracing, if placed on the “dry” side of the wall, would provide more reliable support in a compression rather than tension mode. In regard to the wall being overtopped, a 9-foot-high wall (to eliminate overtopping in this event) probably would have been more expensive than relocating the mobile homes and two permanent buildings. Relocation out of flood-prone areas is the ultimate in flood proofing. Conducting a flood fight by raising the wall with temporary “flashboards” made of supported plywood may have been possible, although a 3-foot extension on a 6-foot wall would probably have reached the upper limits of reliability.

Looking at the floodwall and also the building on the “protected” side. Note the bracing on the “wet” side of the floodwall.

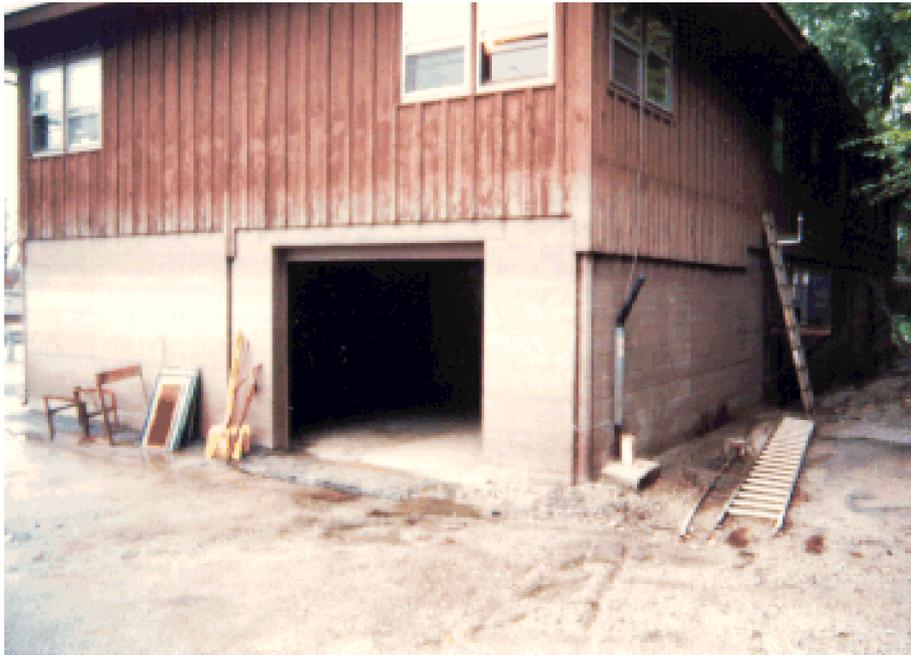
Looking at a typical structure elevated on extended foundation walls. Flood depth was about one foot above the main (elevated) floor. Note the elevated utilities on the outside wall.

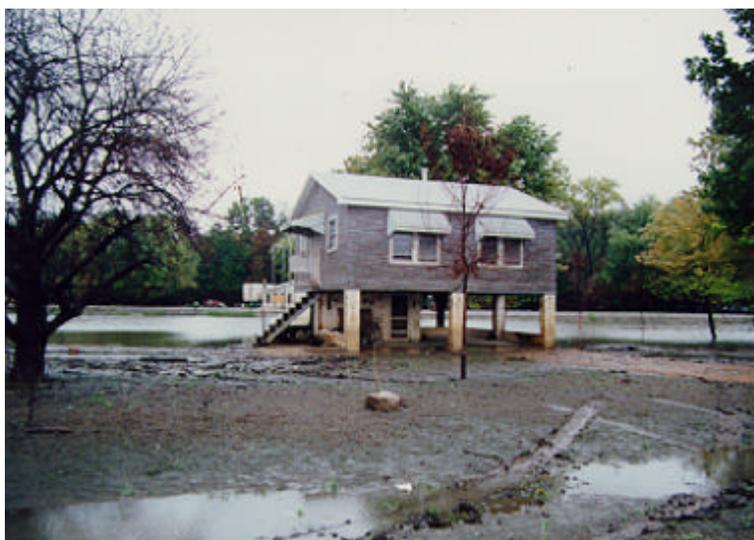
Looking at a typical structure elevated on masonry columns that had water above the main (elevated) floor.

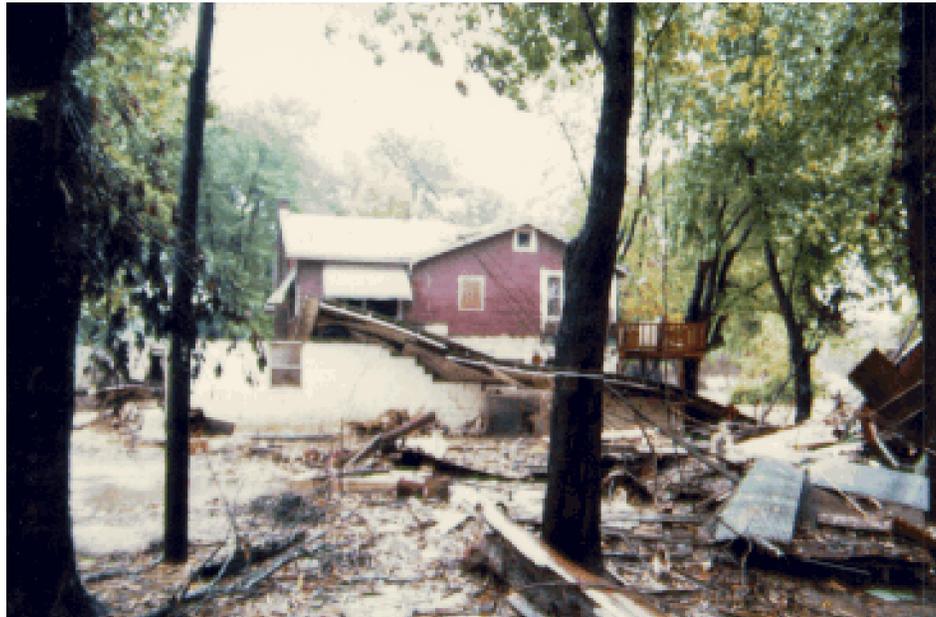
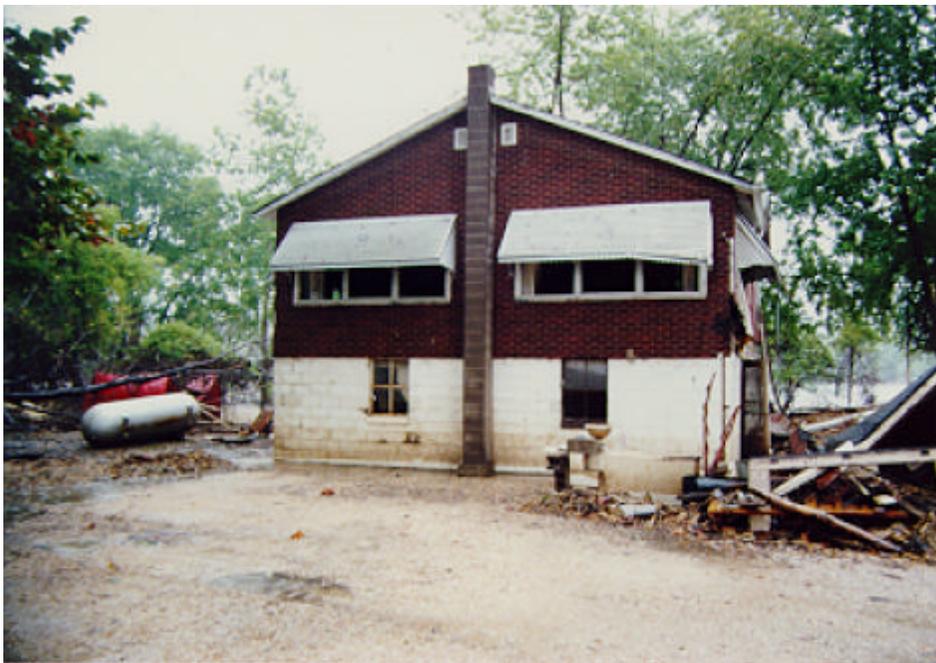
Looking at Structures 52 and 53.

four structures, the extended concrete block wall to support the structure should not have been used in an area close to a major river where high velocity during floodflows could occur. Supports such as columns, posts, or piles embedded sufficiently below grade should have been used, with piles being the preferred choice. Any enclosure of the lower area should have been of minimal strength to easily break under hydrodynamic force.

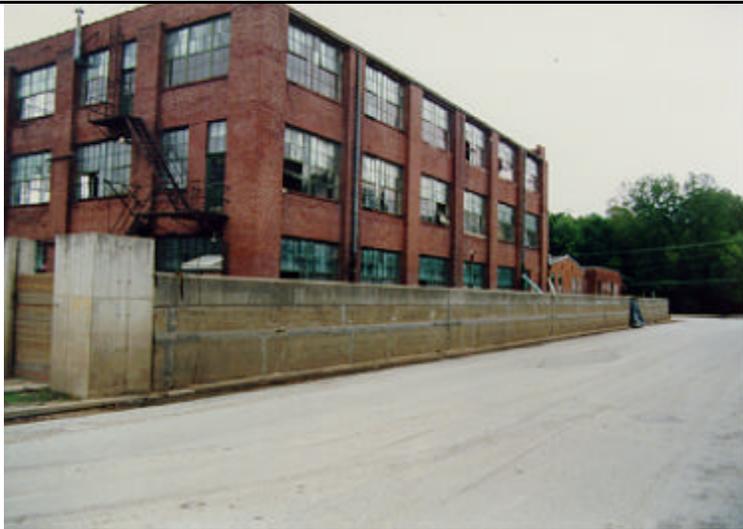
Lesson. About 150 feet of the wall collapsed at the seam between the original wall and the first 2-foot extension. Of the 150-foot section that failed, a 90-foot section had foundation failure. Both failures occurred because (1) the original wall footing was not designed for extensions doubling the original wall height and (2) the assumption that rebar tied the first extension to the original wall was false. Upon wall failure and due in part to the close proximity of the wall to the building, the building roof subsequently failed. After the flood, the building was being abandoned and the industry was relocating to a flood-free site.

Looking at the floodwall. Note the closures at left and far right, the original floodwall, and the two additions. The failed portion is between the building and the trees in the background.

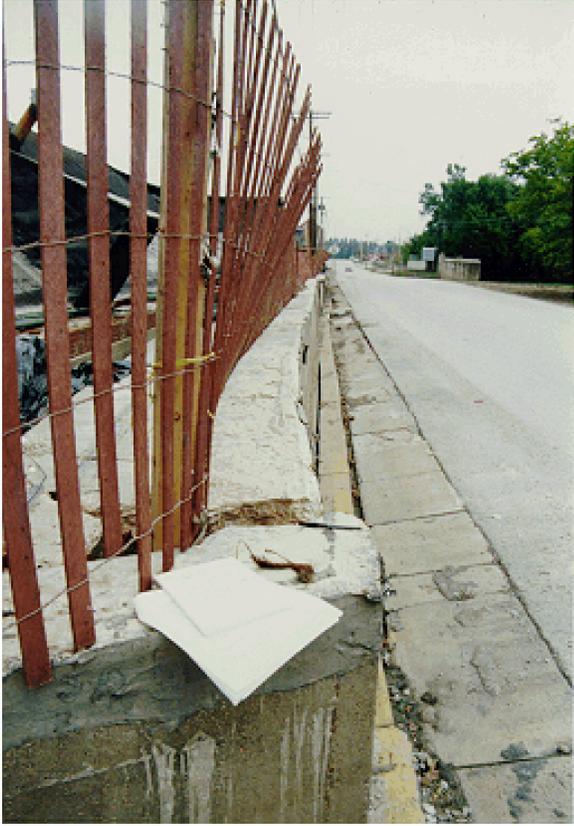
Looking at the original floodwall. Note the foundation failure resulting in wall misalignment. Also, note the absence of rebar on the original floodwall.

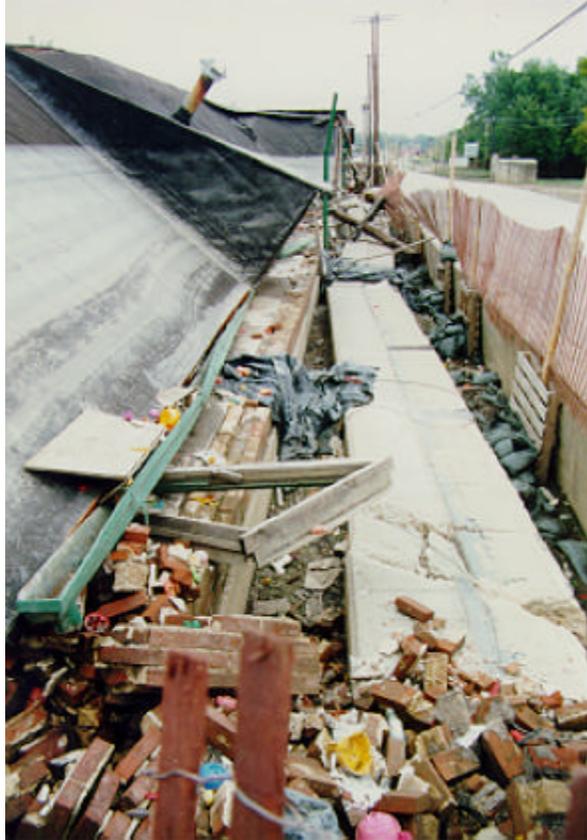
Looking at the collapsed floodwall additions. Note these two additions are still tied together with rebar.

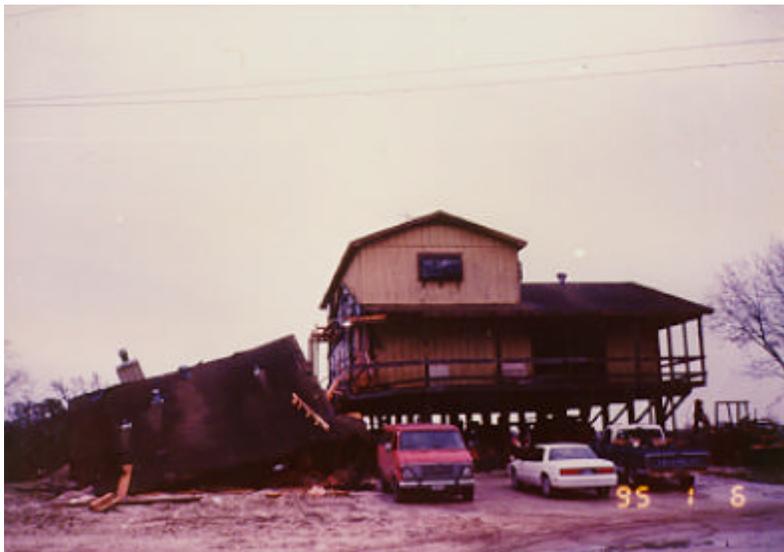
Lesson. This structure was exposed to extreme high velocities. Structure failure occurred because of four basic reasons. First, the enclosed lower area utility room created even higher localized velocities than already present as the floodwater flowed around the obstruction. Second, the enclosed area was near the "upstream" corner of the structure so the localized velocity increase occurred near the slab edge where scour could occur beneath the slab. Third, perimeter footings were not in place under the slab-on-grade to prevent scour beneath the slab. Fourth, the post embedment depth was not deeper than the scour depth. These factors combined to create a situation conducive to massive scour and failure. The eastern portion of the structure, which did not have an enclosed area, functioned successfully.

Looking at the collapsed portion of the structure. The collapsed portion is at the left.
The river is behind the structure

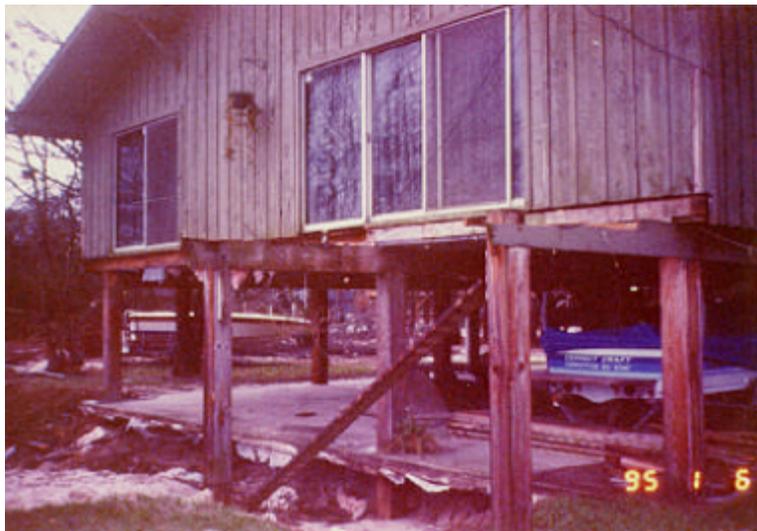
Lesson. This flood proofing system functioned very well. This appears to be due to the lack of a localized velocity-increasing mechanism, such as a lower enclosed area, that would create a situation conducive to large amounts of scour. This structure should be retrofitted with perimeter footings around the slab-on-grade embedded to below scour depth to prevent the amount of scour that did occur.

Looking away from the river at the structure. Note the area beneath the structure is completely open.

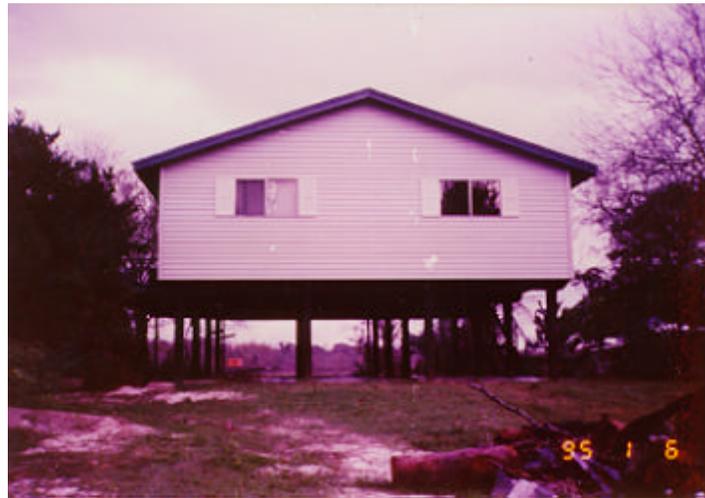
Lesson. This flood proofing system worked well. No scour was evident, probably because of the "shield" effect of a row of trees and brush to the left (upstream) side of the structure. These trees apparently provided protection from the high velocities so scour did not attack even the slab-on-grade. The lack of an enclosed obstruction in the lower area prevented the creation of high localized scour-producing velocities. Scour was evident to the left of the row of trees.

Looking toward the river at the structure. Note the trees on the left that apparently protect this structure.
Note, also the lack of any obstruction beneath the structure.

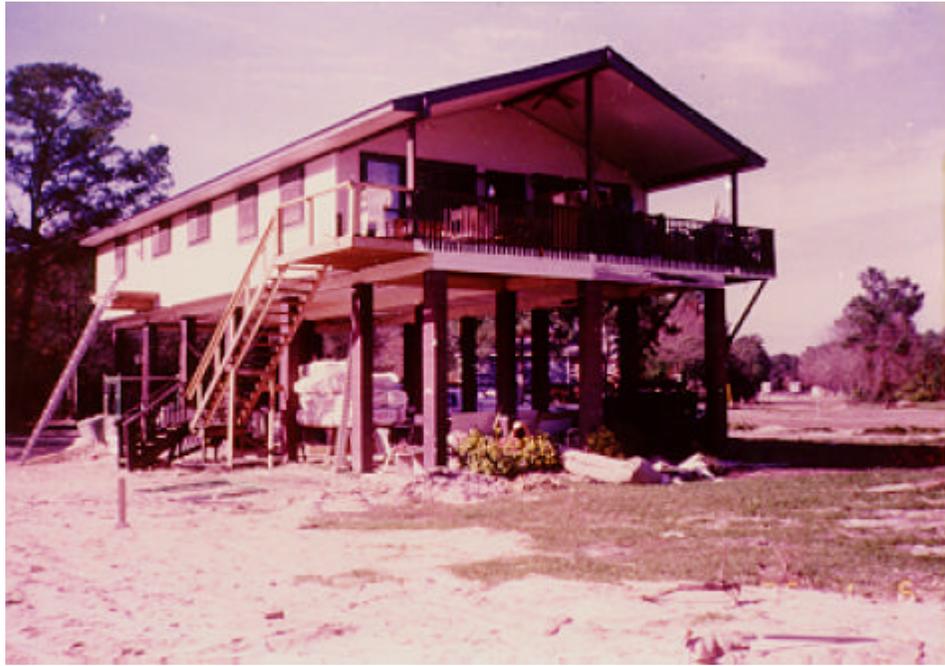
Lesson. This structure received relatively little flood-related damage during this event. The home was realigned and the scoured area filled. Even with this "success," this flood proofing system should not be promoted. The risk to this structure is great for two reasons--both related to debris accumulation. First, severe debris accumulation, coupled with hydrodynamic force, could tip over the structure. Second, scour could severely undermine this structure's foundation because of debris accumulation, also resulting in the structure tipping.

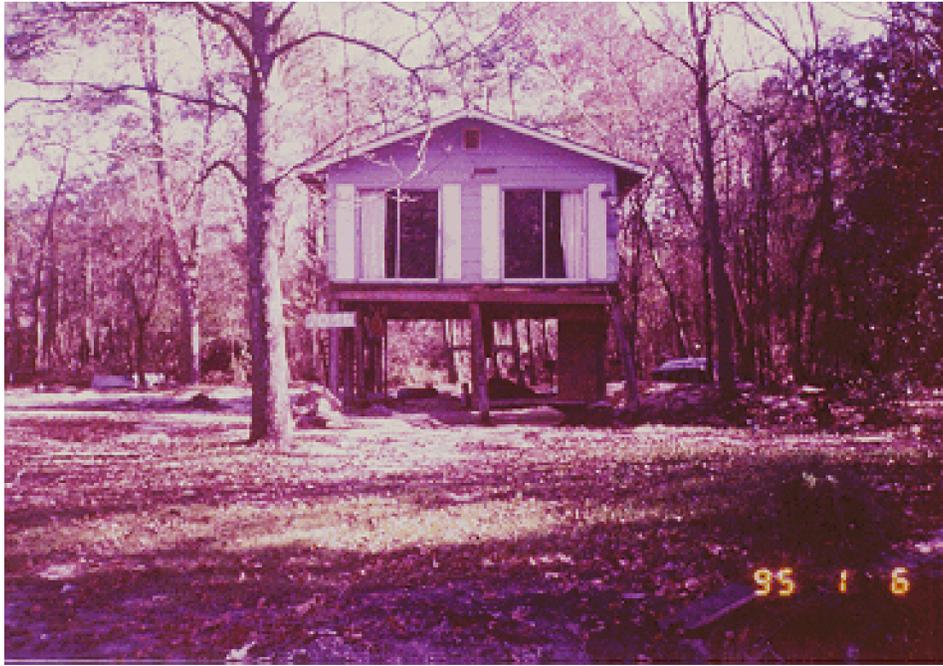
Lesson. Damage occurred with this system because of the enclosed lower area, which created high localized velocities and scour, and the extremely shallow post embedment depth. If the posts had been embedded to a greater depth and placed in concrete and the enclosed area had not been present, this structure would probably have sustained no damage.

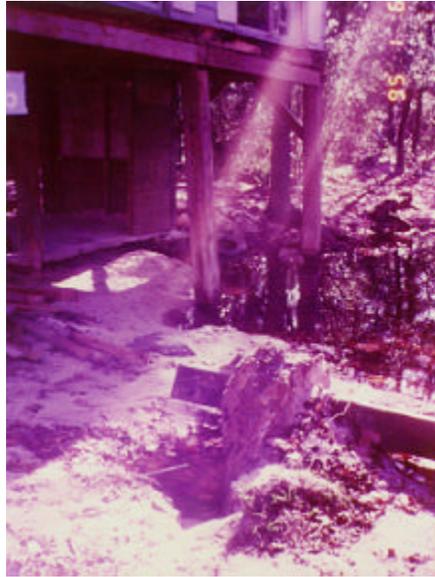
Looking at the structure's shallow post embedment depth.

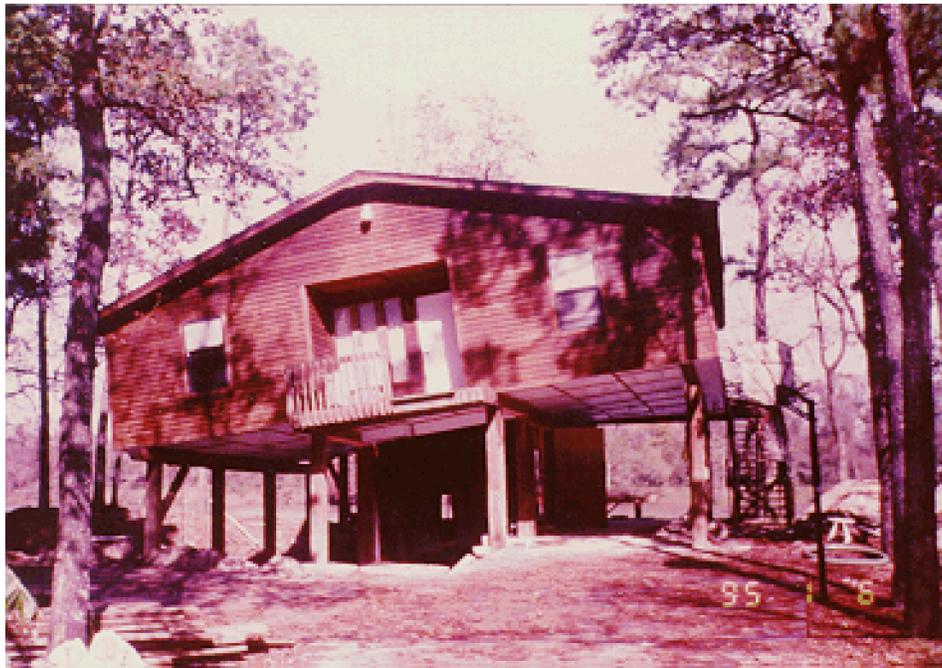
Lesson. This structure had an enclosed area in the central portion of the lower area between the slab-on-grade and the first floor of the home. This enclosed area was conducive to creating high localized velocities. Its location, however, in the central part of the lower area surrounded by a concrete slab for some distance proved in other structures to be not nearly as damaging due to scour as when located near the upstream edge of the slab. Apparently, the tremendous scour that occurred at this structure was aggravated by the enclosed area but was created mostly by the structure's location along the river. Perimeter footings under the slab-on-grade would have greatly reduced the scour even in this apparently bad location. Post embedment depth obviously should have been deeper. For definite protection from this type of damage, piles driven to below the scour depth would have been the ultimate solution.

Looking at tilted structure as a result of scour under the left portion of the structure.

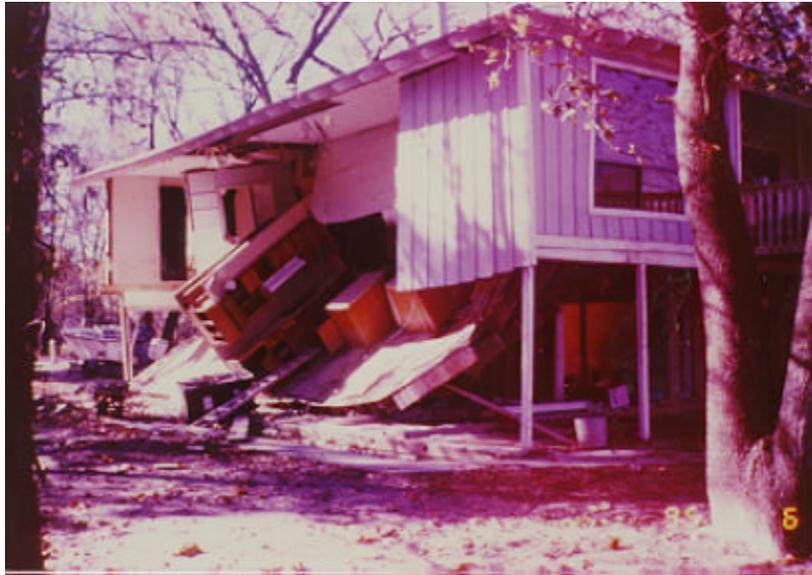
Lesson. This flood proofing system failed for basically two reasons. First, the lower area was completely finished, creating high localized velocities that resulted in extensive damage to the interior. Second, extended foundation walls were used, inappropriately, in high-velocity areas, subjecting the structure to hydrodynamic force.

Looking at the failed structure.

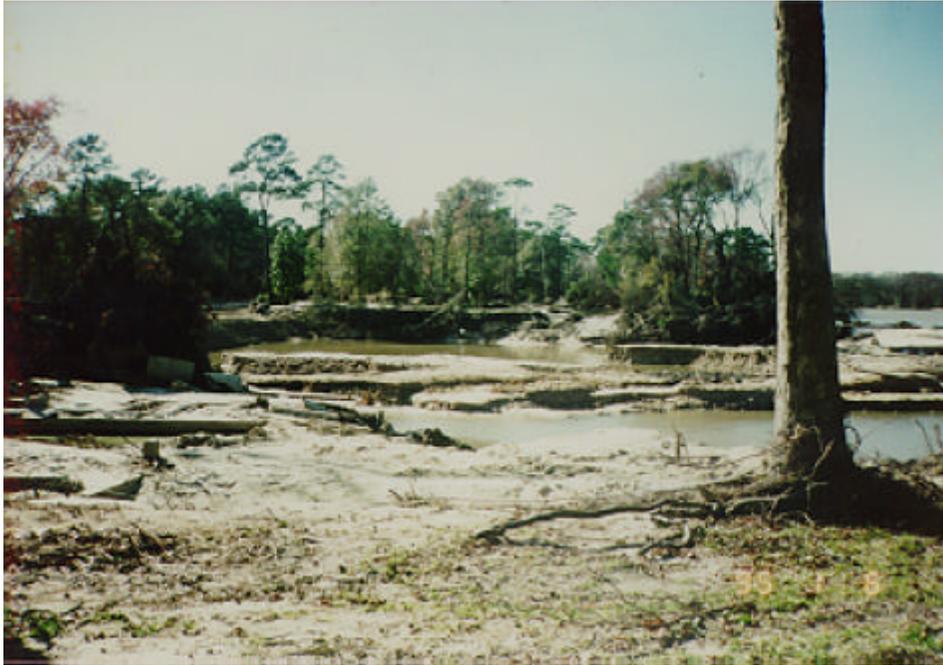
Lesson. No flood proofing system can withstand erosion such as that experienced here. Construction of any type in an area where extremely high velocities can occur is not advised and reflects extremely poor judgment.

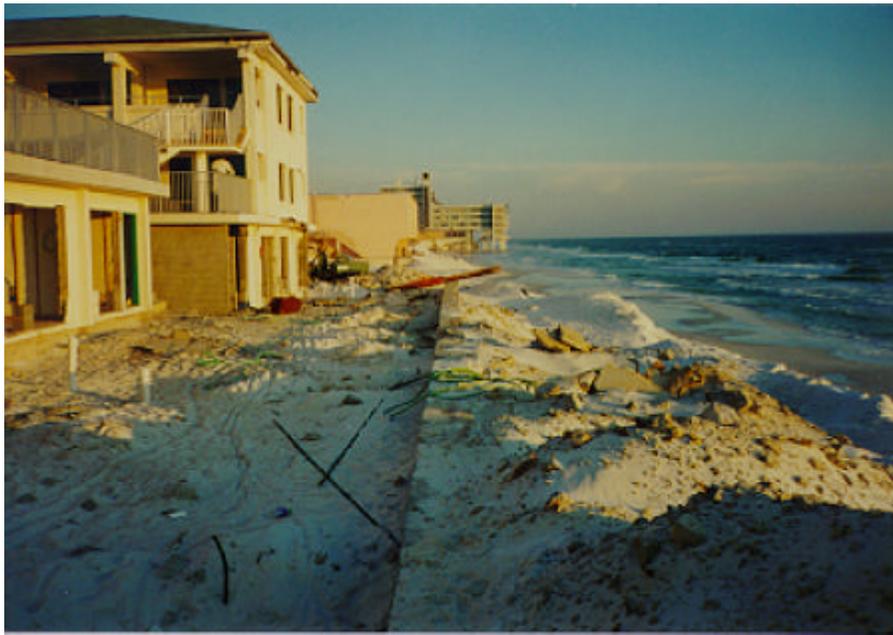
Lesson. Slab-on-grade construction with shallow footings should not have been used in this location because of the enormous potential for scour. The lower floor should not have been developed because of the great potential for flooding from hurricane force wave runup. These structures, as built, were saved from major structural damage by basically two items. One, the presence of the large plate glass windows on the lower floor broke under wave force, allowing flood damage to occur but reducing the potential for complete wall failure due to hydrodynamic force. Two, the presence of the seawall protected the slab-on-grade foundation from extensive scour, which would have allowed substantial structural failure to occur.

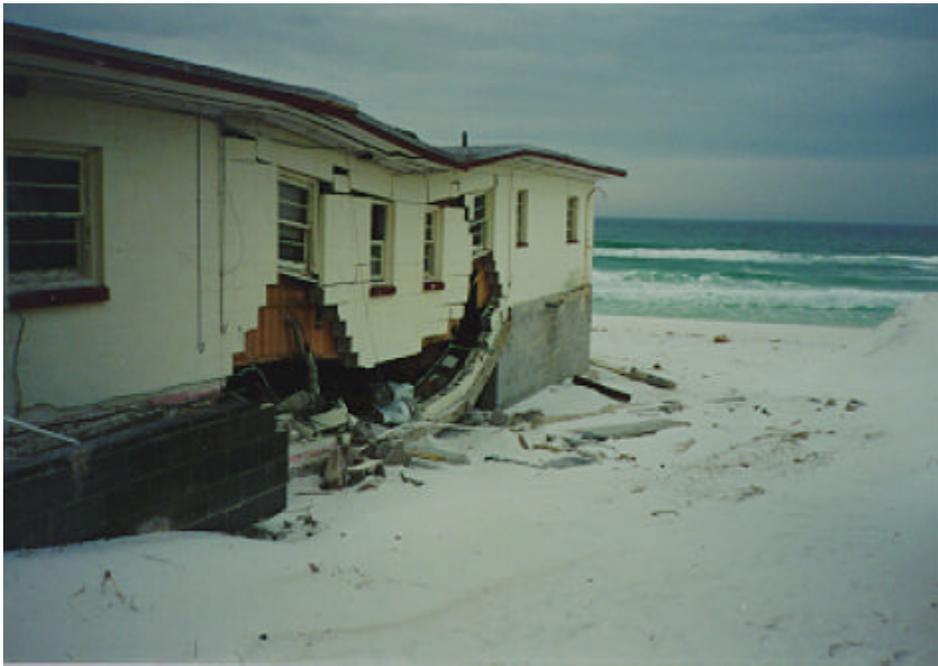
Lesson. Four basic problems were present with this structure. First, the footings were too shallow, allowing scour to undermine them. Second, extended foundation walls, which are not appropriate for coastal areas subject to hydrodynamic force, were used. In this particular case, failure did not occur because of extended walls, but they made the structure highly susceptible. Third, the concrete slab for the first floor was supported by sandfill. When the perimeter wall failed, erosion of the sandfill occurred, causing the floor to collapse. The floor should have been supported on piles driven to a depth below the potential scour, or the perimeter footings supporting the extended foundation walls should have been constructed to below-scour depth. Fourth, the structure was not elevated enough to prevent floodwater damage. Structures such as this in this location need to be elevated on piles.

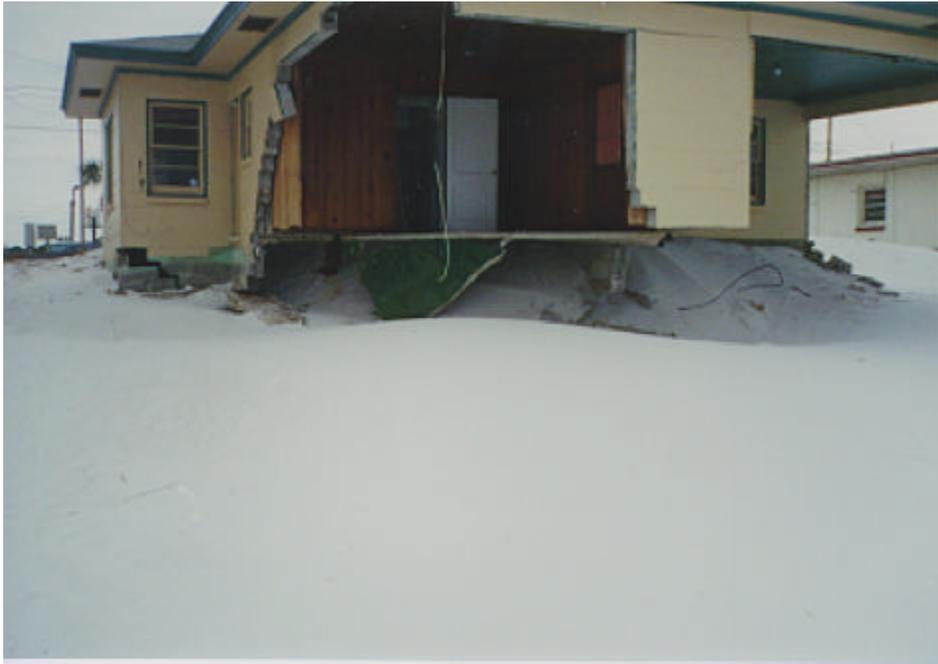
Lesson. This structure had the same basic four problems as Structure 74--shallow footings, extended foundation walls, concrete slab on sandfill, and inadequate structure elevation. Extended foundation wall failure was due first to scour and then to hydrodynamic force. The roofline on this structure was maintained, unlike that on Structure 74, probably because of the presence (in the middle of the structure) of the concrete block support for the floor and interior wall. This example shows the importance of multiple supports beneath a structure in an area subject to excessive scour. As stated for Structure 74, a structure with extended foundation walls, shallow footings, and a concrete slab on sandfill is definitely not appropriate at this location.

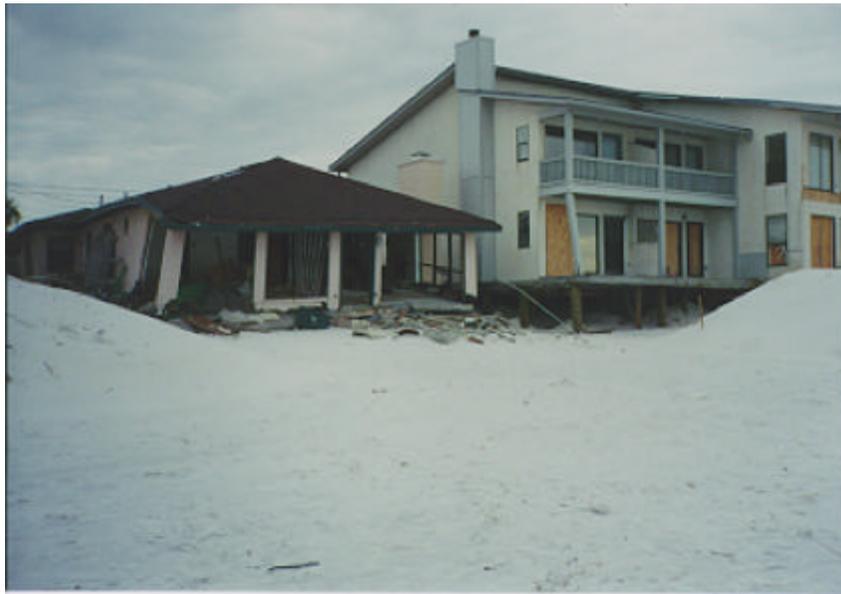
Lesson. Comparing Structures 77 and 78, located adjacent to one another, shows the inherent problem with shallow footings, extended foundation walls, and a first-floor concrete slab supported by sandfill. Scour undermined the shallow footings of Structure 77, causing, with hydrodynamic force, the failure of the extended wall foundations. This allowed erosion of the sandfill supporting the first-floor concrete slab and failure. In contrast, Structure 78, supported on piles embedded below scour depth, sustained no structural damage. Both structures were flooded because of inadequate elevation.

Looking at the structure with extended foundation walls on the left and at the structure with a pile support foundation on the right.

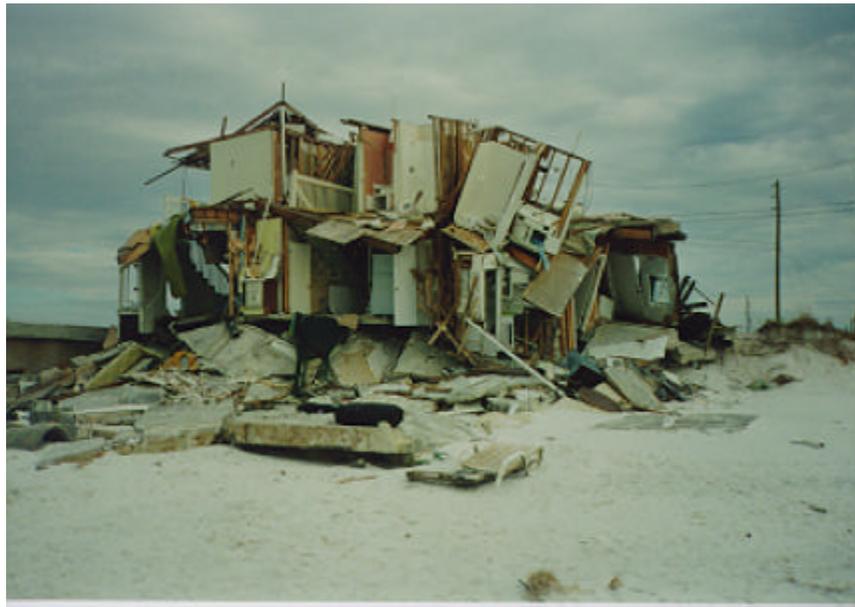
Lesson. This structure is discussed because it sustained massive damage even though it was elevated as much or more than most structures along this reach of beachfront. Failure probably started to occur because of scour beneath the shallow footings and hydrodynamic force against the extended foundation walls and the structure itself. Erosion of the sandfill caused concrete slab failure. Failure of these foundation elements substantially weakened the structural integrity of the wood-frame structure, allowing wind and hydrodynamic force to cause a near total destruction. A foundation of piles embedded below scour depth, with the piles extending to the roofline for proper structure/footing tie-in, and hurricane fasteners would probably have allowed this structure to sustain minimal damage.

Looking at the totally failed structure from the beach.

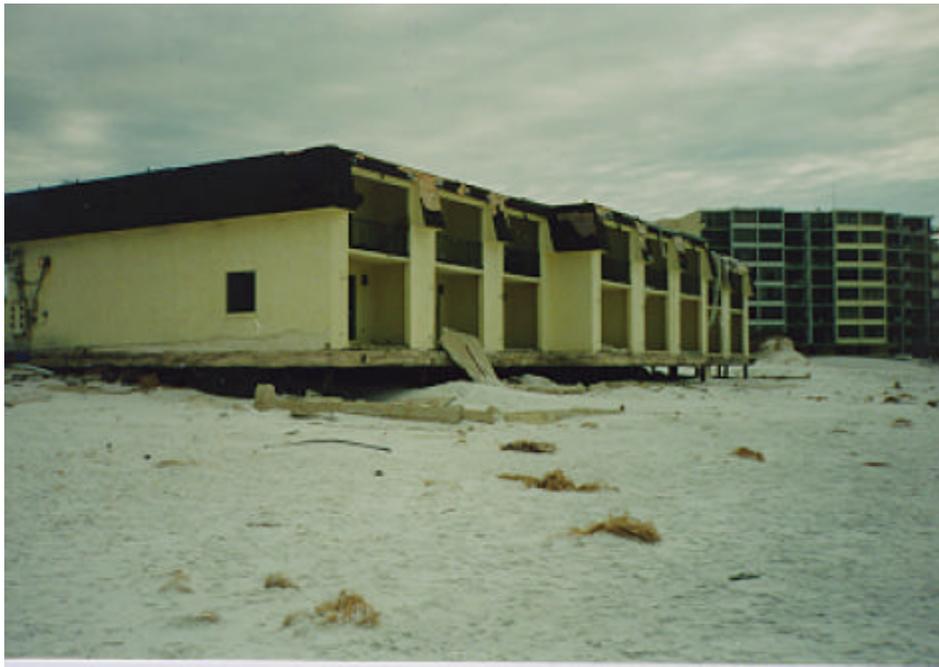
Lesson. The structure performed adequately except for two reasons. One, the structure was not elevated high enough to prevent flooding. Two, the concrete slab on the first floor was supported only by sandfill. When the sand eroded, the floor collapsed. Floor collapse could have been prevented by placing supporting posts beneath the concrete slab or by using rebar to support the floor from the piles located beneath the bearing walls.

Looking at the structure. Note that the building structure did not collapse due to the pile support foundation.

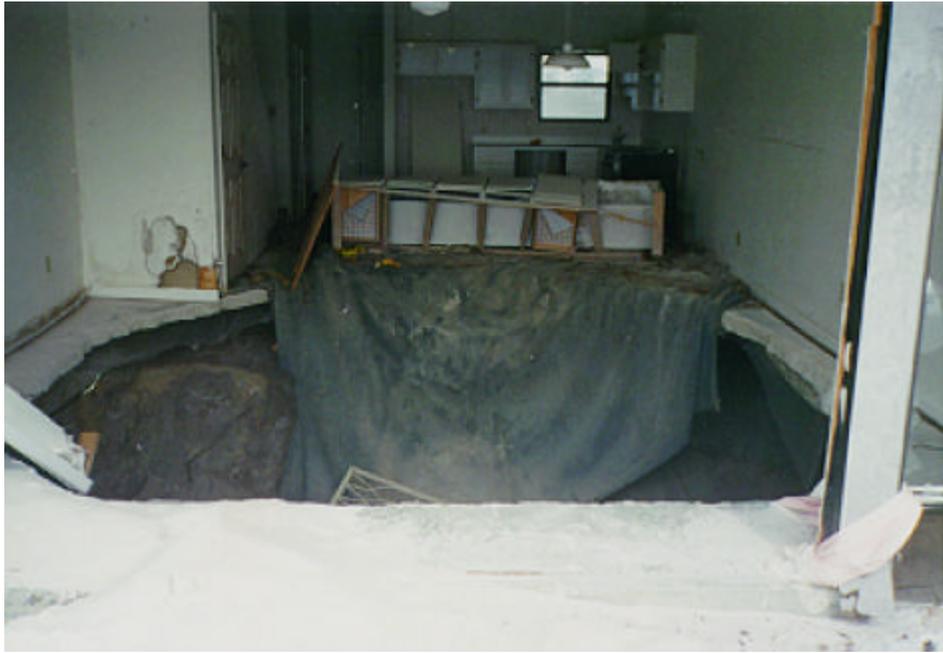
Looking inside the structure at the collapsed floor due to scour of the sand beneath the slab-on-grade floor

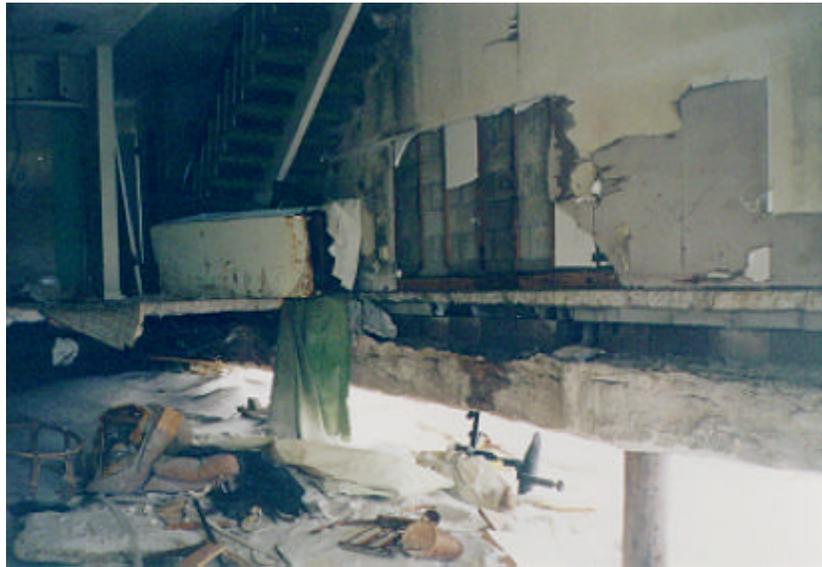
Looking inside the structure at the collapsed floor due to scour of the sand beneath the slab-on-grade floor.

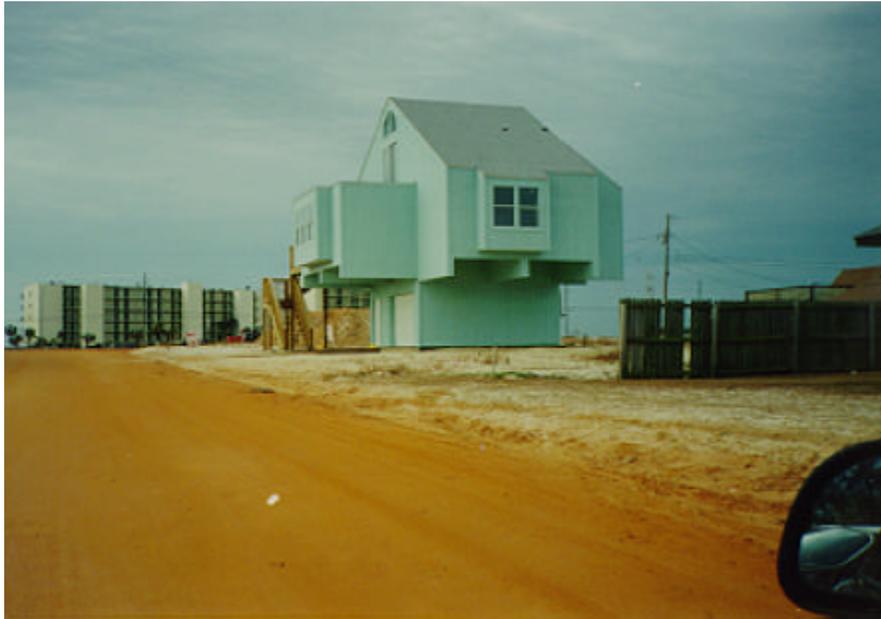
Lesson. This structure was recently constructed. It had adequate elevation and was constructed to state-of-the-art building codes. Because of its location two blocks from the beach and behind a large multistory building that may have provided some protection from hydrodynamic force, the degree of hazard was lower than had it been located directly on the beach. A note of caution with this structure is the enclosed lower area. This type of enclosed construction, unless the walls are able to break away during a hurricane event, subjects the structure to hydrodynamic force and the potential for foundation scour due to the obstruction to waterflow caused by the enclosed walls at ground level.

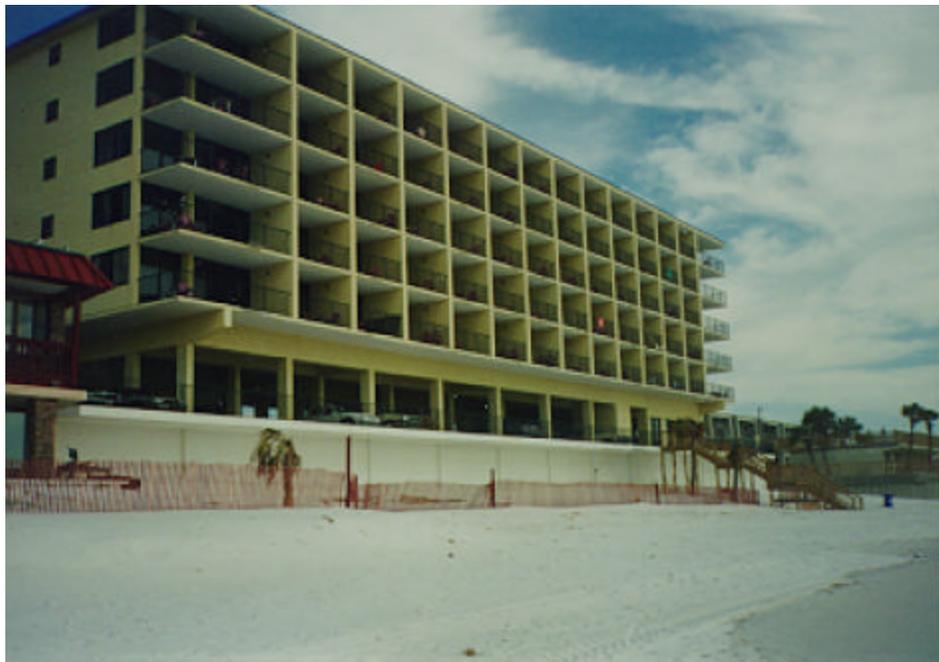
Lesson. This structure was successful for two basic reasons. It had both proper elevation and proper scour/erosion protection. The first damageable floor was well above the flood level since it was two floors above the ocean level. The first floor was occupied by automobiles which can easily be moved to a nonhazard area with proper warning time. Scour did not pose a problem because of the wall and the proper column embedment depth.

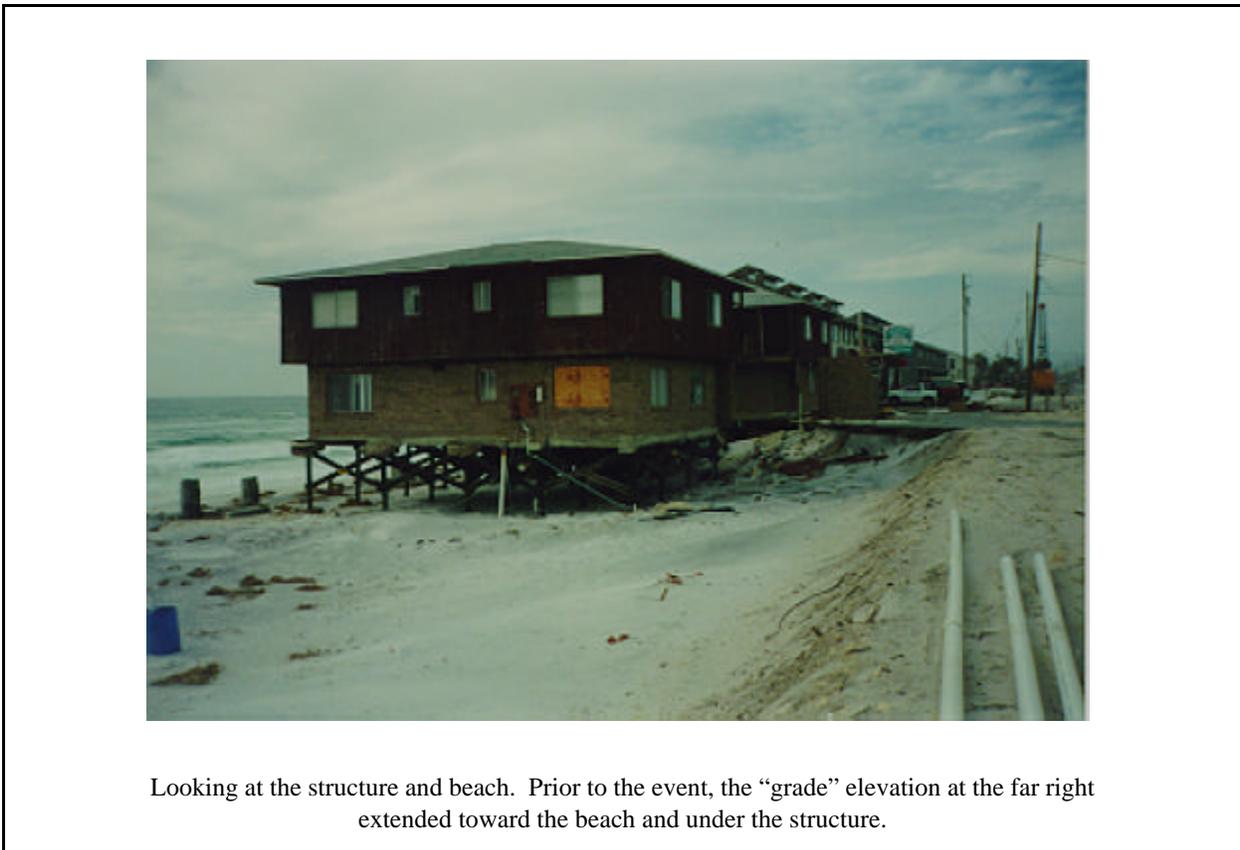
Lesson. Severe scour occurred around and under these structures during the event. The wood piles appeared to be improperly sized, since some were visibly leaning under the weight of the buildings without sandfill support. The “x” bracing on the piles may have saved the building from collapsing. This shows the need not only for proper embedment depth of posts or piles but also for proper size of posts or piles for needed strength. In this case, where sandfill appears to have been factored in as a part of the building support/stability system, a protection wall around the building that could have withstood the scour hazard and hydrodynamic force should have been built. The most proper design, however, would have been to elevate the buildings on larger diameter piles that were completely independent of sandfill for added support to the buildings.

Looking at the structure and beach. Prior to the event, the “grade” elevation at the far right extended toward the beach and under the structure.

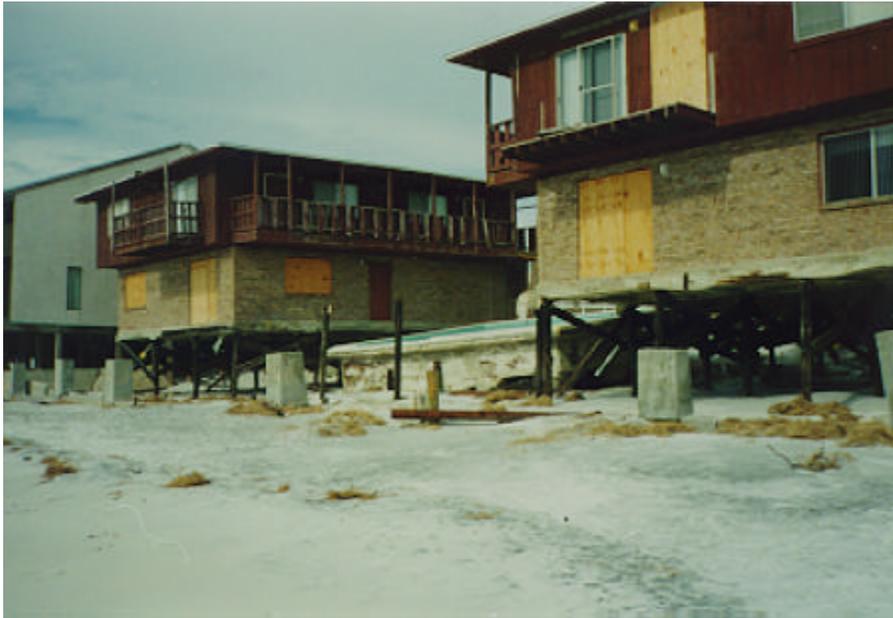
Looking from the beach at the structure. Note the collapsed swimming pool between the structures.

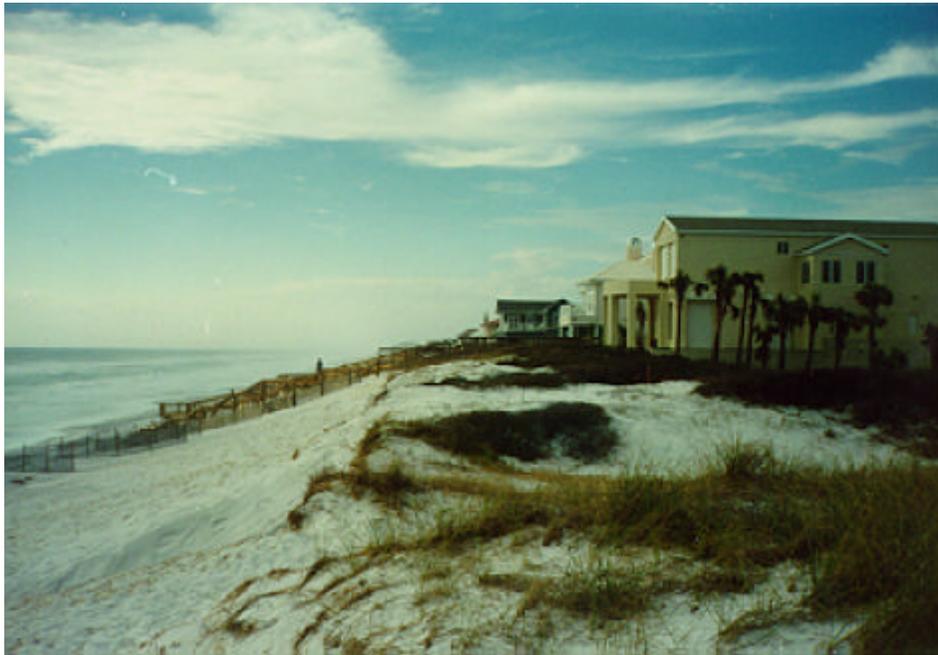
Lesson. “Conventional” construction techniques in the structure itself are often very adequate to mitigate hazards from floods, erosion, and hydrodynamic force if other nonstructure-related techniques are employed. In this case, constructing structures on higher ground is a large step toward hazard mitigation in the form of reduced flood damages. A large setback allows room for either a natural or a manmade dune to be located between the ocean and the structure. This can diminish or eliminate hydrodynamic force on the structure and the potential for scour at the structure.

Looking along the beach at the structure and the dune. Note the structure elevation and the dune protection.

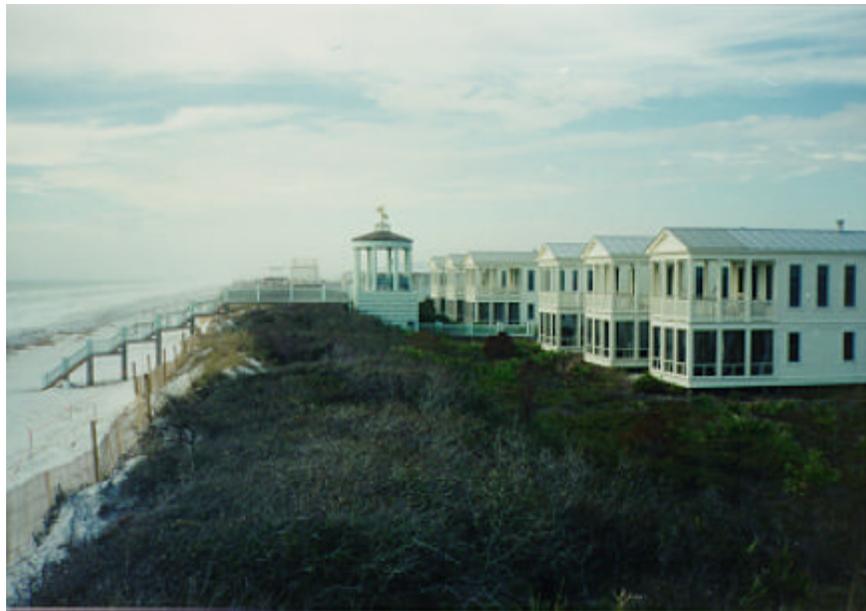
Looking along the beach at the structures and the dune. Note these structures are not elevated as high as those in the above photograph but the dune has much more vegetation.
