FLOOD PROOFING PERFORMANCE

Successes
&
Failures

US Army Corps
of Engineers

December 1998

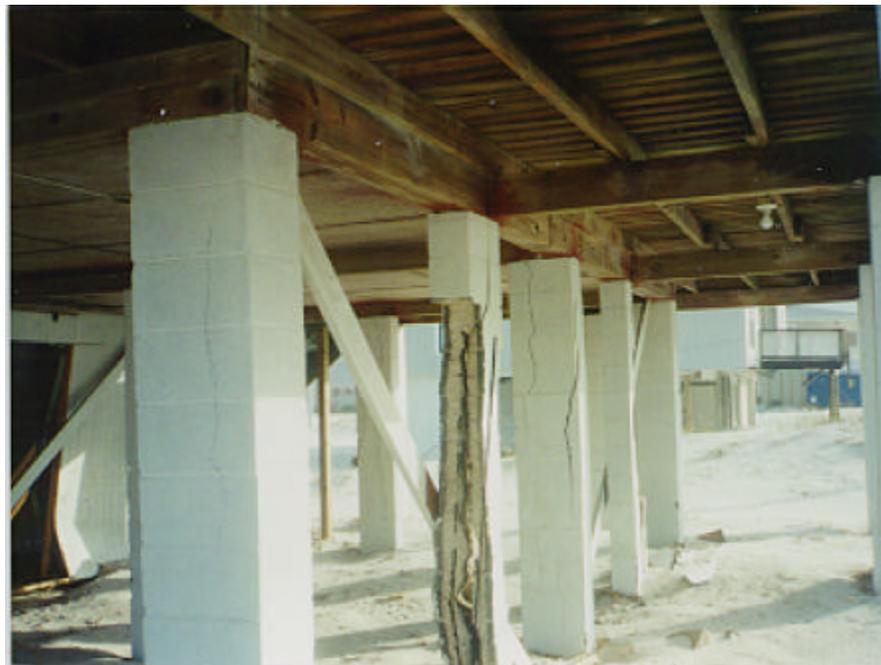
Looking at the column support that was nearing failure.

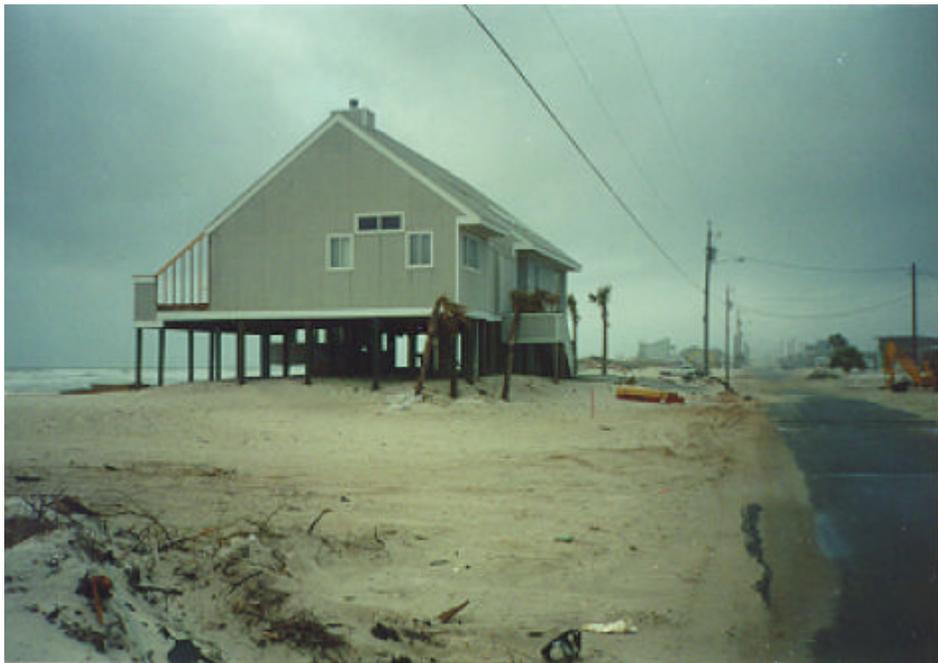
Lesson. This structure survived the event well because it incorporated proper design and construction to withstand hurricane force winds, flooding, and hydrodynamic force associated with such a storm.

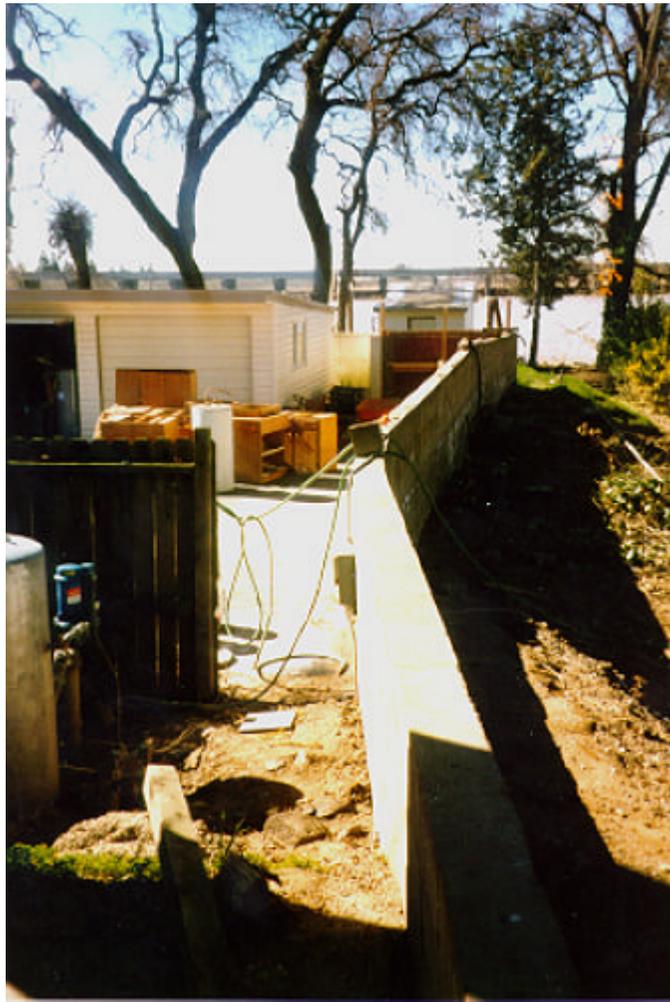
Looking along a portion of the floodwall. The failure under the wall occurred in the immediate foreground. Note the largest closure at the right of the structure. Also note the Sacramento River in the background.

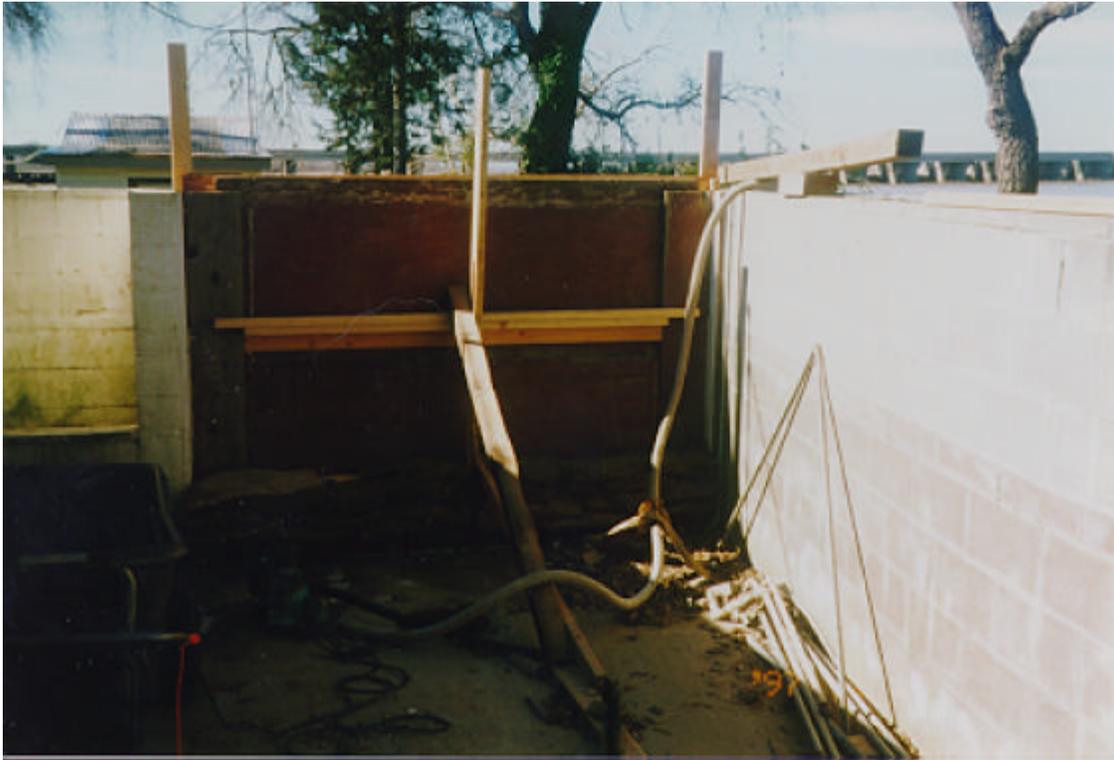
Looking at the largest closure structure and sump pump. Note the electrical cords on the concrete floor.

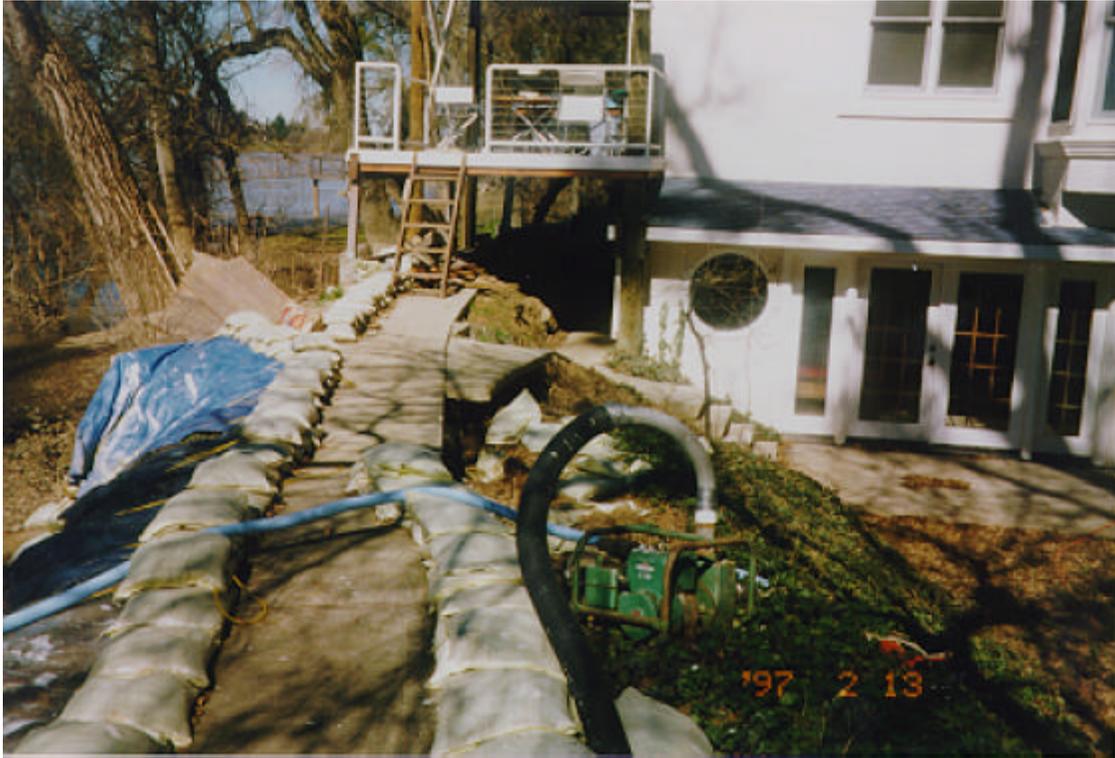
Looking along the overtopped levee. Note the Sacramento River at the left and the low elevation of the developed first floor of the structure relative to the river elevation.

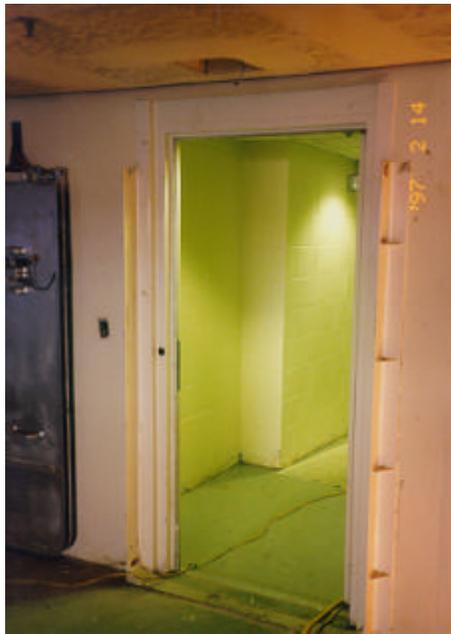
Looking at a doorway into the “protected” area. Note the state-of-the-art pneumatic seal closure at the left in its storage position. Also note the gap between the top of the closure and the top of the doorway.

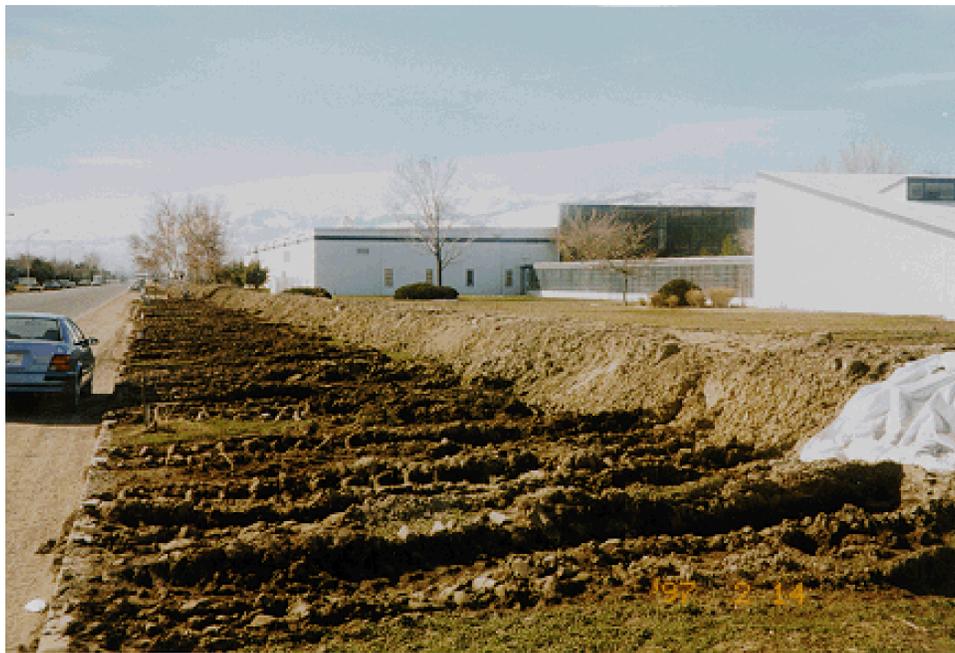
Looking at the recently constructed earthen embankment protecting Structure 95. Note the plastic sheeting at the far right that was placed over the embankment's unprotected side and held in place with sandbags to provide impermeability to the embankment.

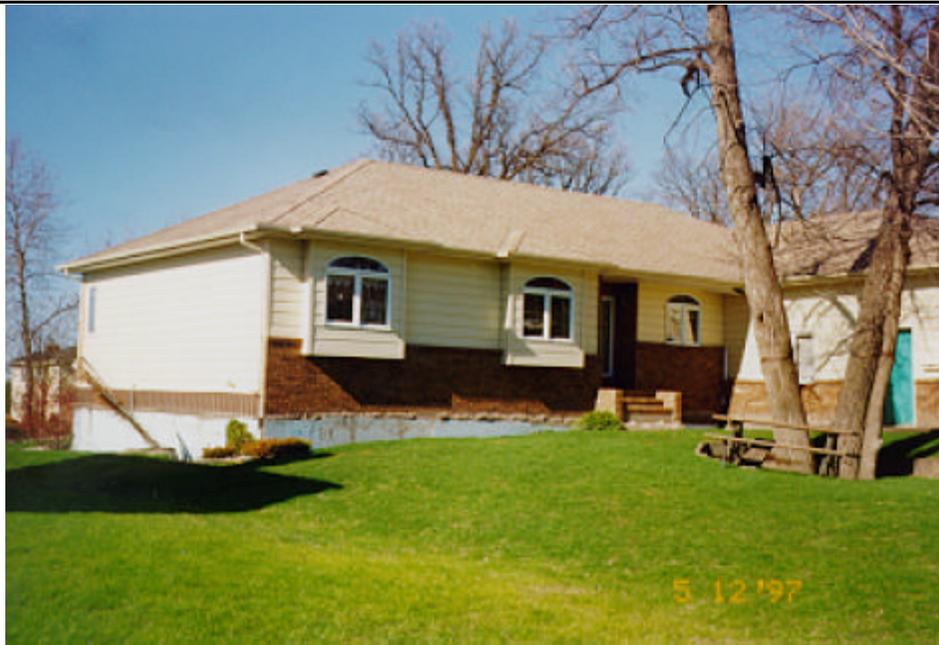
Looking at the structure. Note the garage on the right that held that part of the structure down and the exposed basement wall on the left indicating the amount of lifting that occurred on the west side.
