## Appendix C Lessons Learned - Case Histories

### C-1. General

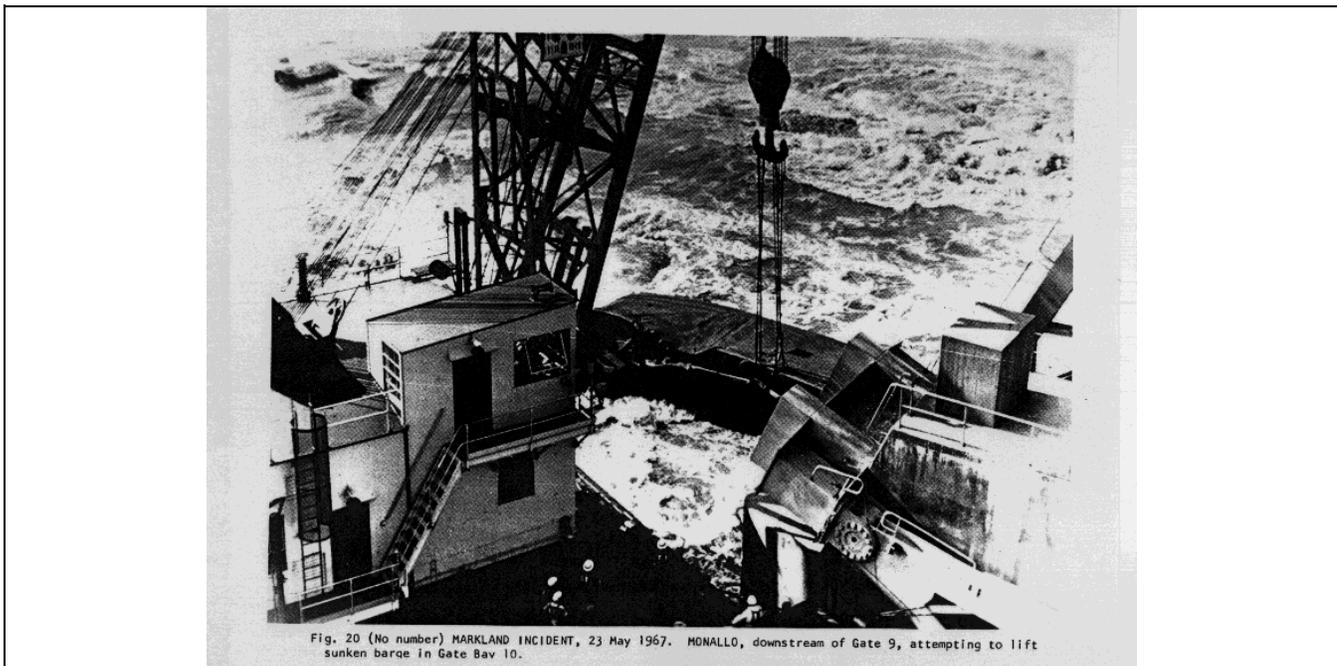
This incident resulted from a barge tow breaking loose from an upstream mooring (tied to a tree on the bank that pulled out) and floating into the dam. The barges sank in the dam gate bays with some of the barges wrapping around the piers, preventing the tainter gates from closing during a return from open river conditions. The resulting loss of pool caused major damage to harbors, stranded boats, sloughed highway embankments, and exposed water intakes and sewer outfalls. Figure C-1 shows the removal of one barge from the Markland Dam. Based on this incident, the Corps developed recommendations for future applications as summarized in the following paragraph.

Figure C-1 - Removal of barge wrapped around dam pier - Markland Lock and Dam, Ohio River, 1967

(3) Recommend each district fabricate or procure effective power-driven cutting beams to separate barges wrapped around the dam pier structures.
