Los Angeles River Ecosystem Restoration Feasibility Study

**DRAFT – APPENDIX D
GEOTECHNICAL, INCLUDING HTRW**

DRAFT Geotechnical Feasibility Report
Los Angeles River Ecosystem Restoration Study Project Area, Los Angeles County, CA

SUBJECT: Los Angeles River Ecosystem Restoration Study
Levee Condition Inspection and Issue Discussion

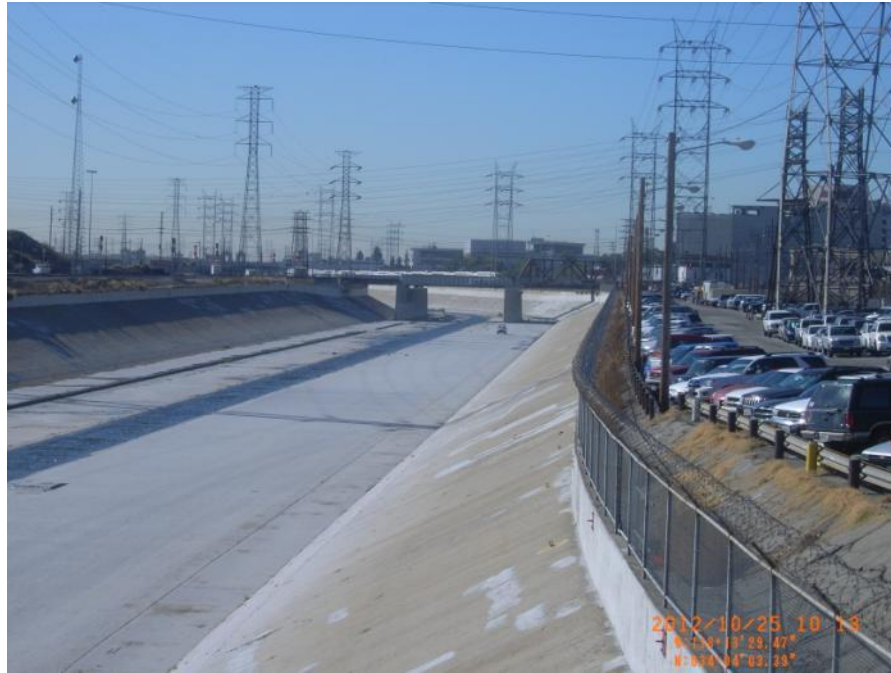
Photo 1: View looking downstream at N. Main Street. LAR 2 on right side. Not a levee condition. From top of wall and ascending slope approximately 5-feet in height with relatively level ground on landside.

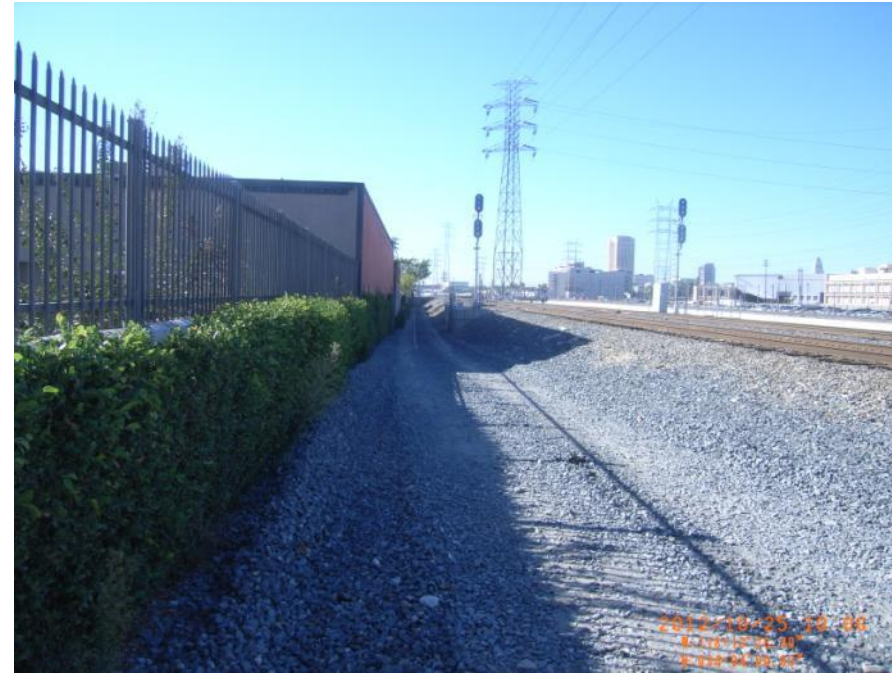
Photo 3: View looking downstream at N. Main Street. LAR 5 on right side. Not a levee condition. Ground in immediate foreground at approximately the same elevation of the wall depicted in Photo 2.

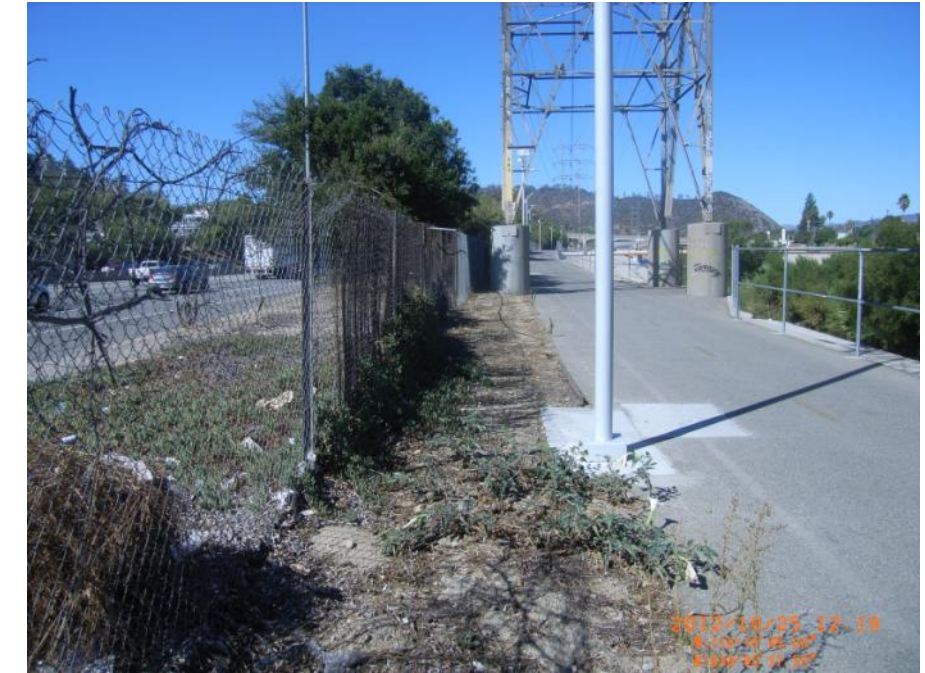
Photo 5: On crest of LAR 3 looking upstream. Not a levee condition. Although landside is slightly lower than crest. Flow would be directed along I-5 (on left) and the crest of the highway is above the crest of LAR 3.

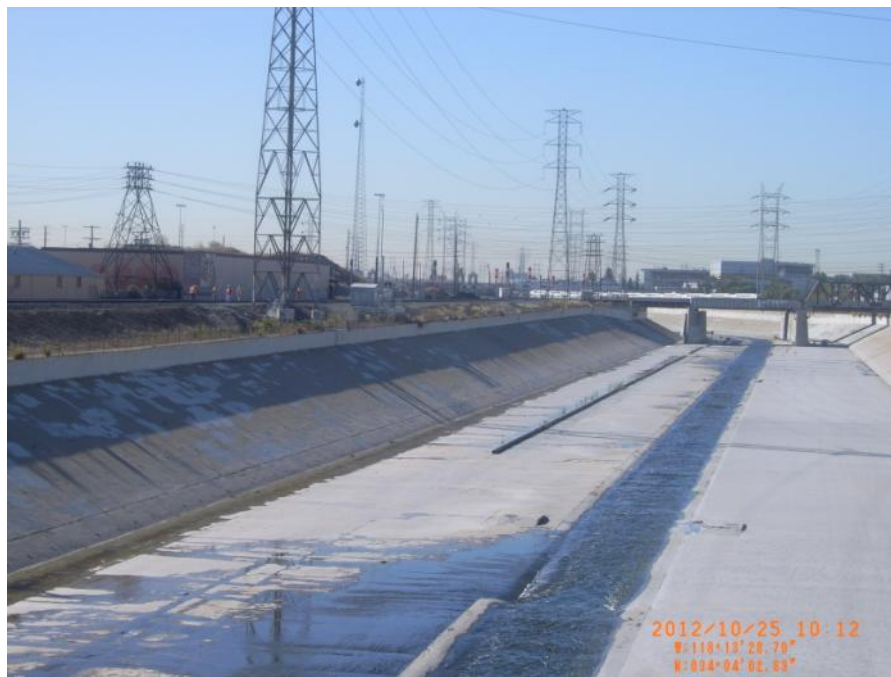
Photo 2: View looking downstream at N. Main Street. LAR 5 on left side. Not a levee condition. Railroad embankment with ascending slope above top of wall. Photo 3 depicts landside condition further.

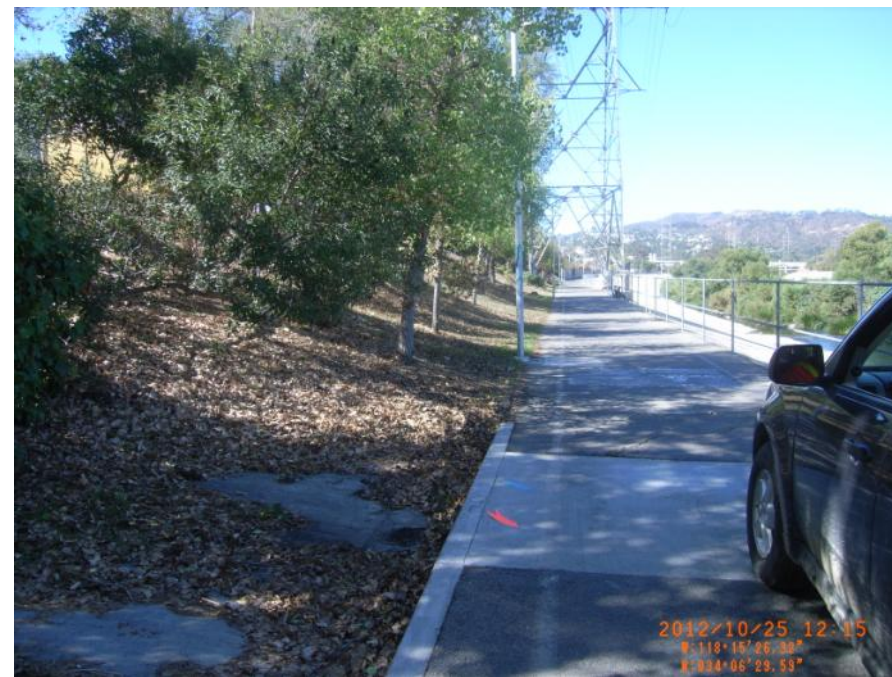
Photo 4: Looking upstream near downstream end of LAR 3. Not a levee condition. Ascending slope to high ground on landside. Vegetation would be within the VFZ if this portion is to remain listed as levee or is required for levee support upstream or downstream.

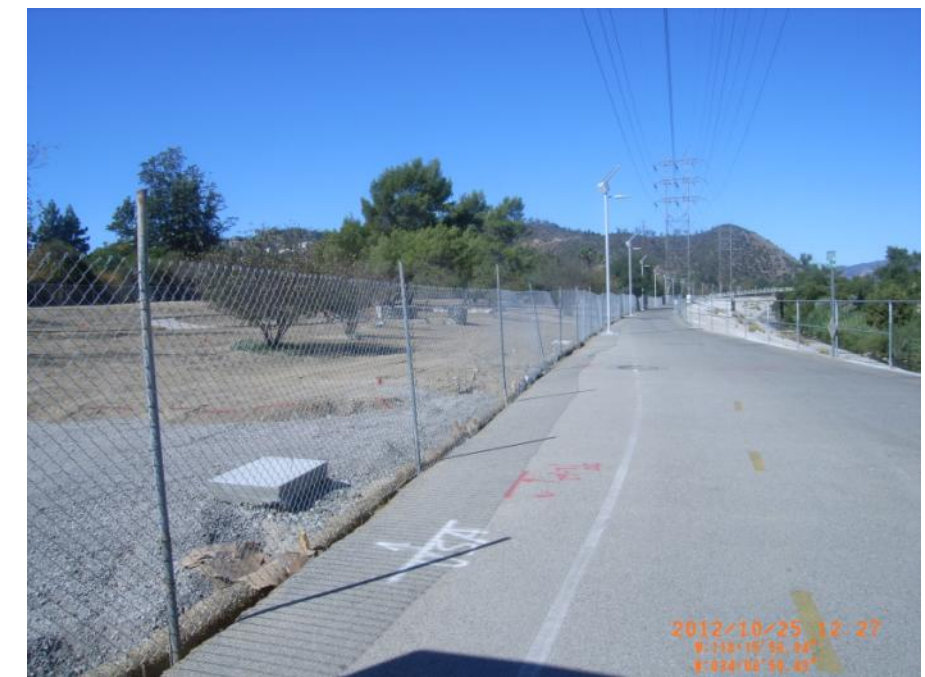
Photo 6: Looking upstream along LAR 3 just upstream of Hyperion Ave. Not a levee condition. Grades for park are above crest.

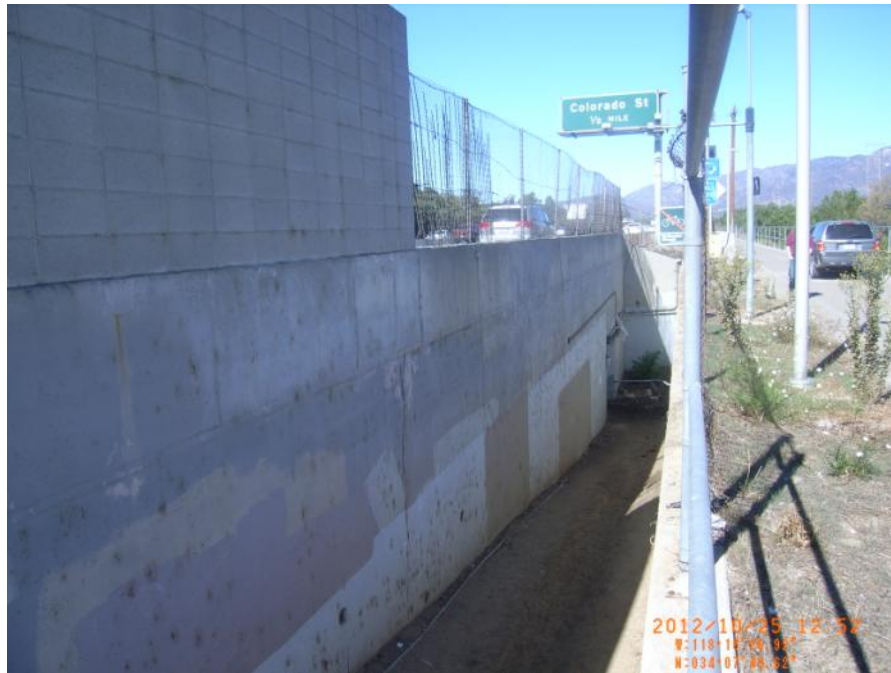
Photo 7: Equestrian ramp and tunnel entrance. Note crest on right, highway on left. Tunnel and culvert at base of down-ramp in center.

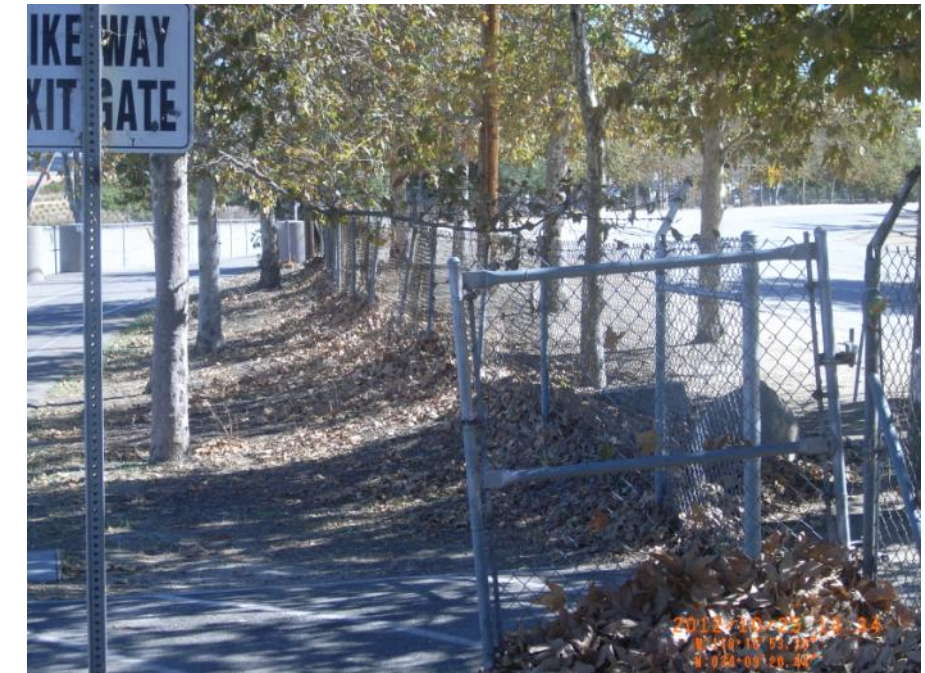
Photo 11: At Ferraro Fields looking downstream on LAR 3. Levee condition beyond right of photo and vegetation on landside crest.

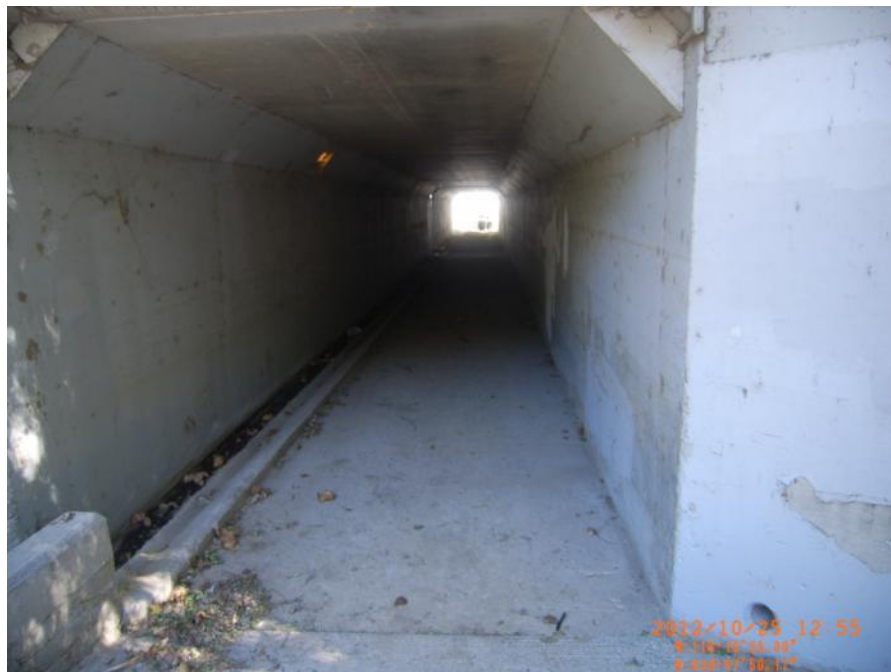
Photo 8: Landside of tunnel culvert at end of tunnel in background. Tunnel height allows horse and rider to pass through without rider bending over. Note small wall in foreground as it is the same wall depicted in Photo 9.

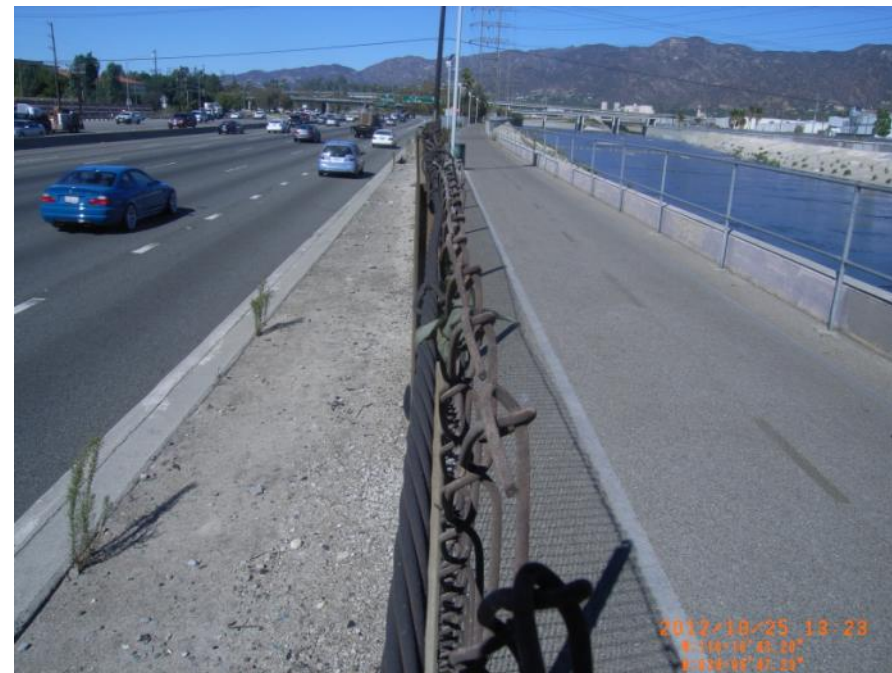
Photo 10: Looking upstream on LAR 3 near Gene Autry Museum. Levee condition of approximately 2 to 4-feet exists and flow would be directed on I-5 and along levee. Southbound lanes are higher than northbound lanes.

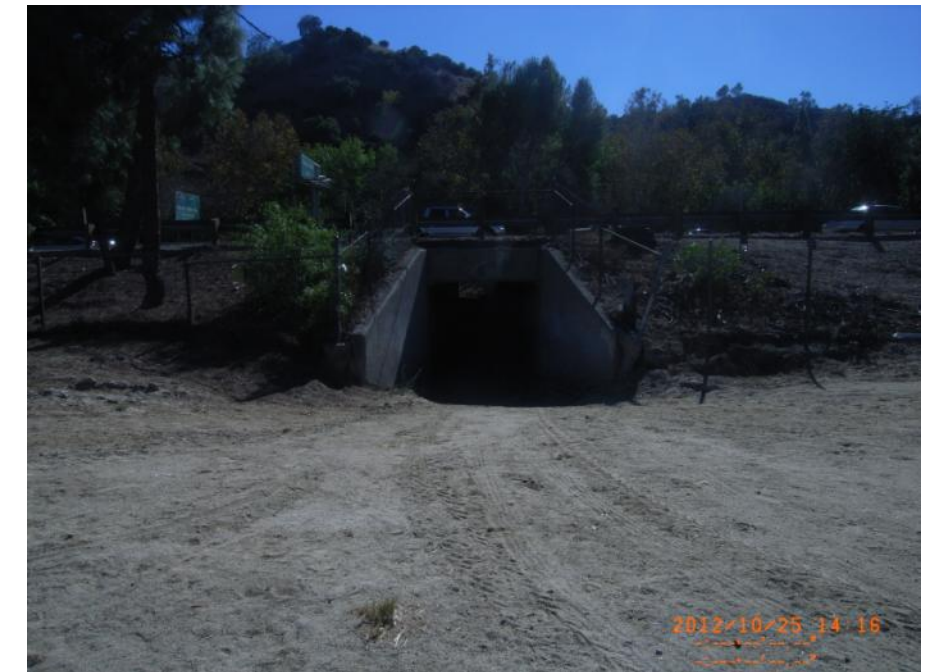
Photo 12: Equestrian undercrossing on landside of LAR 3. Photo taken at landside crest.

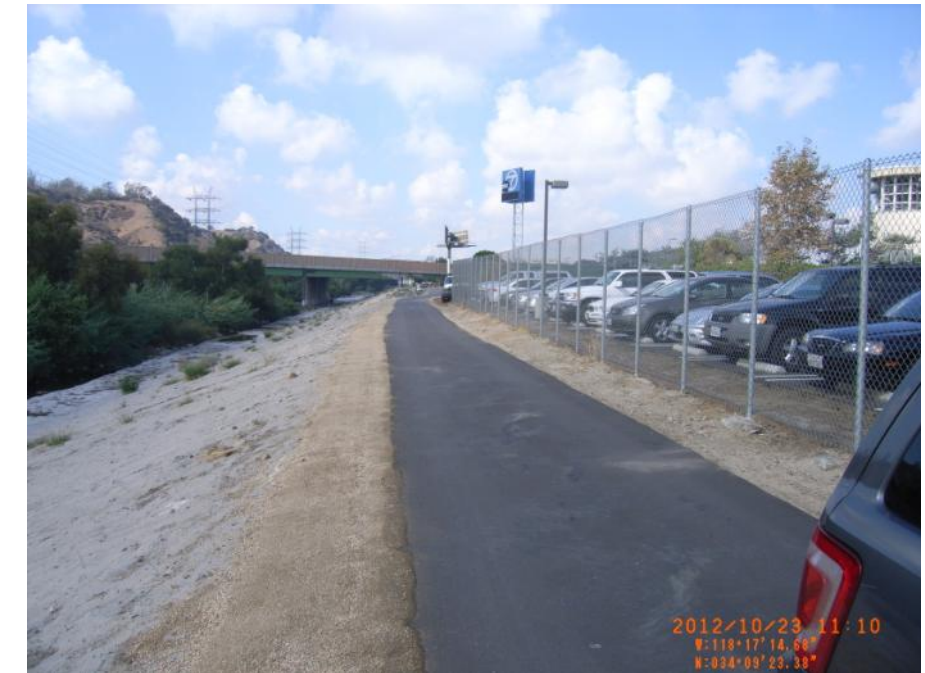
Photo 17: Looking upstream on LAR 7. Landside backfilled and not a levee condition.

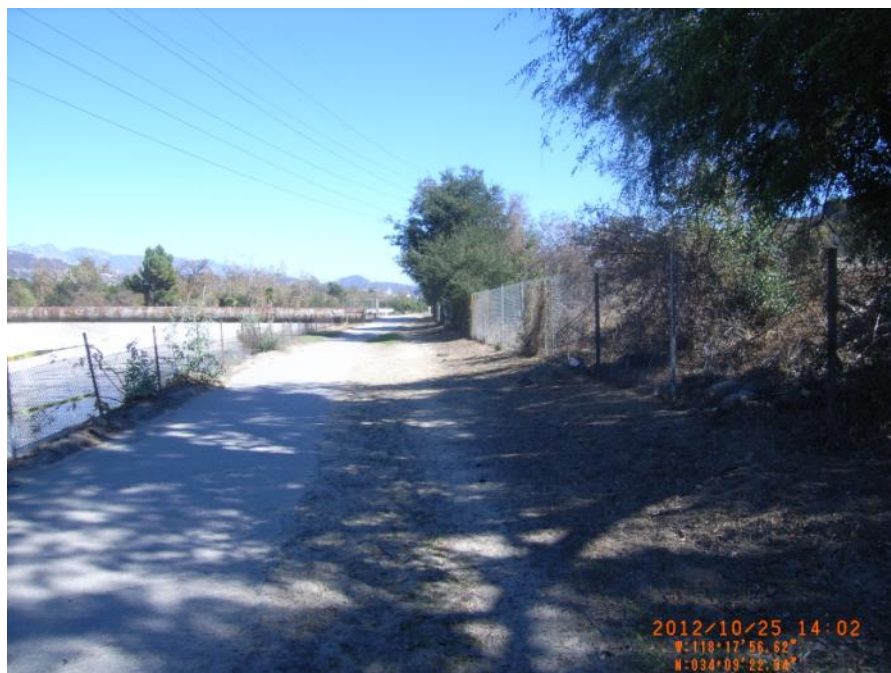
Photo 14: Upstream end of LAR 3 looking downstream. Vegetation on landside.

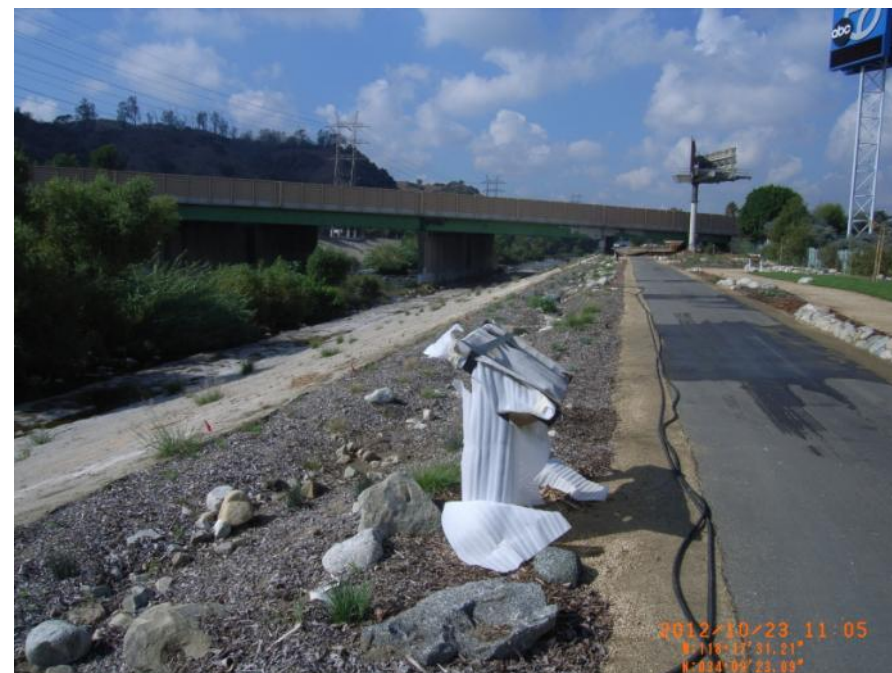
Photo 16: Looking upstream on LAR 7. Levee condition and irrigation lines at riverside crest and across entire landside slope. I-5 in background.

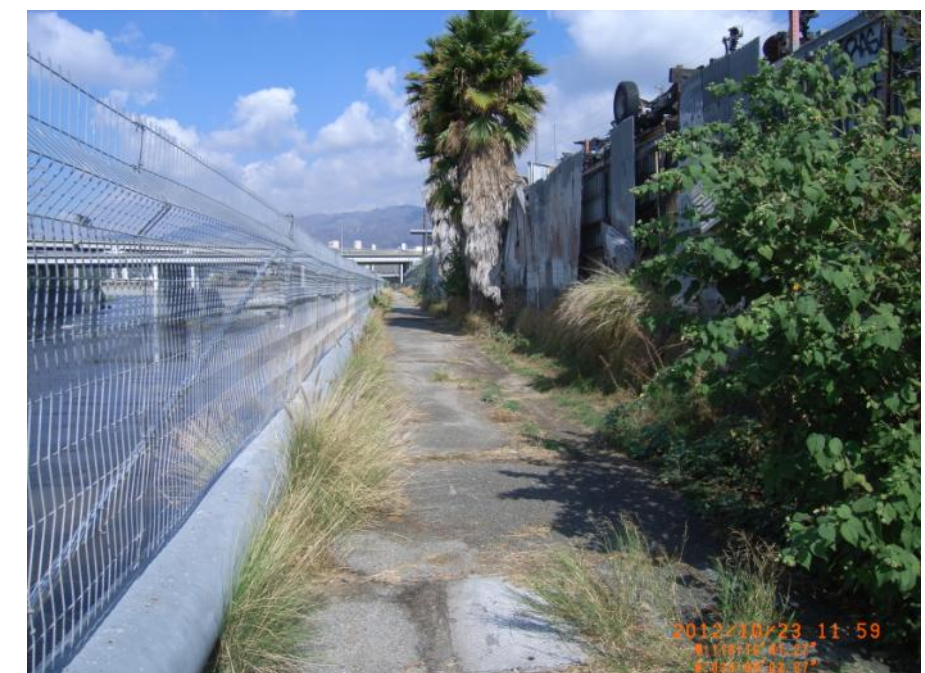
Photo 18: Looking upstream on LAR 6. Vegetation on levee and cannot inspect toe with fence.

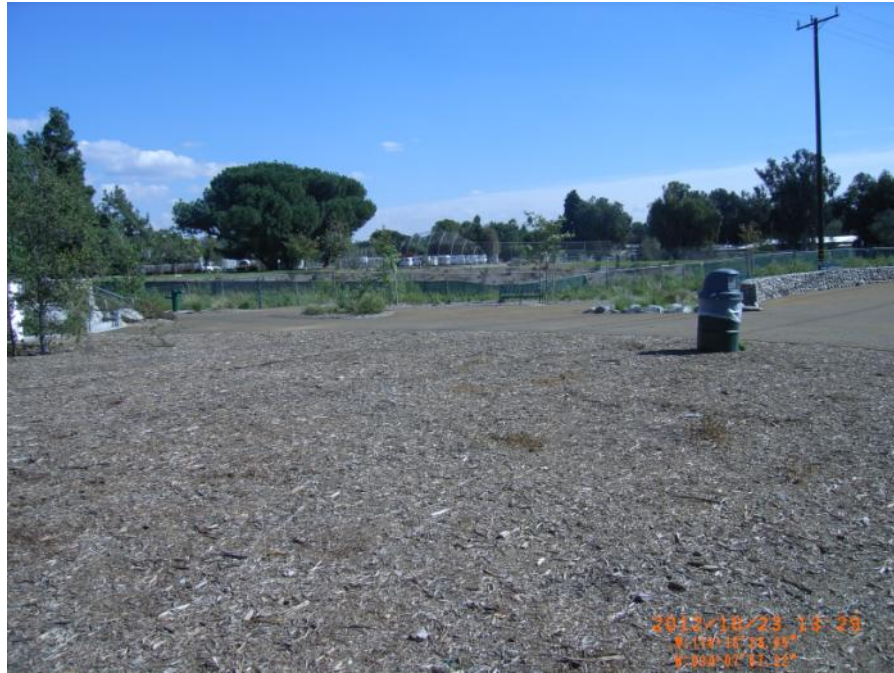
Photo 19: Atwater Park. Not a levee condition on LAR 6 but needed as levee conditions exist upstream and downstream.

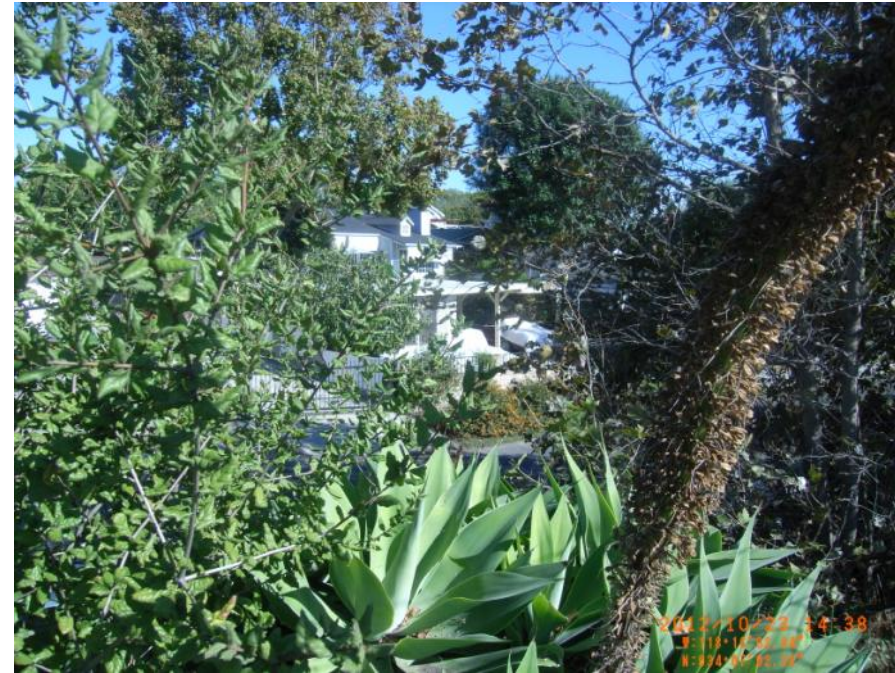
Photo 21: Vegetation on landside and levee condition on LAR 6.

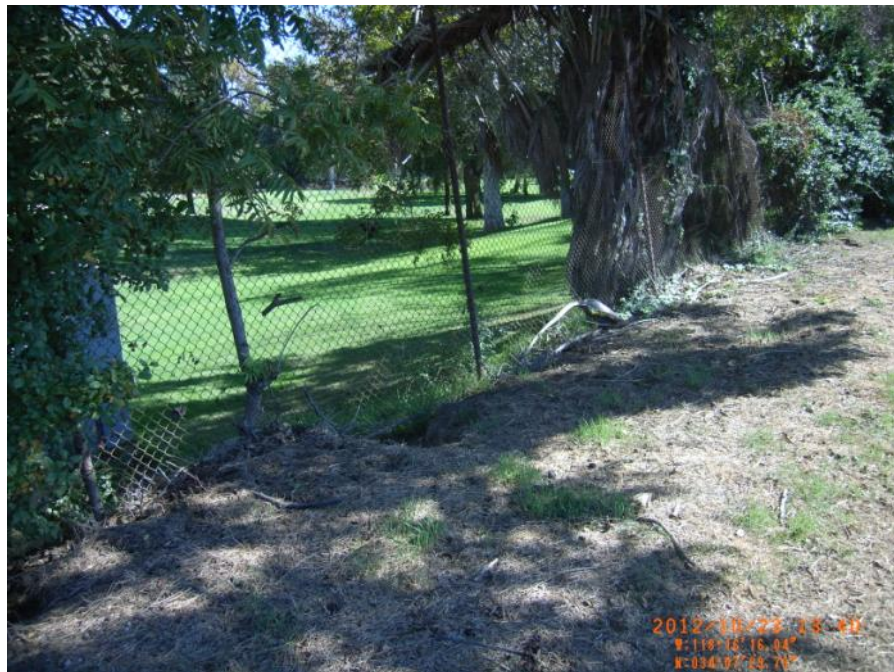
Photo 20: Los Feliz Golf Course. Vegetation on landside.

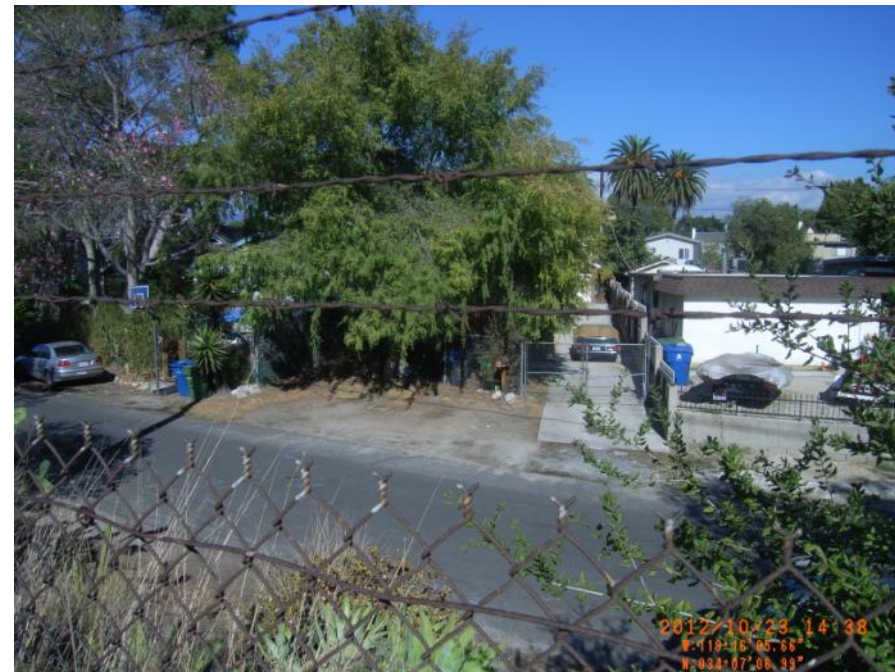
Photo 22: Taken in same vicinity of Photo 21 showing that this is a levee condition.
