# **UPLAND, BENEFICIAL USE, AND SEDIMENT DEWATERING SITE INVESTIGATIONS PHASE 2**

## **Long Island Sound Regional Dredged Material Management Plan (DMMP)**

**Contract No. W912WJ-09-D-0001  
Task Order #24**

November 15, 2010

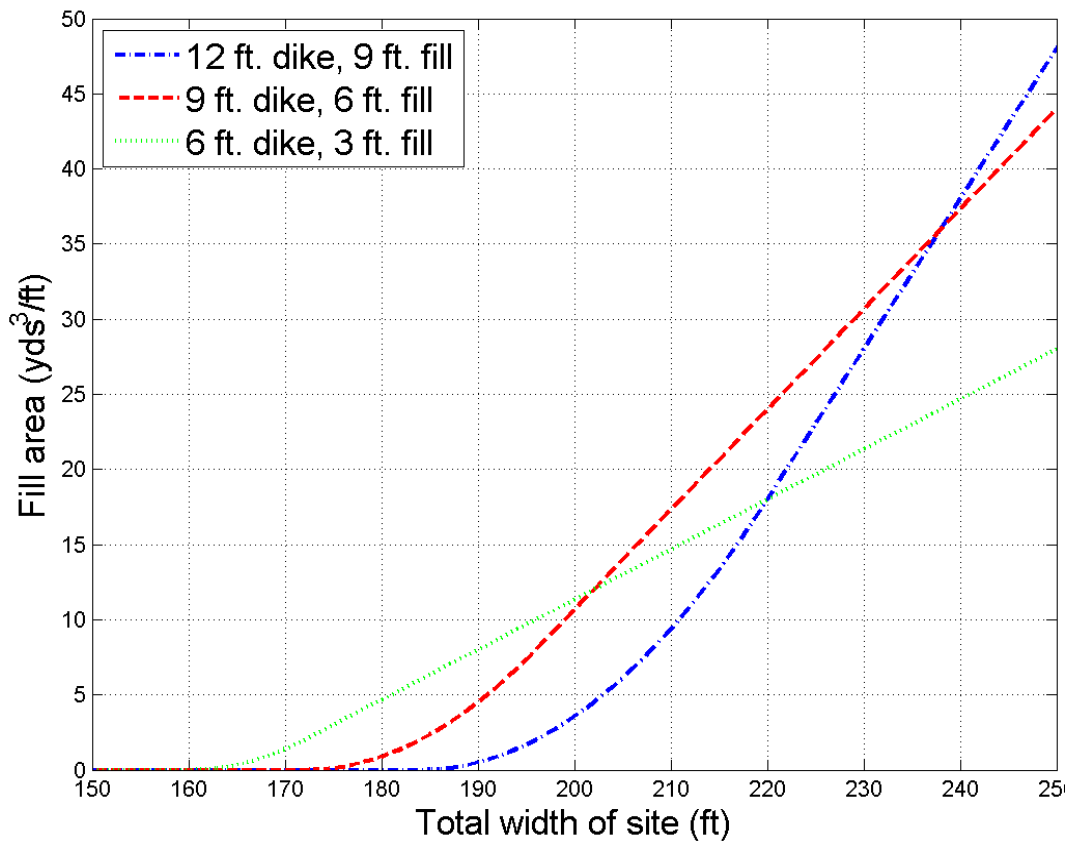
Figure 6. Site Width Versus Fill Area for Various Dike and Fill Heights.

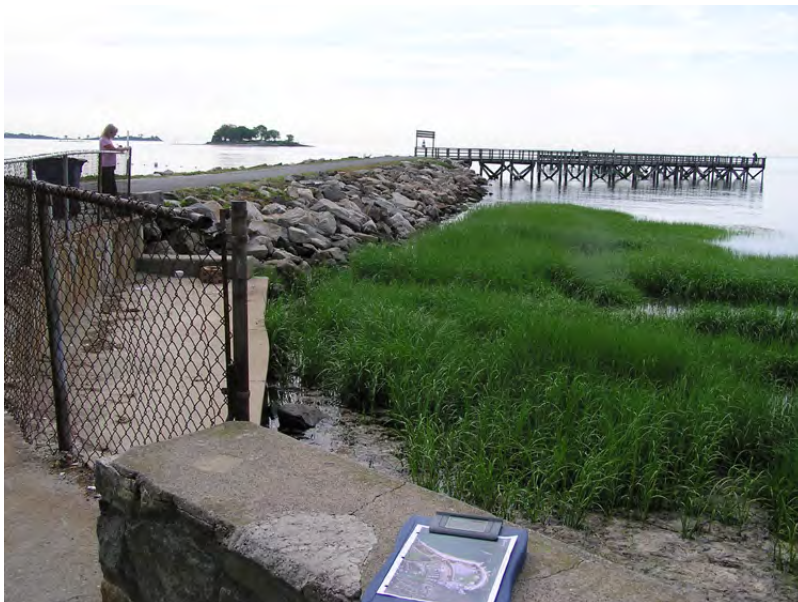
Beach profile looking north. Repairs on walk/bike path were underway during site visit.

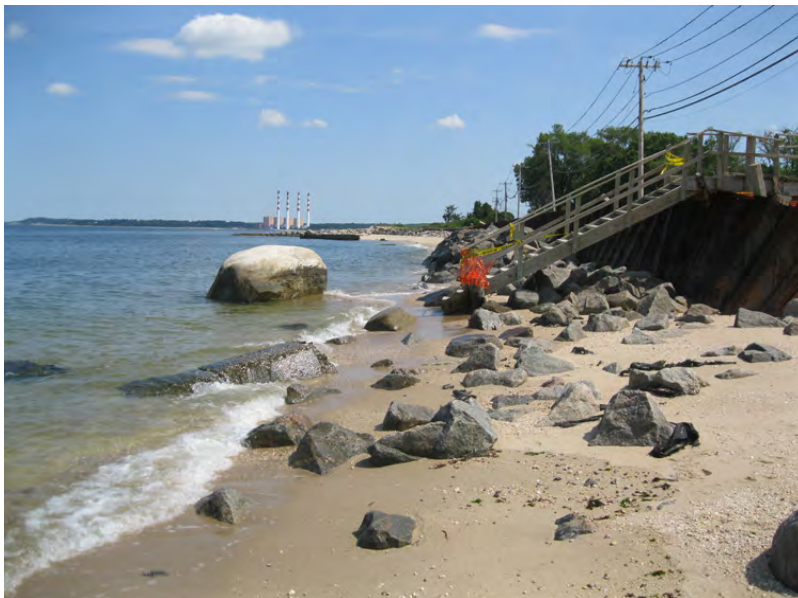
Western end of Asharoken Ave. threatened by erosion and ongoing repair work on the shore protection structures.

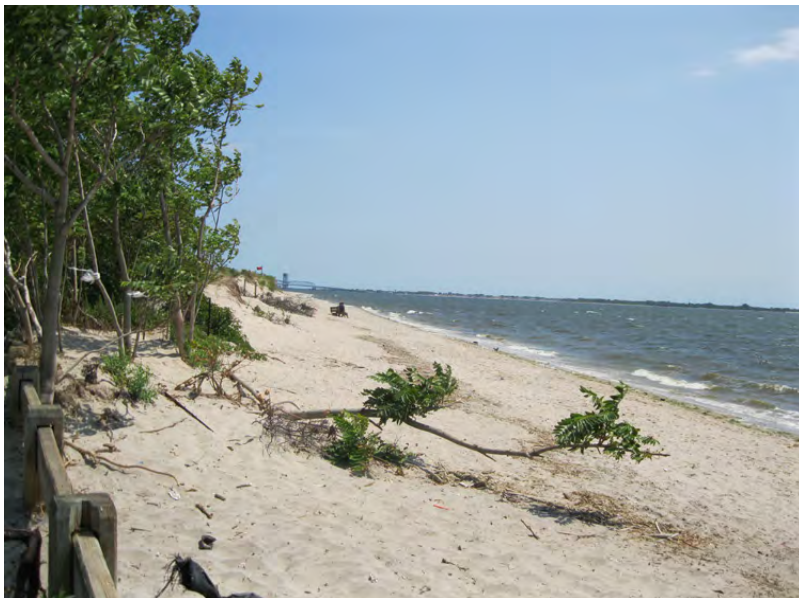
Current condition. Beach severely eroded and temporary sand bags have been placed to protect road and parking area.

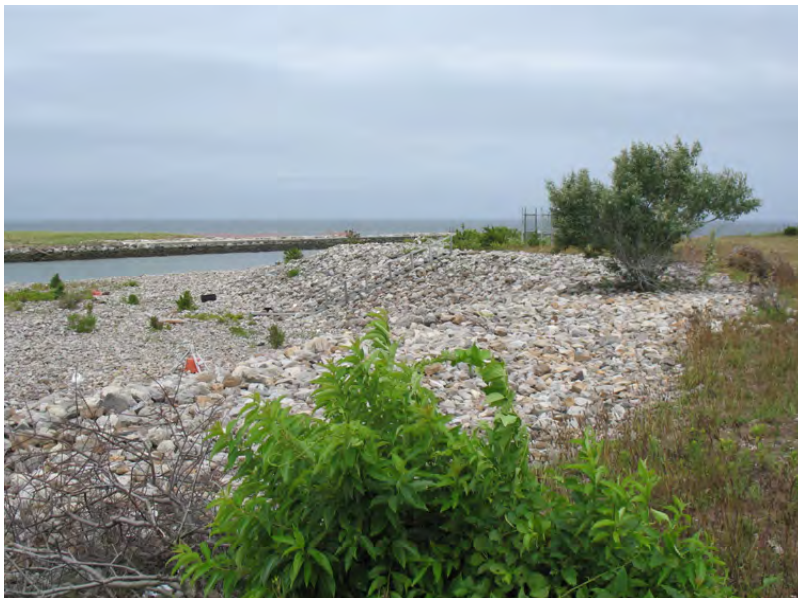
Existing conditions at site showing flat topography and vegetation consisting of weeds and grasses.

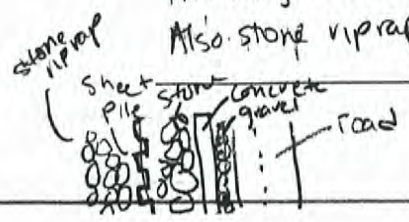
At narrowest section, sheet piles in place but damaged by Spring 2010 storm.  
Armoring includes steel sheet piles, with concrete behind (on road side of piles)  
Also stone riprap between sheet piles + concrete; gravel between road + concrete.

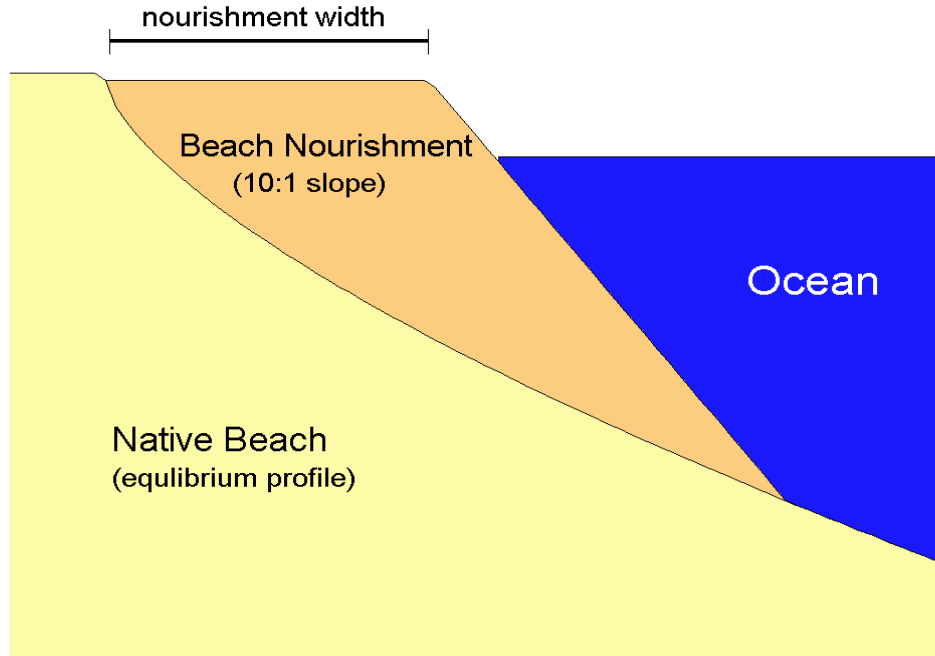
Appropriate values for the sediment scale parameter will be chosen based on the categorization of beach sediment during the site visits. Figure 1 shows an example of the equilibrium beach profile concept for a native beach and an assumed profile for the beach nourishment. The beach nourishment profile will be generated by extending the existing beach berm horizontally a distance equal to the proposed nourishment berm width, then grading the material down to the native profile with a slope no steeper than 10:1. A maximum 10:1 slope is recommended to accommodate potential shorebird habitat, to provide a conservative estimate of the capacity of the beach, and to make construction feasible. The volume per unit beach length is equivalent to “Beach Nourishment” area in Figure 1.

**Figure 1. Example equilibrium beach profile for native beach and assumed beach fill profile.**

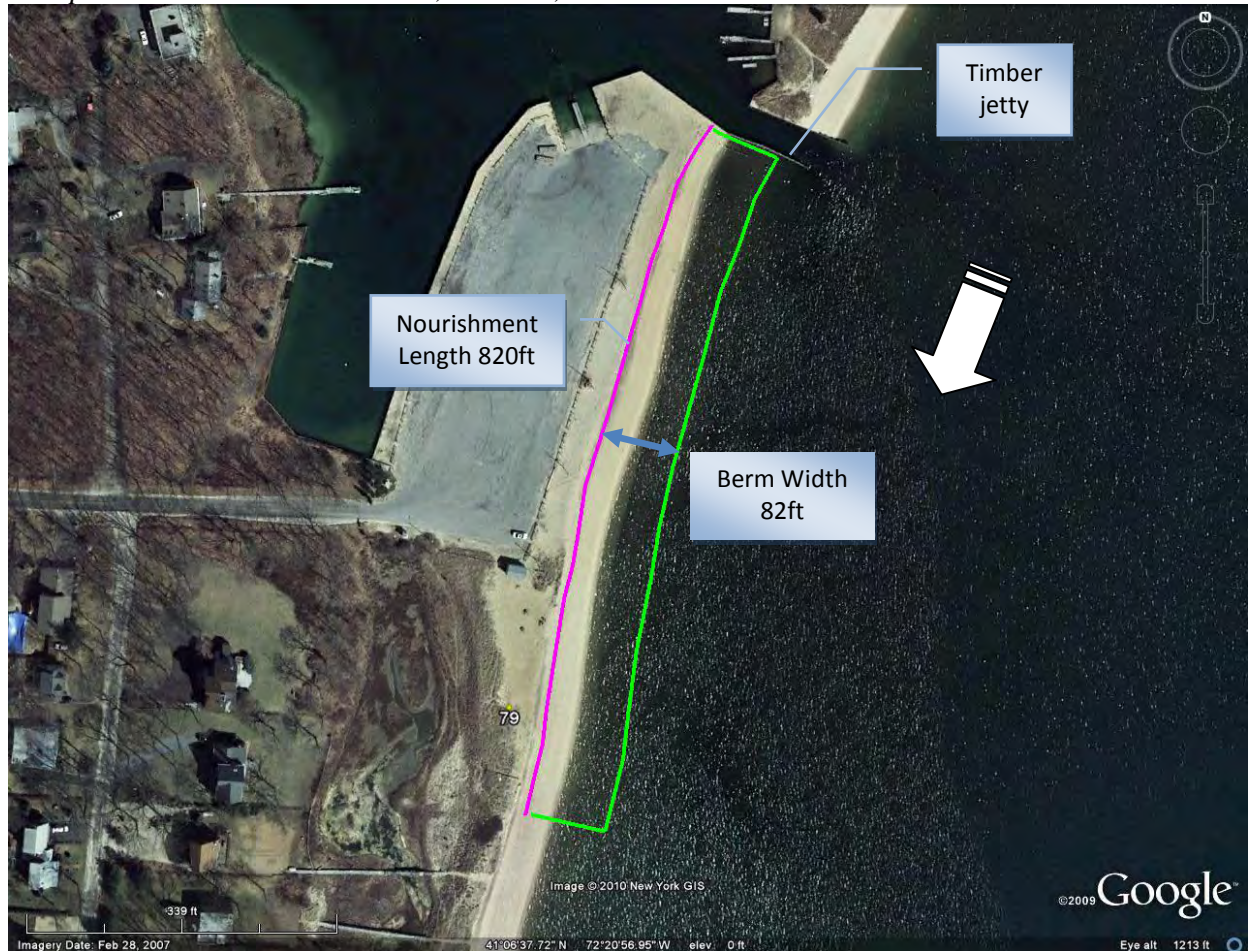
*Example: Site 79 – Gull Pond Beach, Southold, NY*

*Approach: Choose the smaller of (a) extend berm to end of structure, (b) extend berm 10% of the length of the beach, or (c) extend berm to 100 feet.*

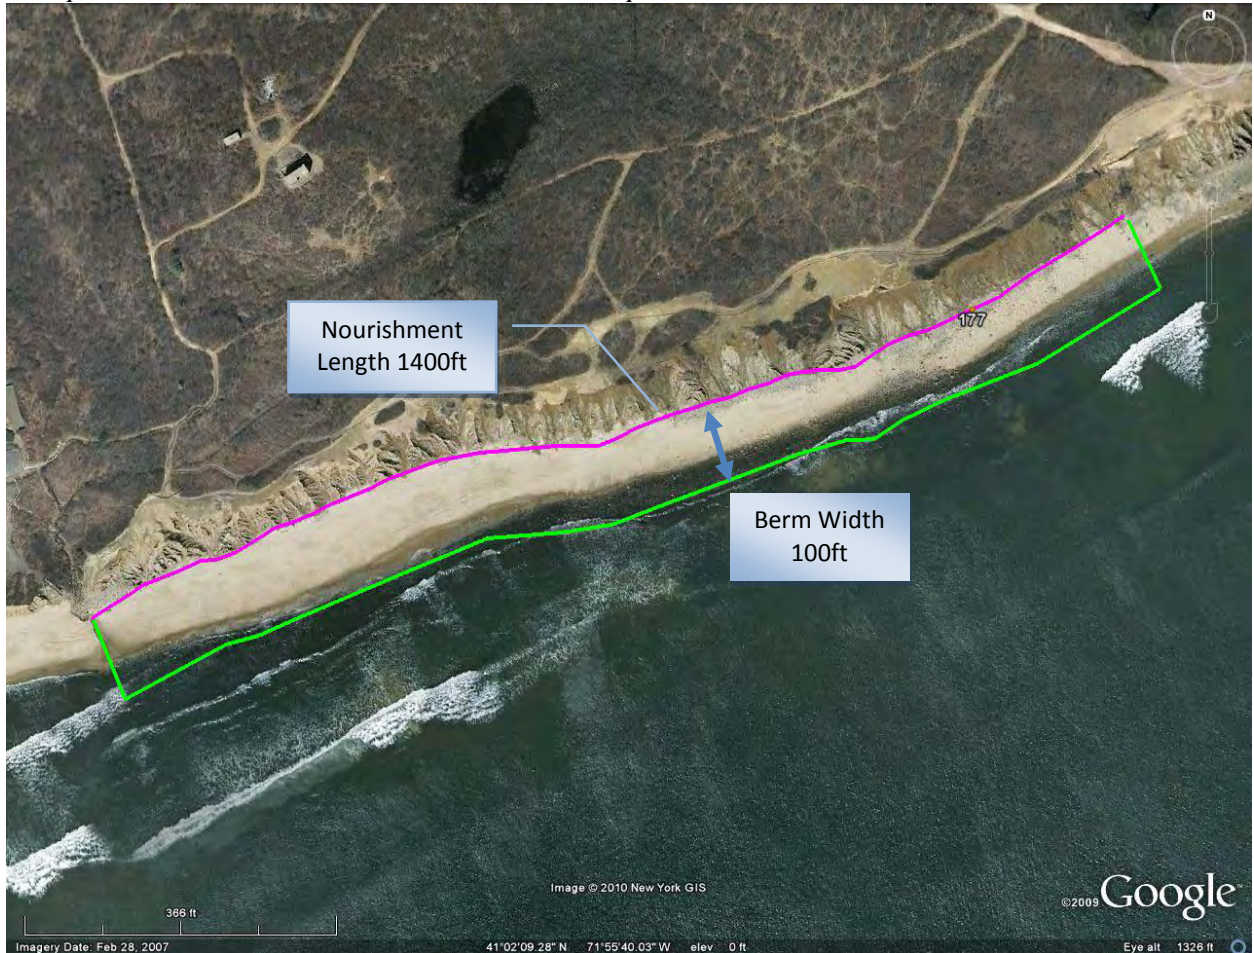
*Example: Site 177 – Shadmoor State Park, East Hampton, NY*

*Approach: Extend berm 10% of the length of the beach, to a maximum of 100 feet.*

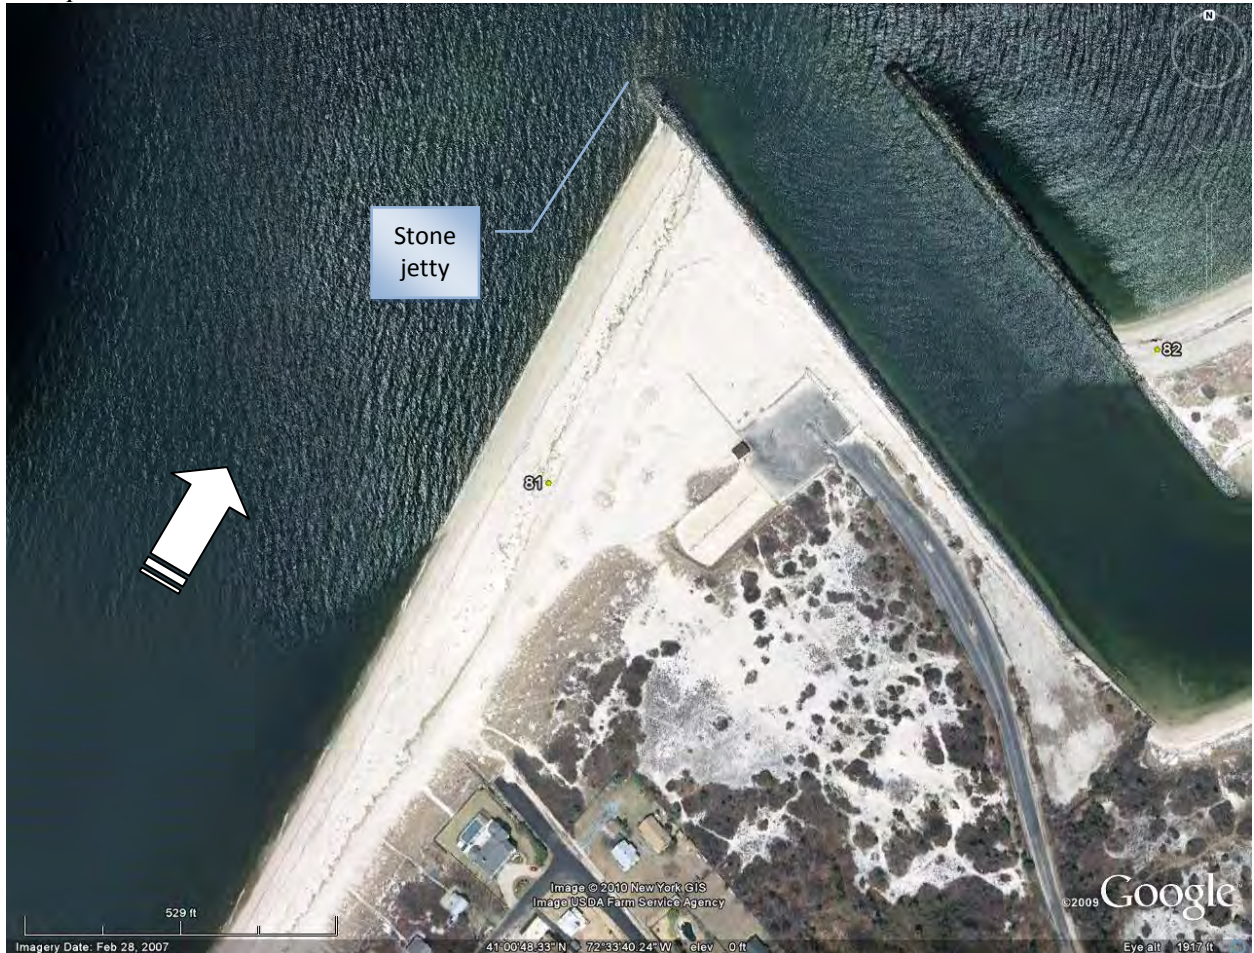
*Example: Site 81 – Breakwater Park Beach, Mattituck, NY*

*Approach: No nourishment recommended.*

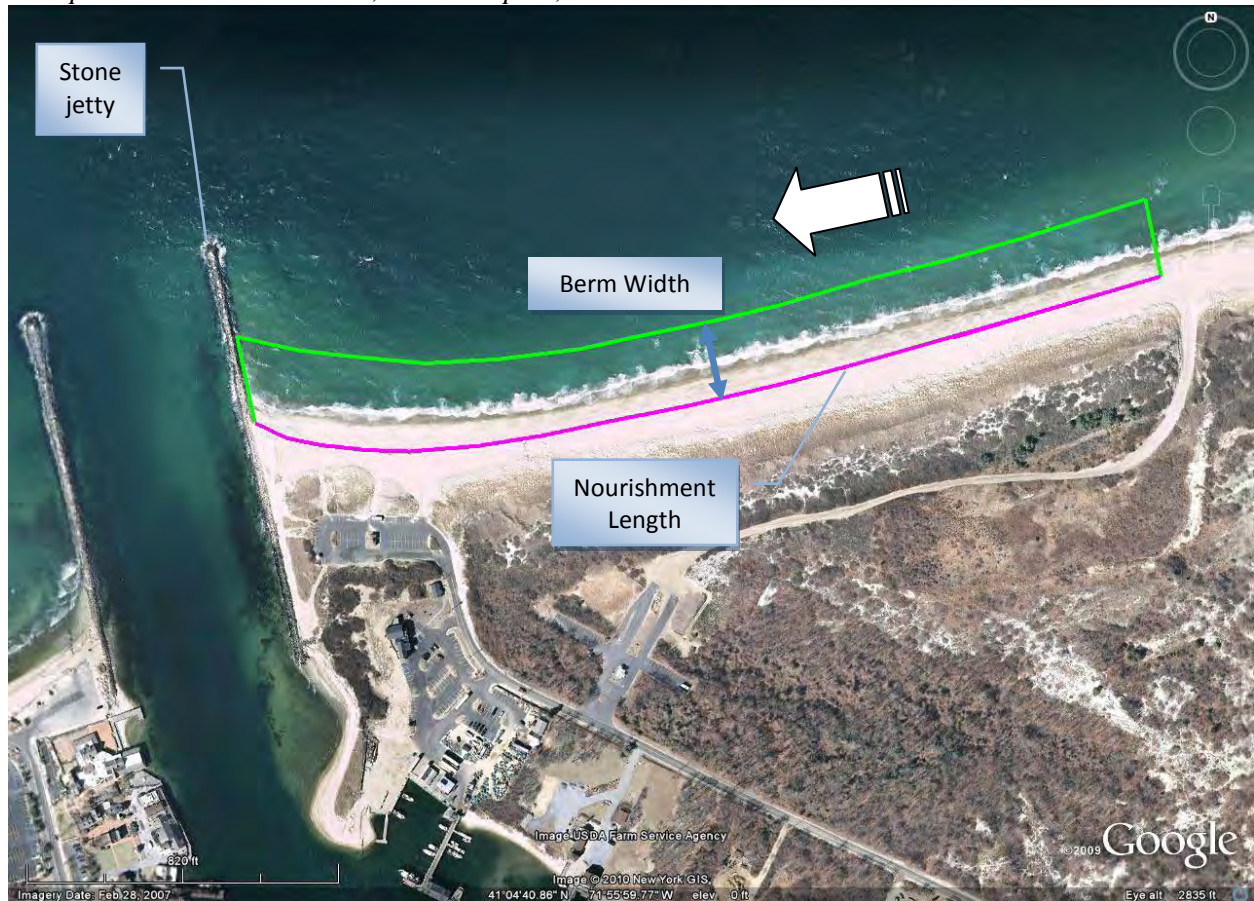
*Example: Site 121 – Gin Beach, East Hampton, NY*

*Approach: There is nourishment capacity, but amount and configuration to be determined by engineering judgment.*

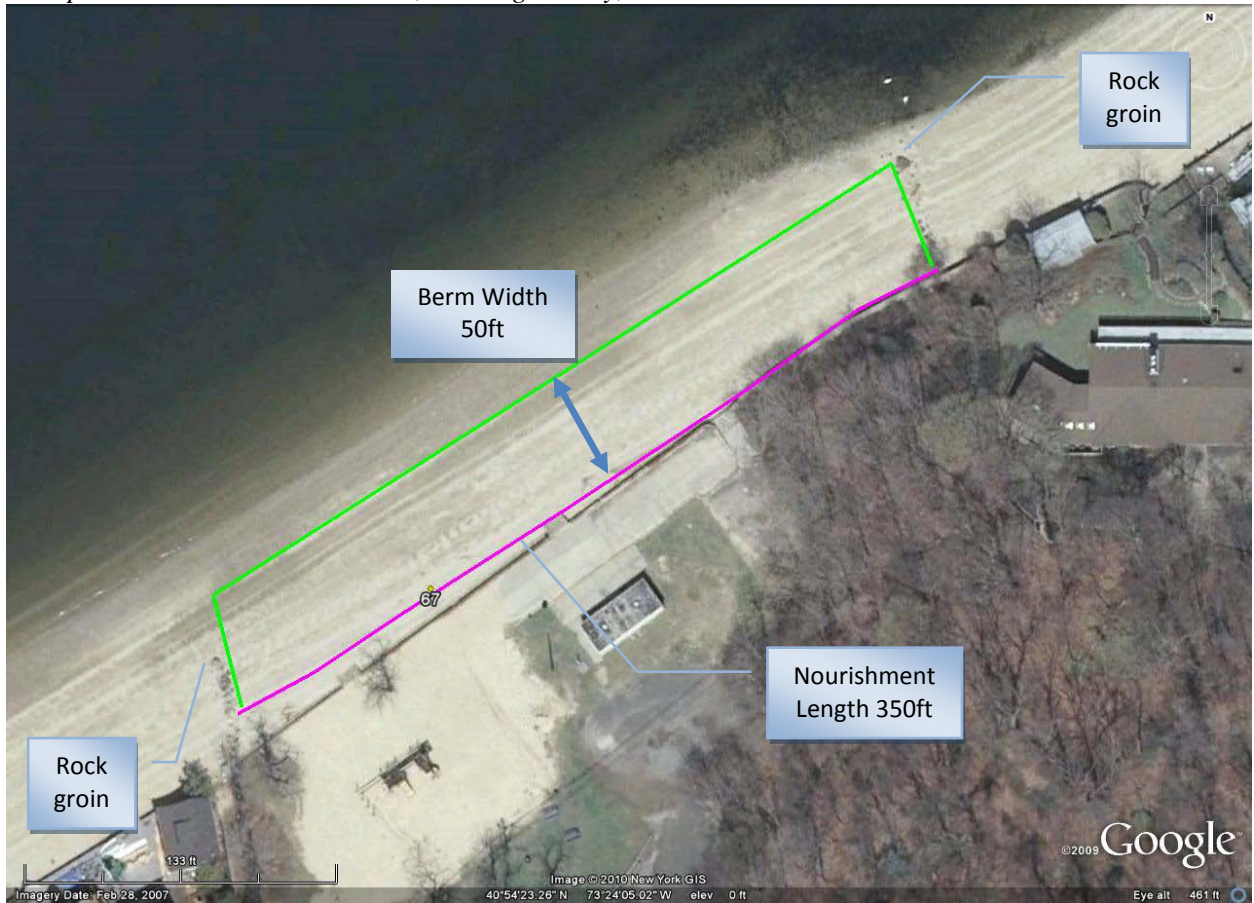
*Example: Site 67 – Crescent Beach, Huntington Bay, NY*

*Approach: Extend berm to end of structure (in this case, to a width of 14% of beach length).*

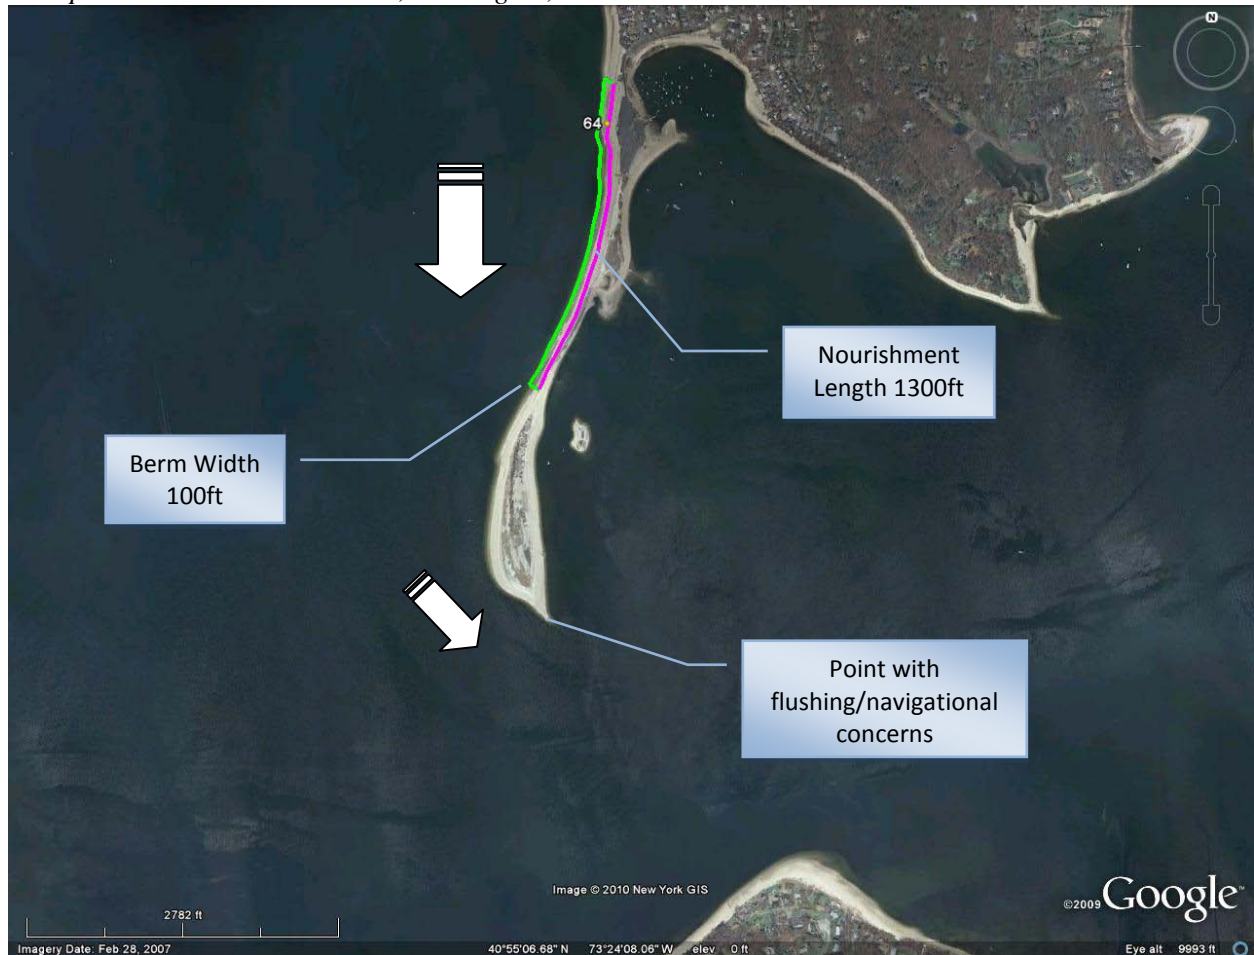
*Example: Site 64 – Hobart Beach, Huntington, NY*

*Approach: Use engineering judgment to determine appropriate length of beach nourishment, then extend berm 10% of the length of the beach, to a maximum of 100 feet.*
