#### **I-2-4. Erosion**

#### **I-2-5. Solutions**

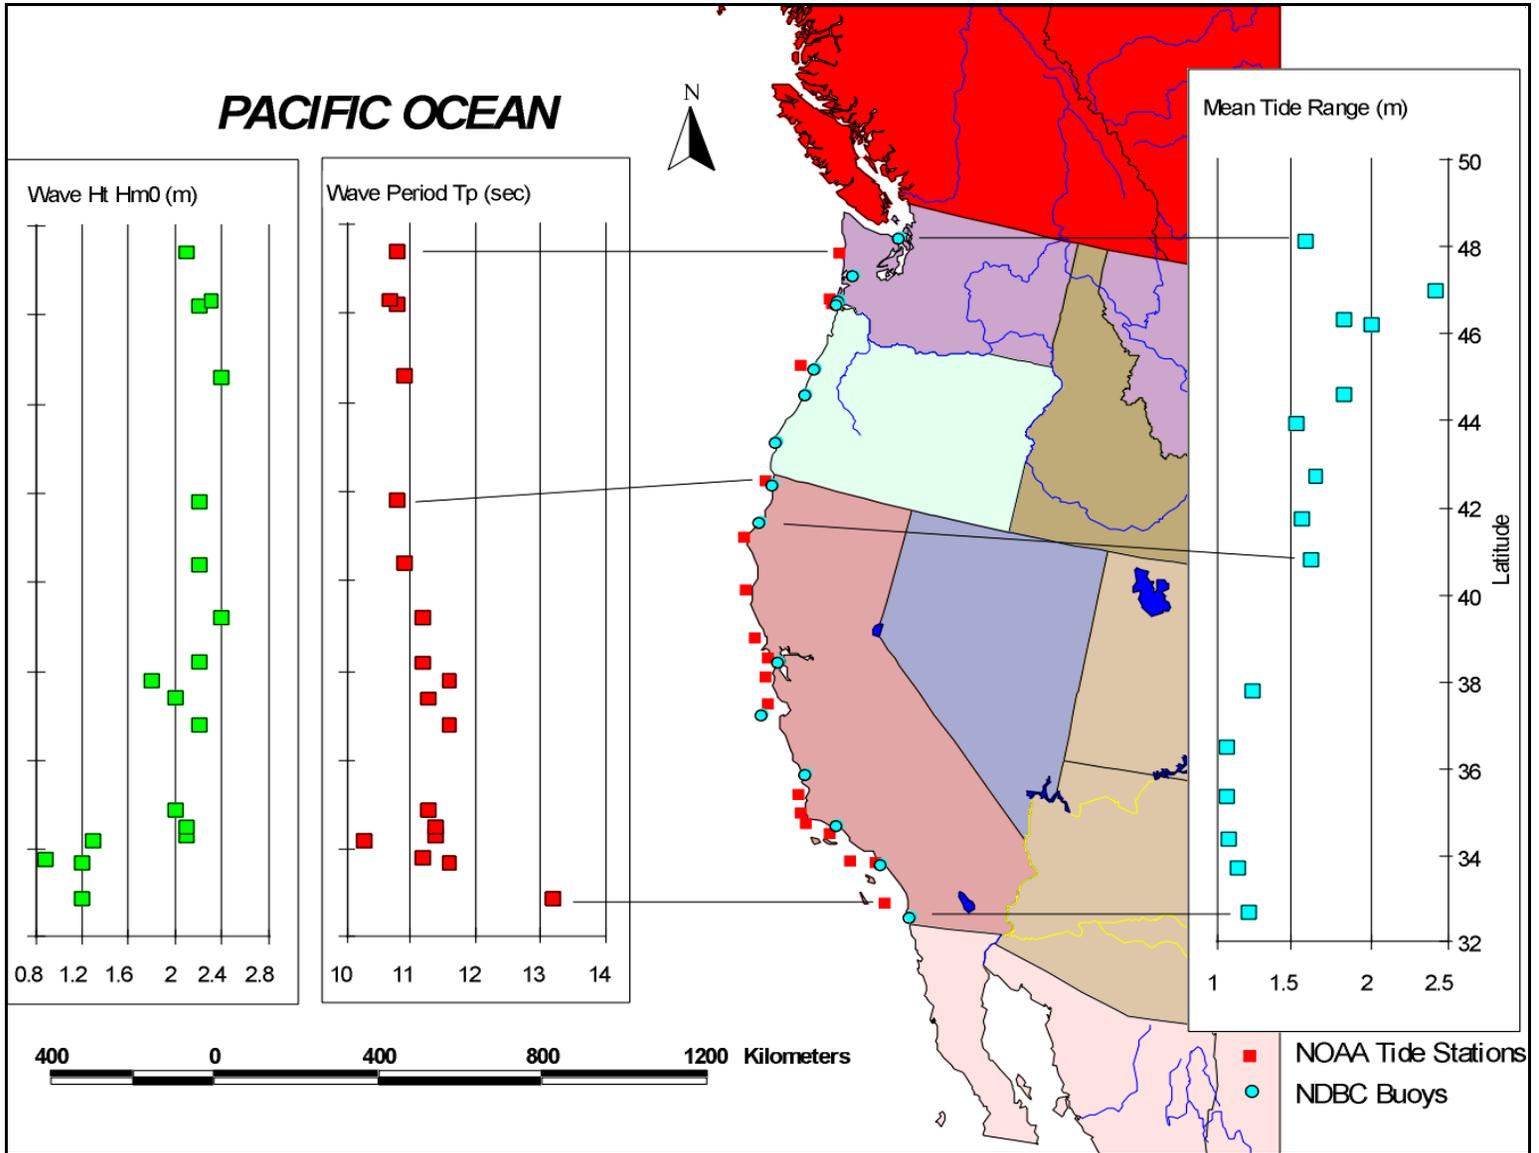
Figure I-2-14. Pacific coast tide and wave characteristics. The southernmost buoy shows high wave period because of the influence of swell waves and sheltering from wind waves provided by offshore islands

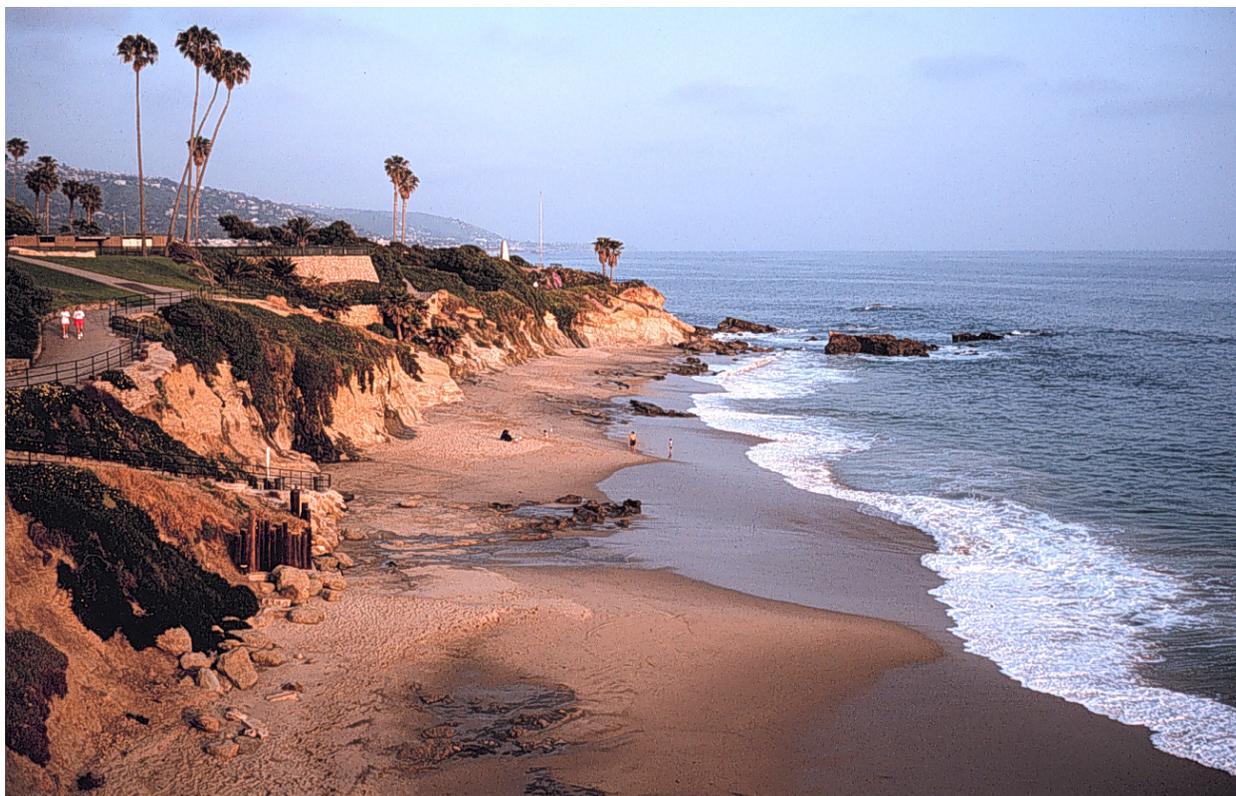
**Figure I-2-15. Pocket beach just north of Laguna Beach, southern California (April 1993). Poorly consolidated sandstone and conglomerate bluffs in this area are highly vulnerable to erosion, jeopardizing exclusive residential properties. Erosion is caused by storm waves and groundwater runoff**

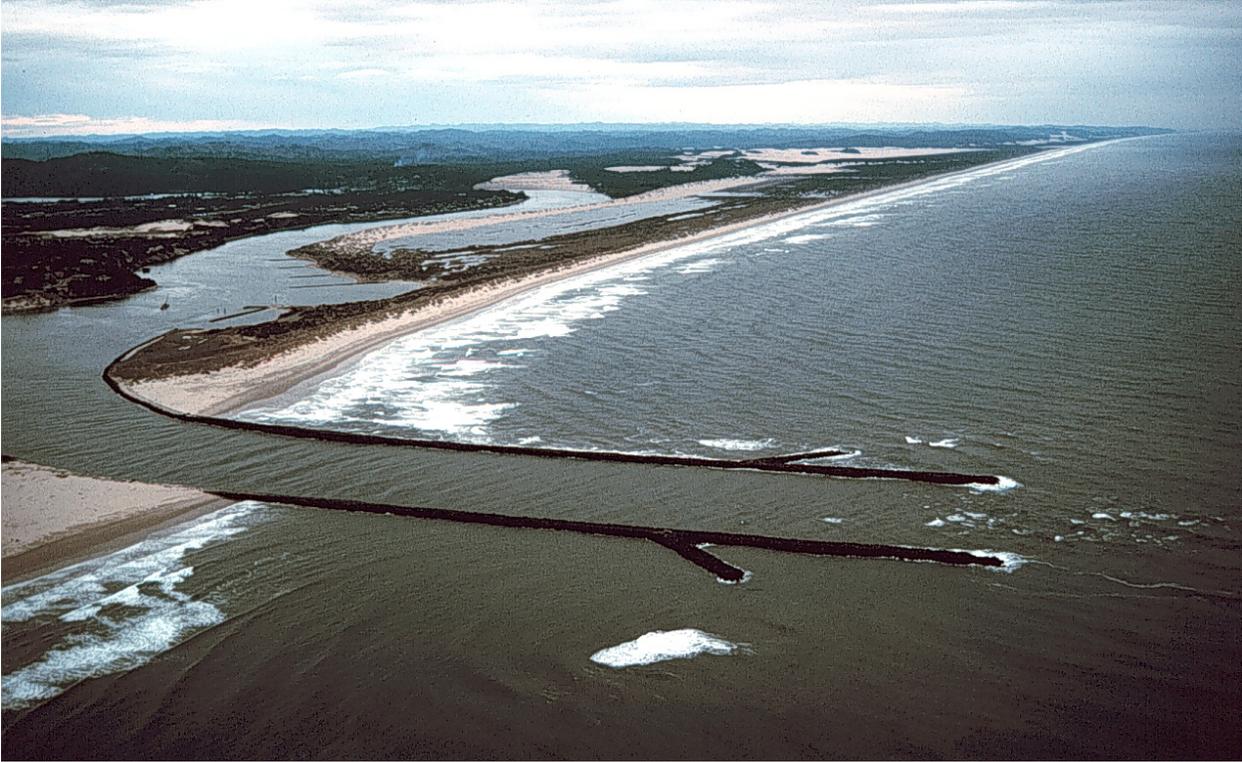
**Figure I-2-16. Mouth of the Siuslaw River, southern Oregon near the town of Florence (December 1994; view looking south). This and other Federal navigation projects on the Oregon and Washington coasts are difficult and expensive to maintain because of high wave energy and a short construction season. The scale of these Pacific projects is difficult to appreciate from aerial photographs: the Siuslaw rubble-mound jetties, first built in 1917, are 180 m apart and the north jetty is 2300 m long. The shore in this area consists of long barrier spits interrupted with rocky headlands**
