**US Army Corps
of Engineers**

NATIONAL CRANE PDT

WEIGHT HANDLING SAFETY

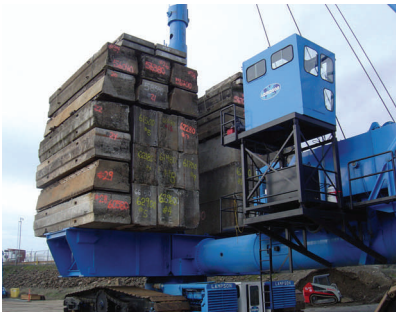
The Dalles Lock and Dam - Completed over 50 years ago, both of the 350-ton downstream gates have suffered cracks and other metal stress in the past 5 years that caused the gate to vibrate and not close properly. In February 2010, the Portland District contracted with Dix Corporation (Spokane, WA) to replace the two gates and their associated components.

Dix Corporation brought in a Lampson Transi-Lift LTL-1100 crane to facilitate the removal and replacement of the gates. Lampson builds the largest cranes in the United States and this job required the biggest and the best to ensure that all went as planned.

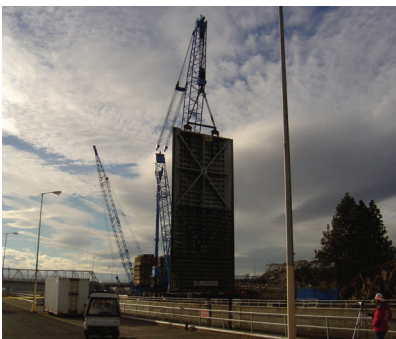
The weather and all unknown factors were discussed and really didn't hinder gate removal operations.

Lesson learned: checking numbers/weights is critical but preparing for the unknown is VITAL. The estimated gate weight was 780-790,000lbs but in the end the true weight was 850,000lbs. The vital part is in the crane capacity and by having a larger crane you can overcome these unknown factors when they occur. "When things go in the wrong direction they multiply fast and you can't go back, so always use the 6 P's".

The lift for the first gate started at approximately 1040 hrs and the laying down of the gate was completed at or around 1700 hrs—slow, precise movements with great communication for the three crane operators and lift director were key to the success of this phase of work.

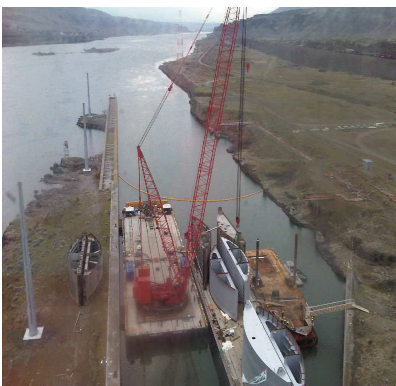
John Day Lock and Dam - The guillotine gate on the downstream navigation lock has been in place since the 1960's. Replacing this gate and all associate equipment to include two 150,000 pound each friction drums, has taken a great deal of planning and preparation from Corps of Engineers and Contractor employees. The old navigational lock gate was taken out in 4 pieces with each piece weighing up to 550,000 pounds, making every lift a critical lift. After all the sections were cut, the contractor lifted each section using a Manitowoc 888 Ringer crane with 250 foot of boom, mounted on a 286' X 76' flat deck barge. Due to the floating bulkhead that keeps the water out of the lock area during repairs, the floating crane could only get within 100 feet of the picking location. This caused some concern as the margins for safety are small due to all high winds, water chop, etc that are present at John Day this time of year.

Installation of the new gate is underway. Just like the old sections, the new gate sections are being put back into place as 4 sections with the 1st section weighing the most at over 572,000 pounds. As of January 28th, all 4 sections of the old gate have been removed and two new sections have been re-installed. Both the south and north friction drums are in place. A Manitowoc 2250 crawler crane is being used to place these friction drums into the north and south towers.

Lesson Learned: You can always prepare for the worst, but you also need to take your time on these extremely heavy picks to ensure the entire crew is on the same page. The Manitowoc 888 ringer crane and barge configuration was load tested in Vancouver per ASME B30.8 standard, which states the crane will be tested at 100% of the capacity while putting the crane thru the full range of motion that will be utilized for the picks. Due to the naval architect engineer's calculations, the barge has to be ballasted during picking, swinging, and placement of the gate sections. The crane only has a half of degree load chart, so when ballasting, it is crucial to have great communication to ensure the pick goes as planned. The crane operator

has to continuously monitor the list and trim indicator while the crew ballast from side to side to ensure the crane does not exceed the 1/2 degree load chart. Also to achieve the height needed to get the new and old sections of gates in and out, the Bonneville Power Administration (BPA) was asked to hold the tailrace elevation at 161 feet (msl) to facilitate the radius of the pick during the critical lift. Once again this highlights the high level of communication not only from the contractor, but from the Corps of engineer's project engineer and the BPA.

The first pick at John Day started at approximately 0900 hours on January 5, 2011 by removing the first old gate section. The lift cycle was completed approximately 1800 hours when the gate section was placed on the barge and secured.

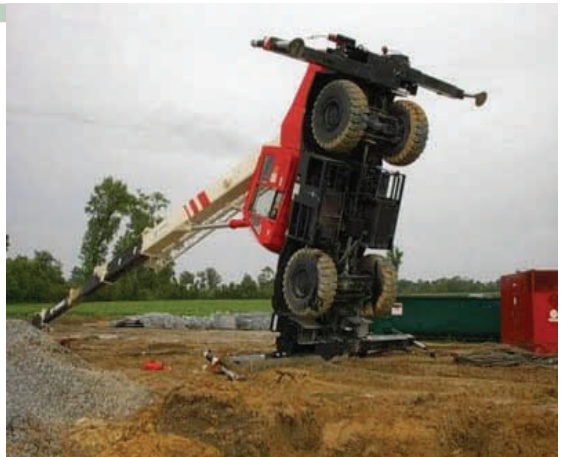
THE ANSWER— Unstable soil conditions. The direct cause of this accident...

In our EM, Section 16.D.08 (Start-up Inspections), 8(k) denotes to inspect, "ground conditions around the equipment for proper support, including ground settling under and around outriggers and supporting foundations, ground water accumulation, or similar conditions;
