Los Angeles River Ecosystem Restoration Feasibility Study

**DRAFT – APPENDIX D
GEOTECHNICAL, INCLUDING HTRW**

DRAFT Geotechnical Feasibility Report
Los Angeles River Ecosystem Restoration Study Project Area, Los Angeles County, CA

SUBJECT: Los Angeles River Ecosystem Restoration Study
Levee Condition Inspection and Issue Discussion

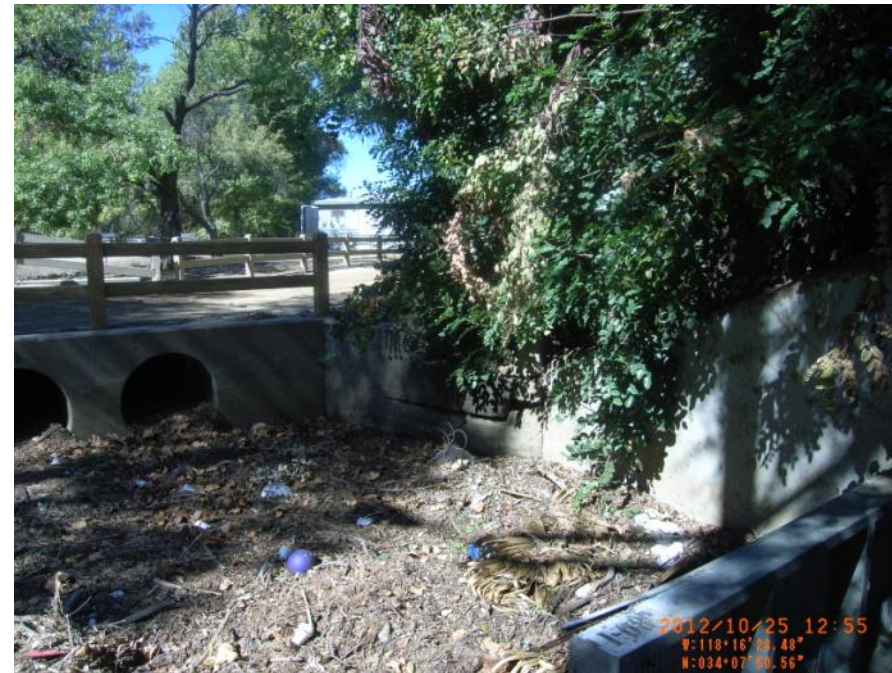
Photo 9: Landside of tunnel looking upstream. Wall in foreground is the wall depicted in Photo 8. The building in background is at approximately same grade as top of tunnel.

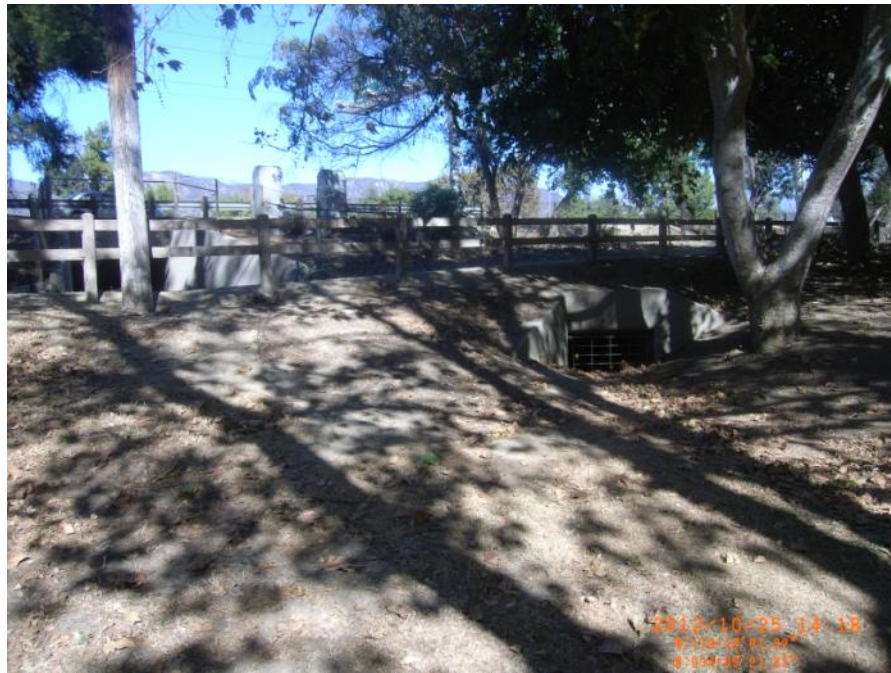
Photo 13: Landside of undercrossing on left side. Inlet of drain on right side.

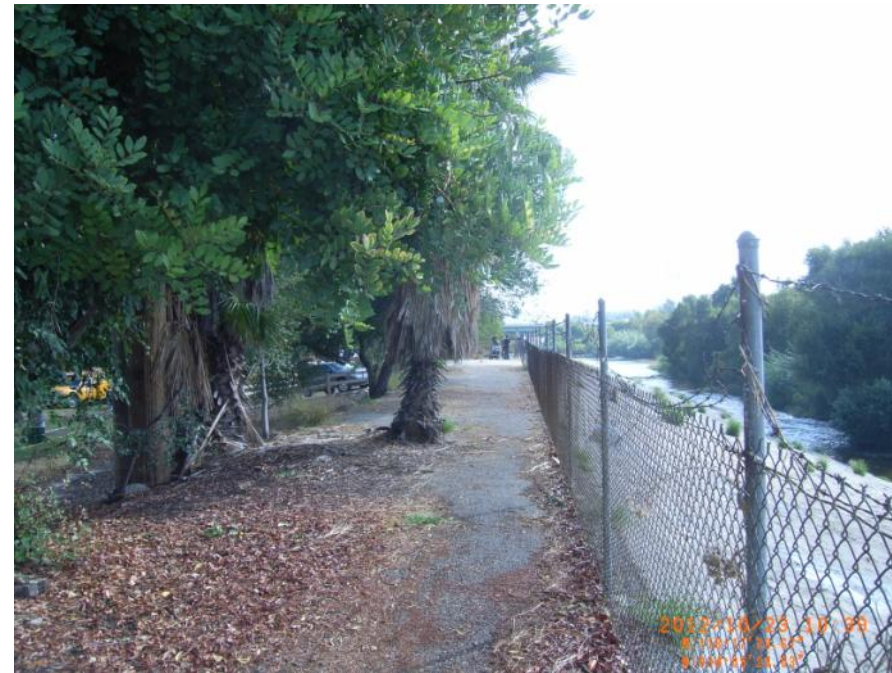
Photo 15: Downstream of Riverside Drive looking downstream on LAR 7. Vegetation on landside.

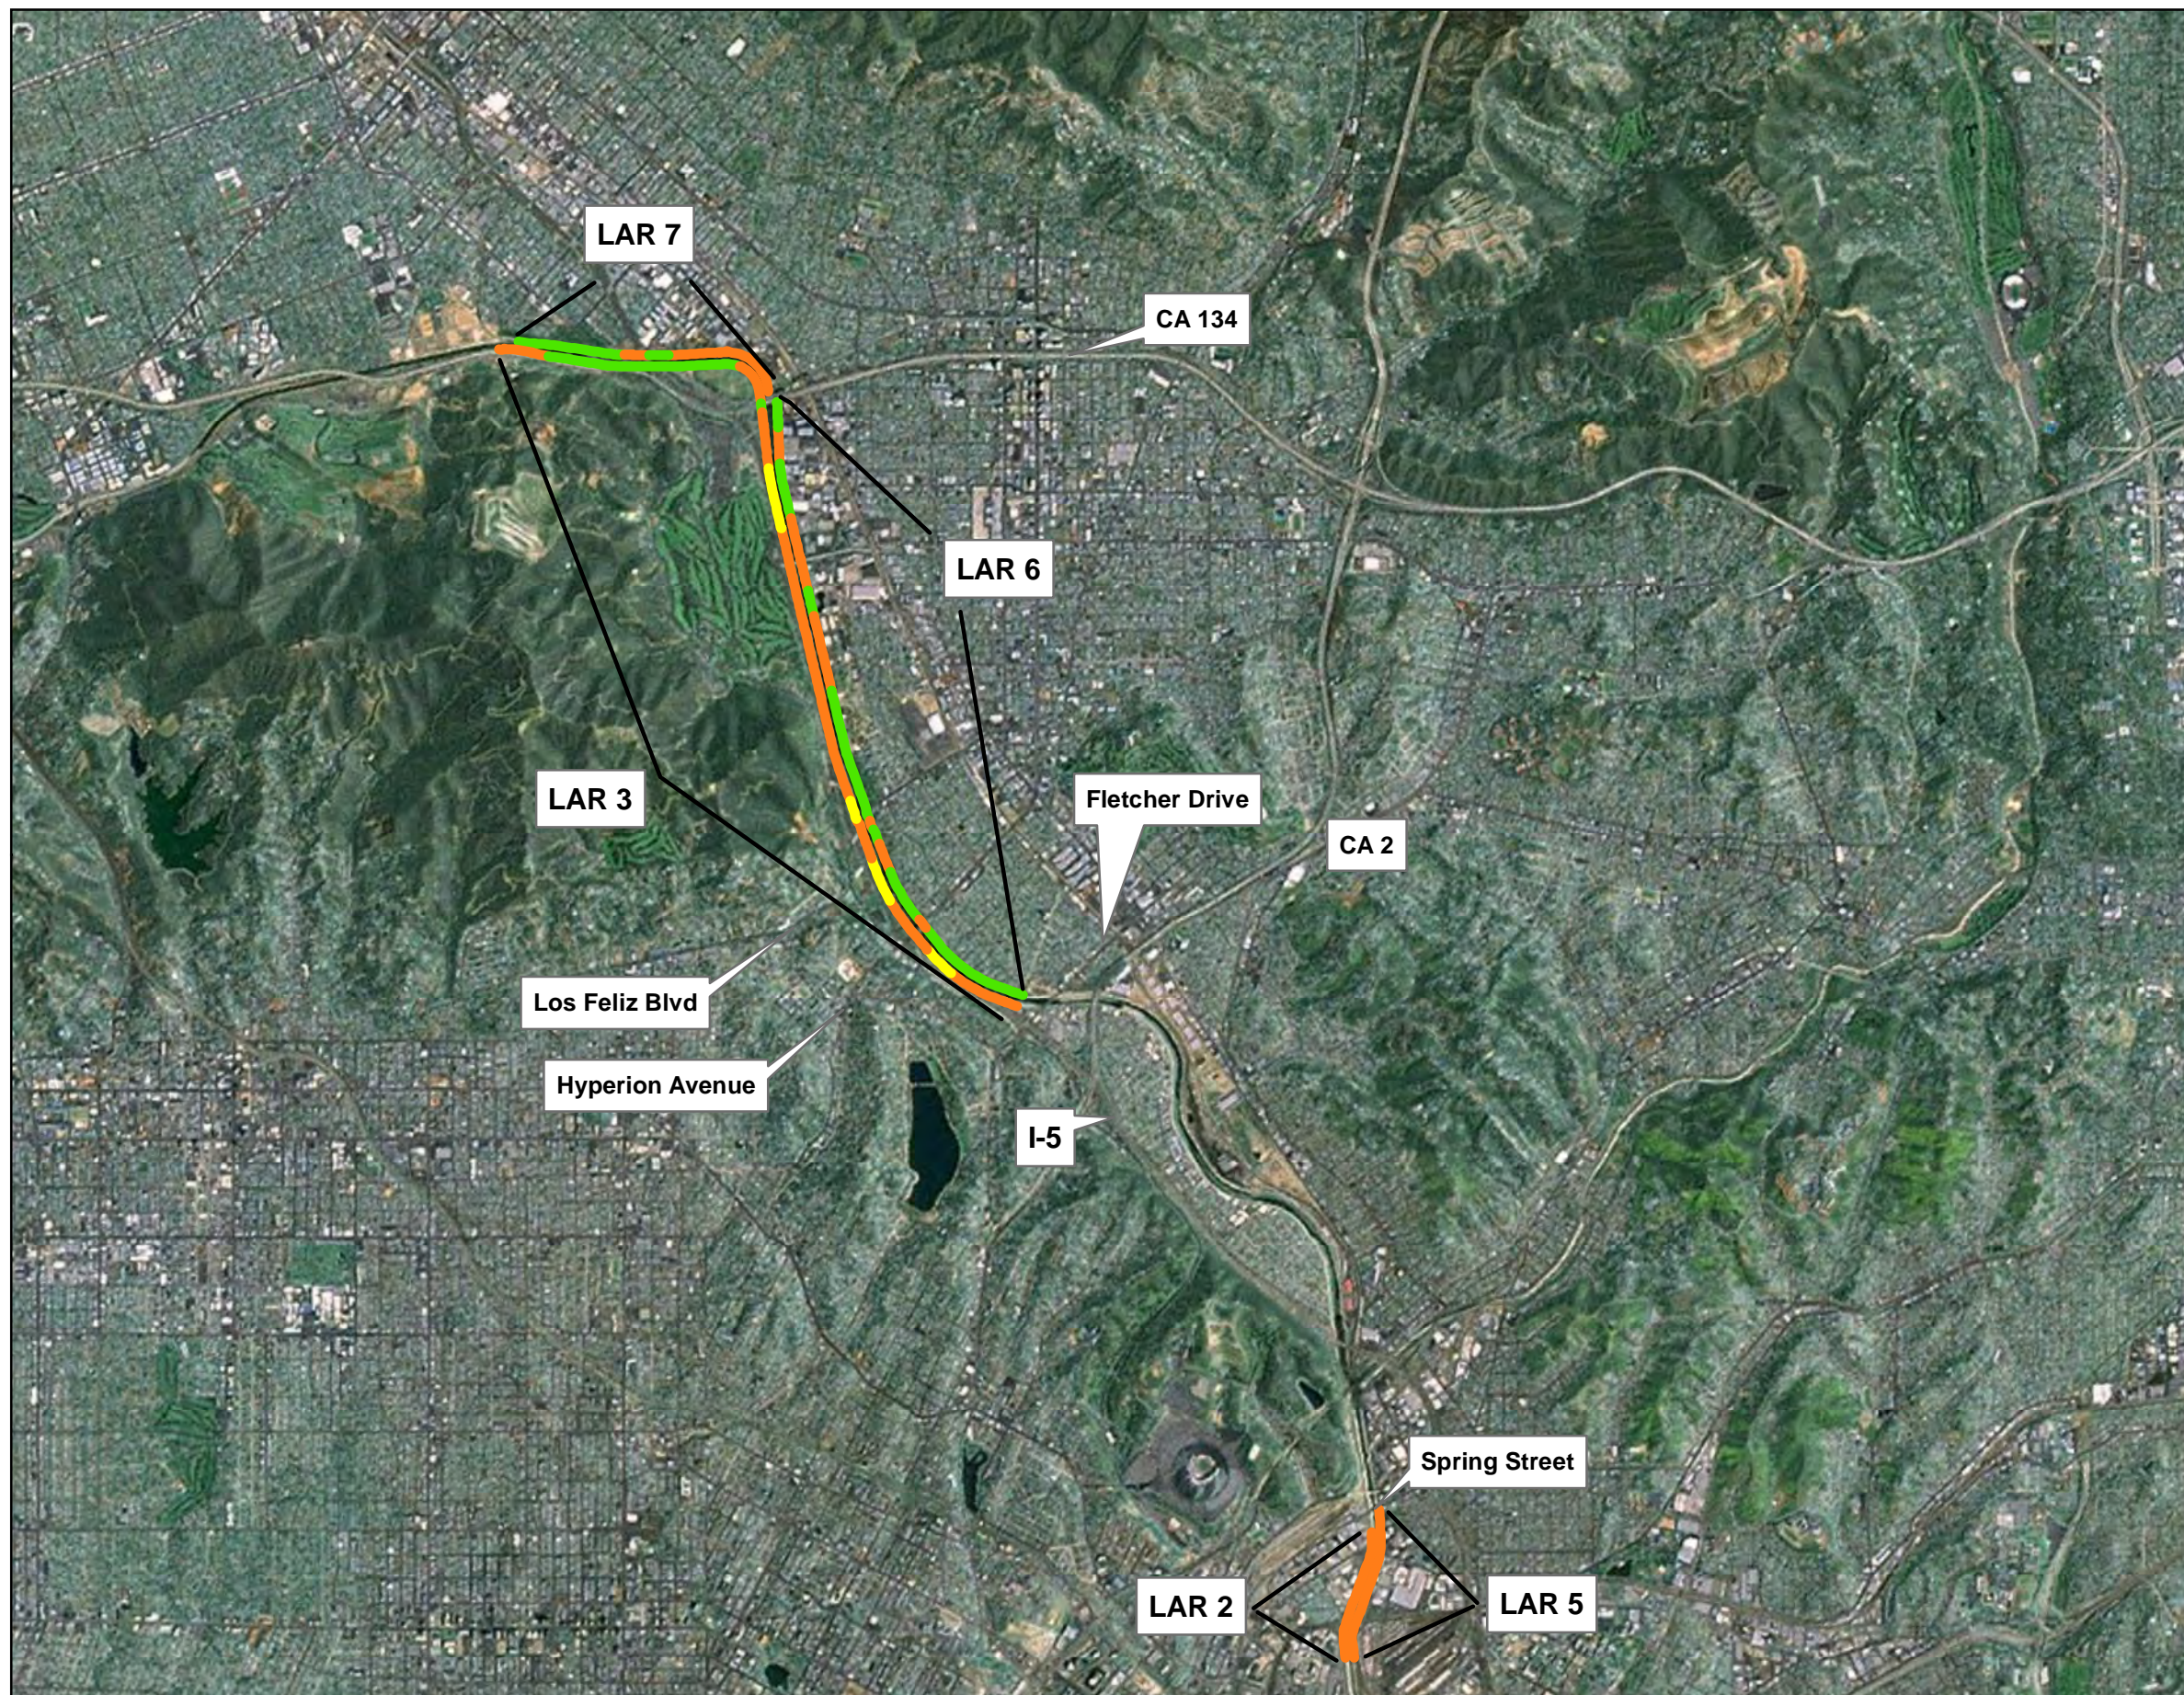
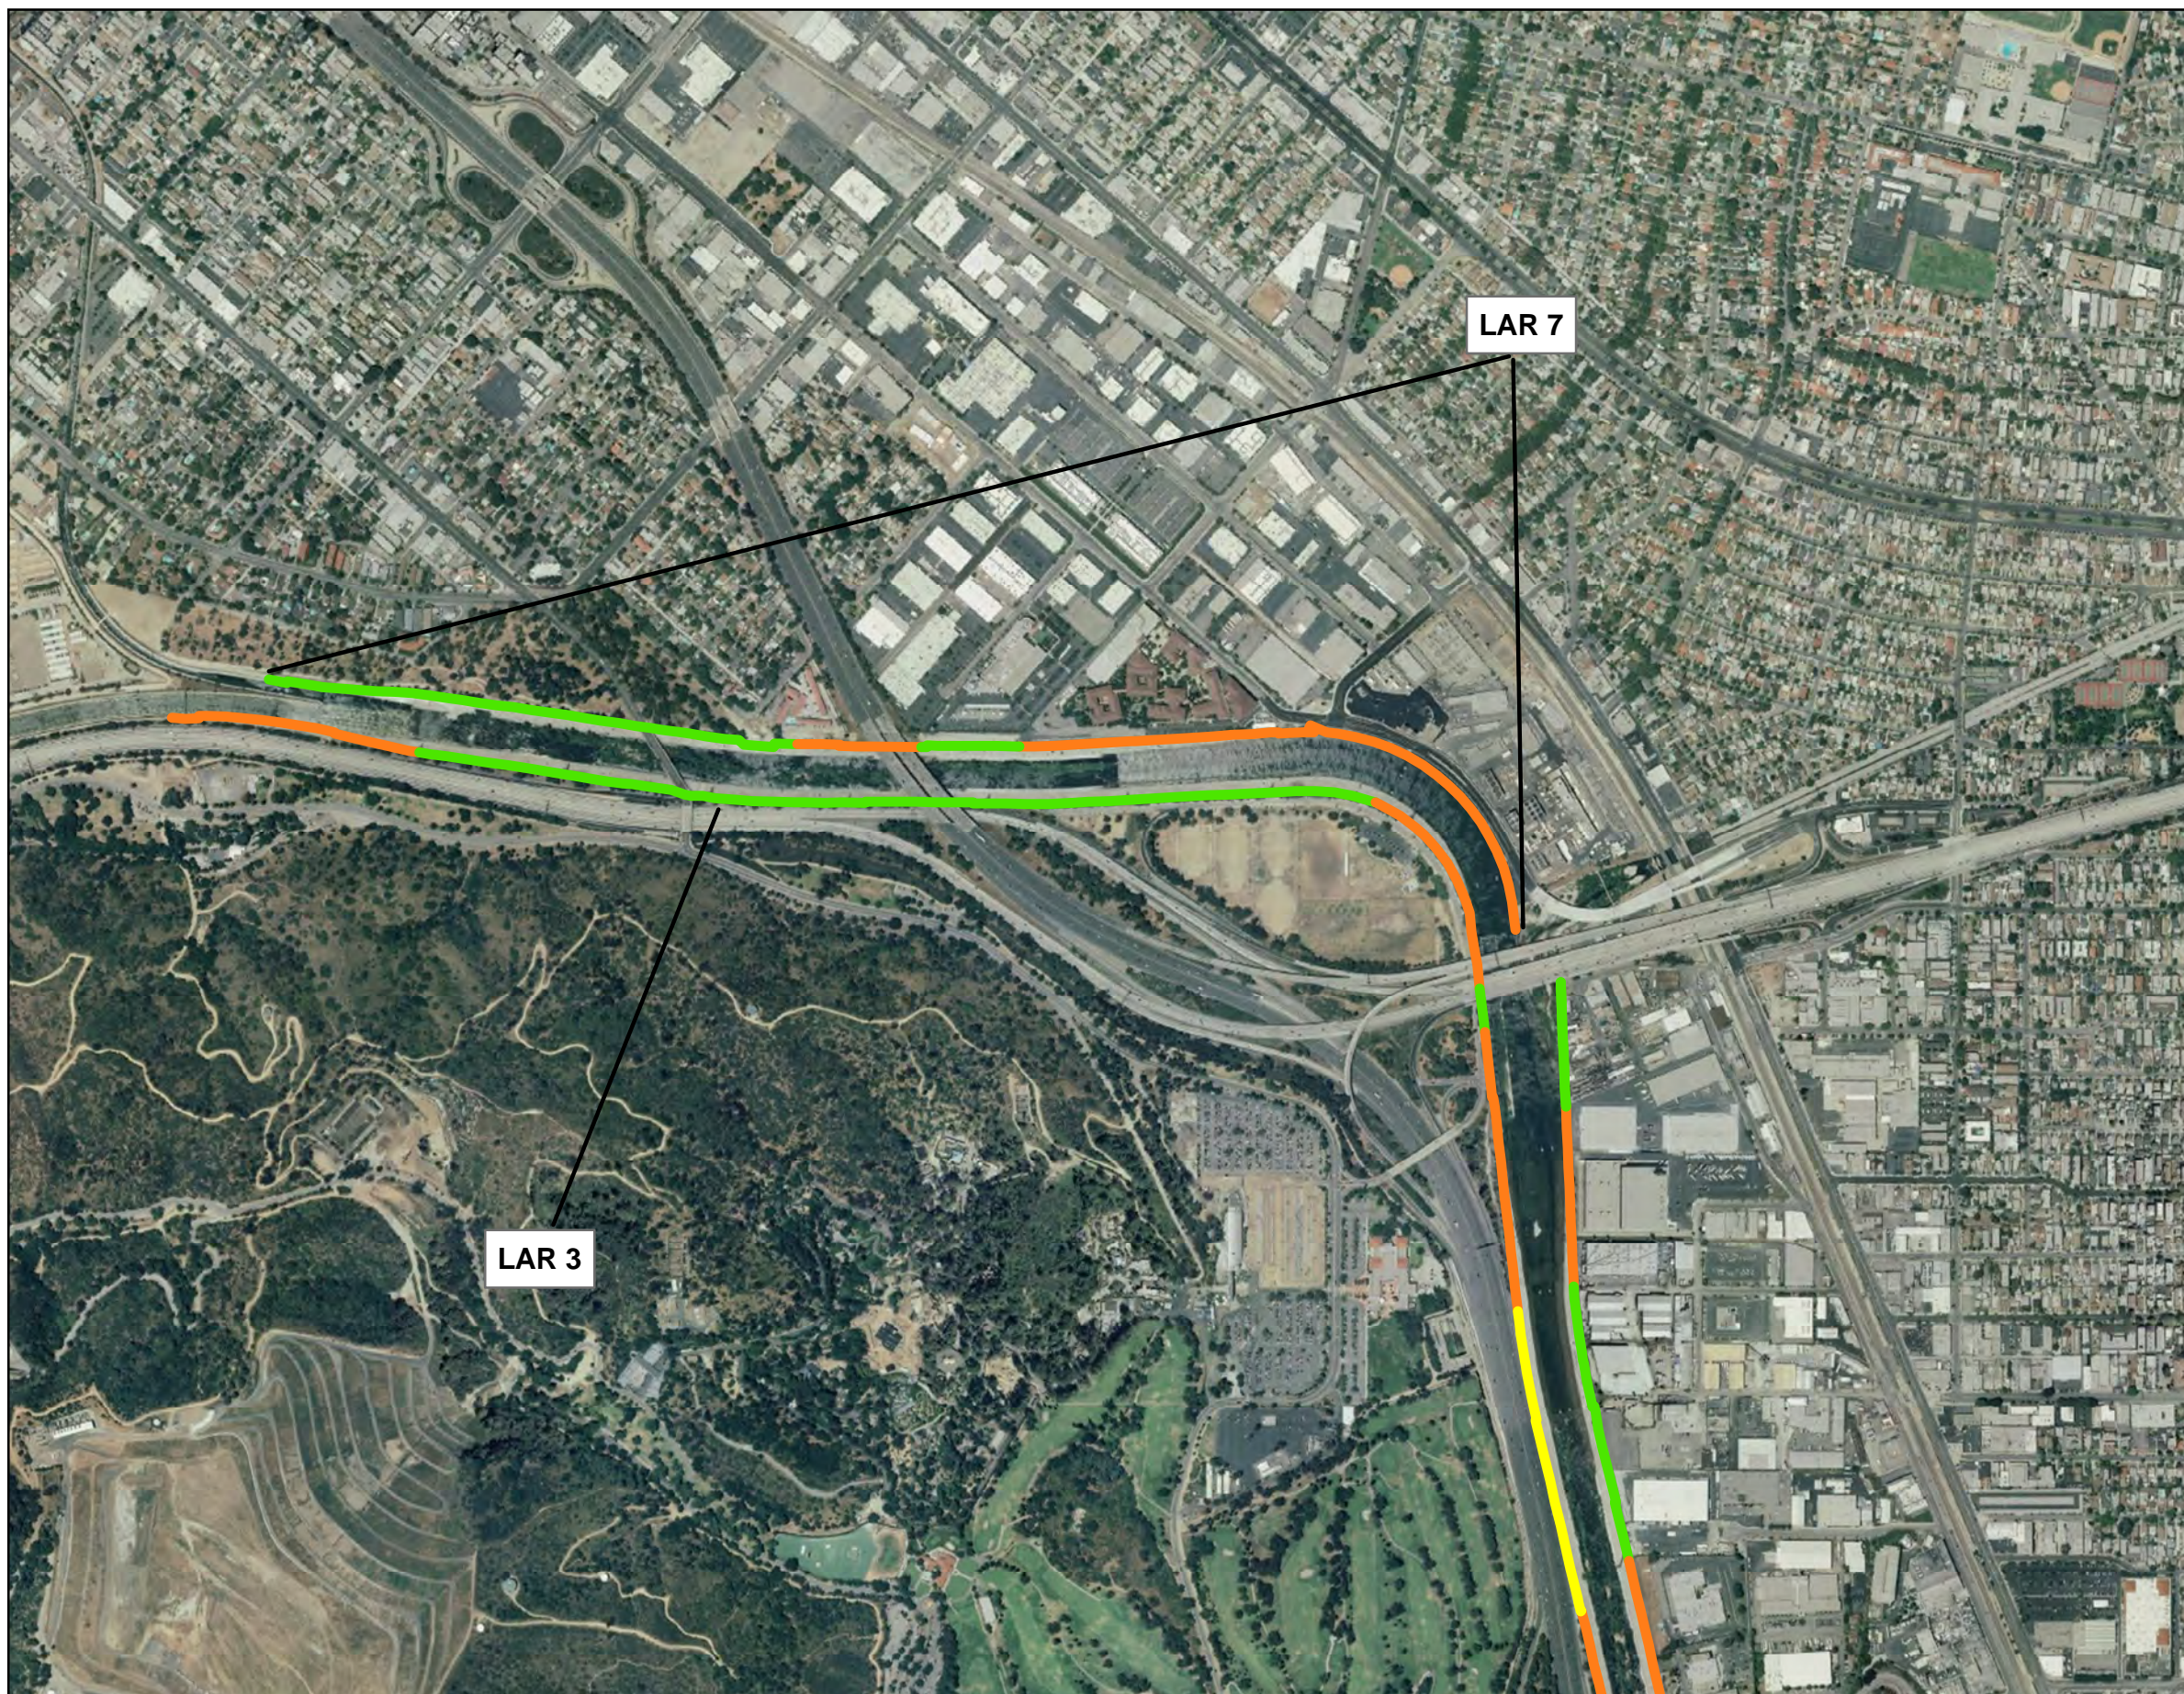
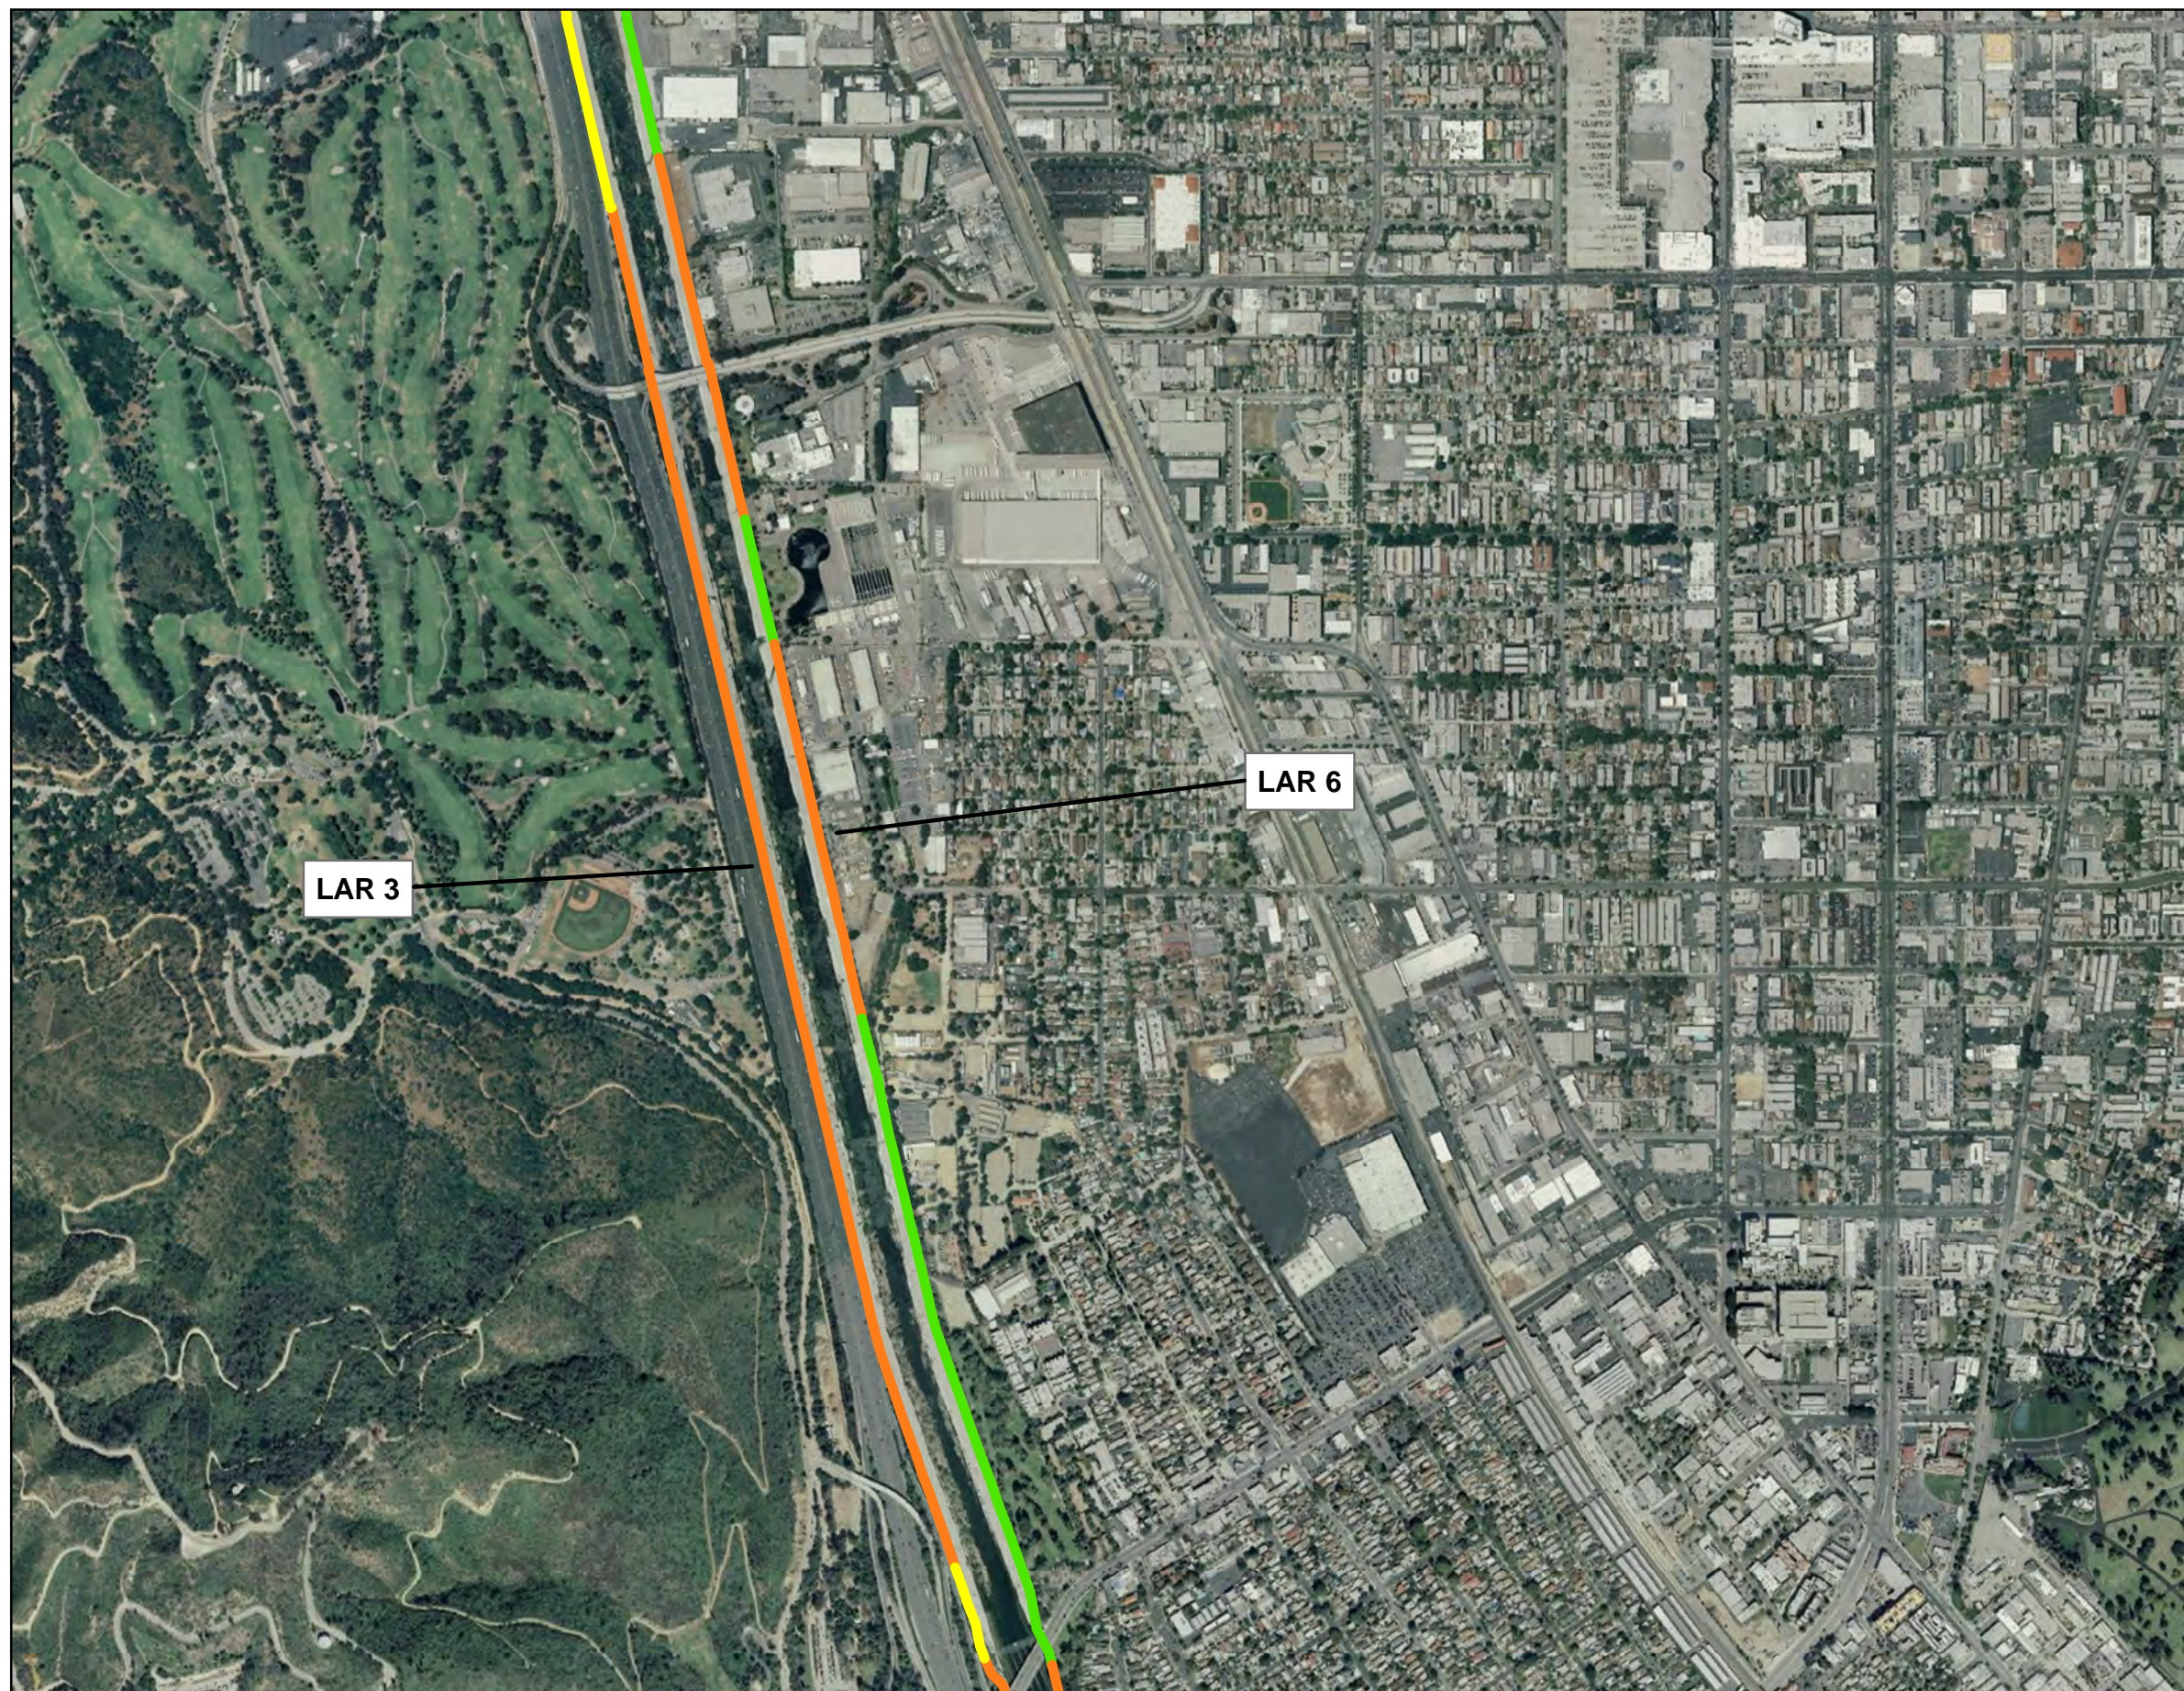
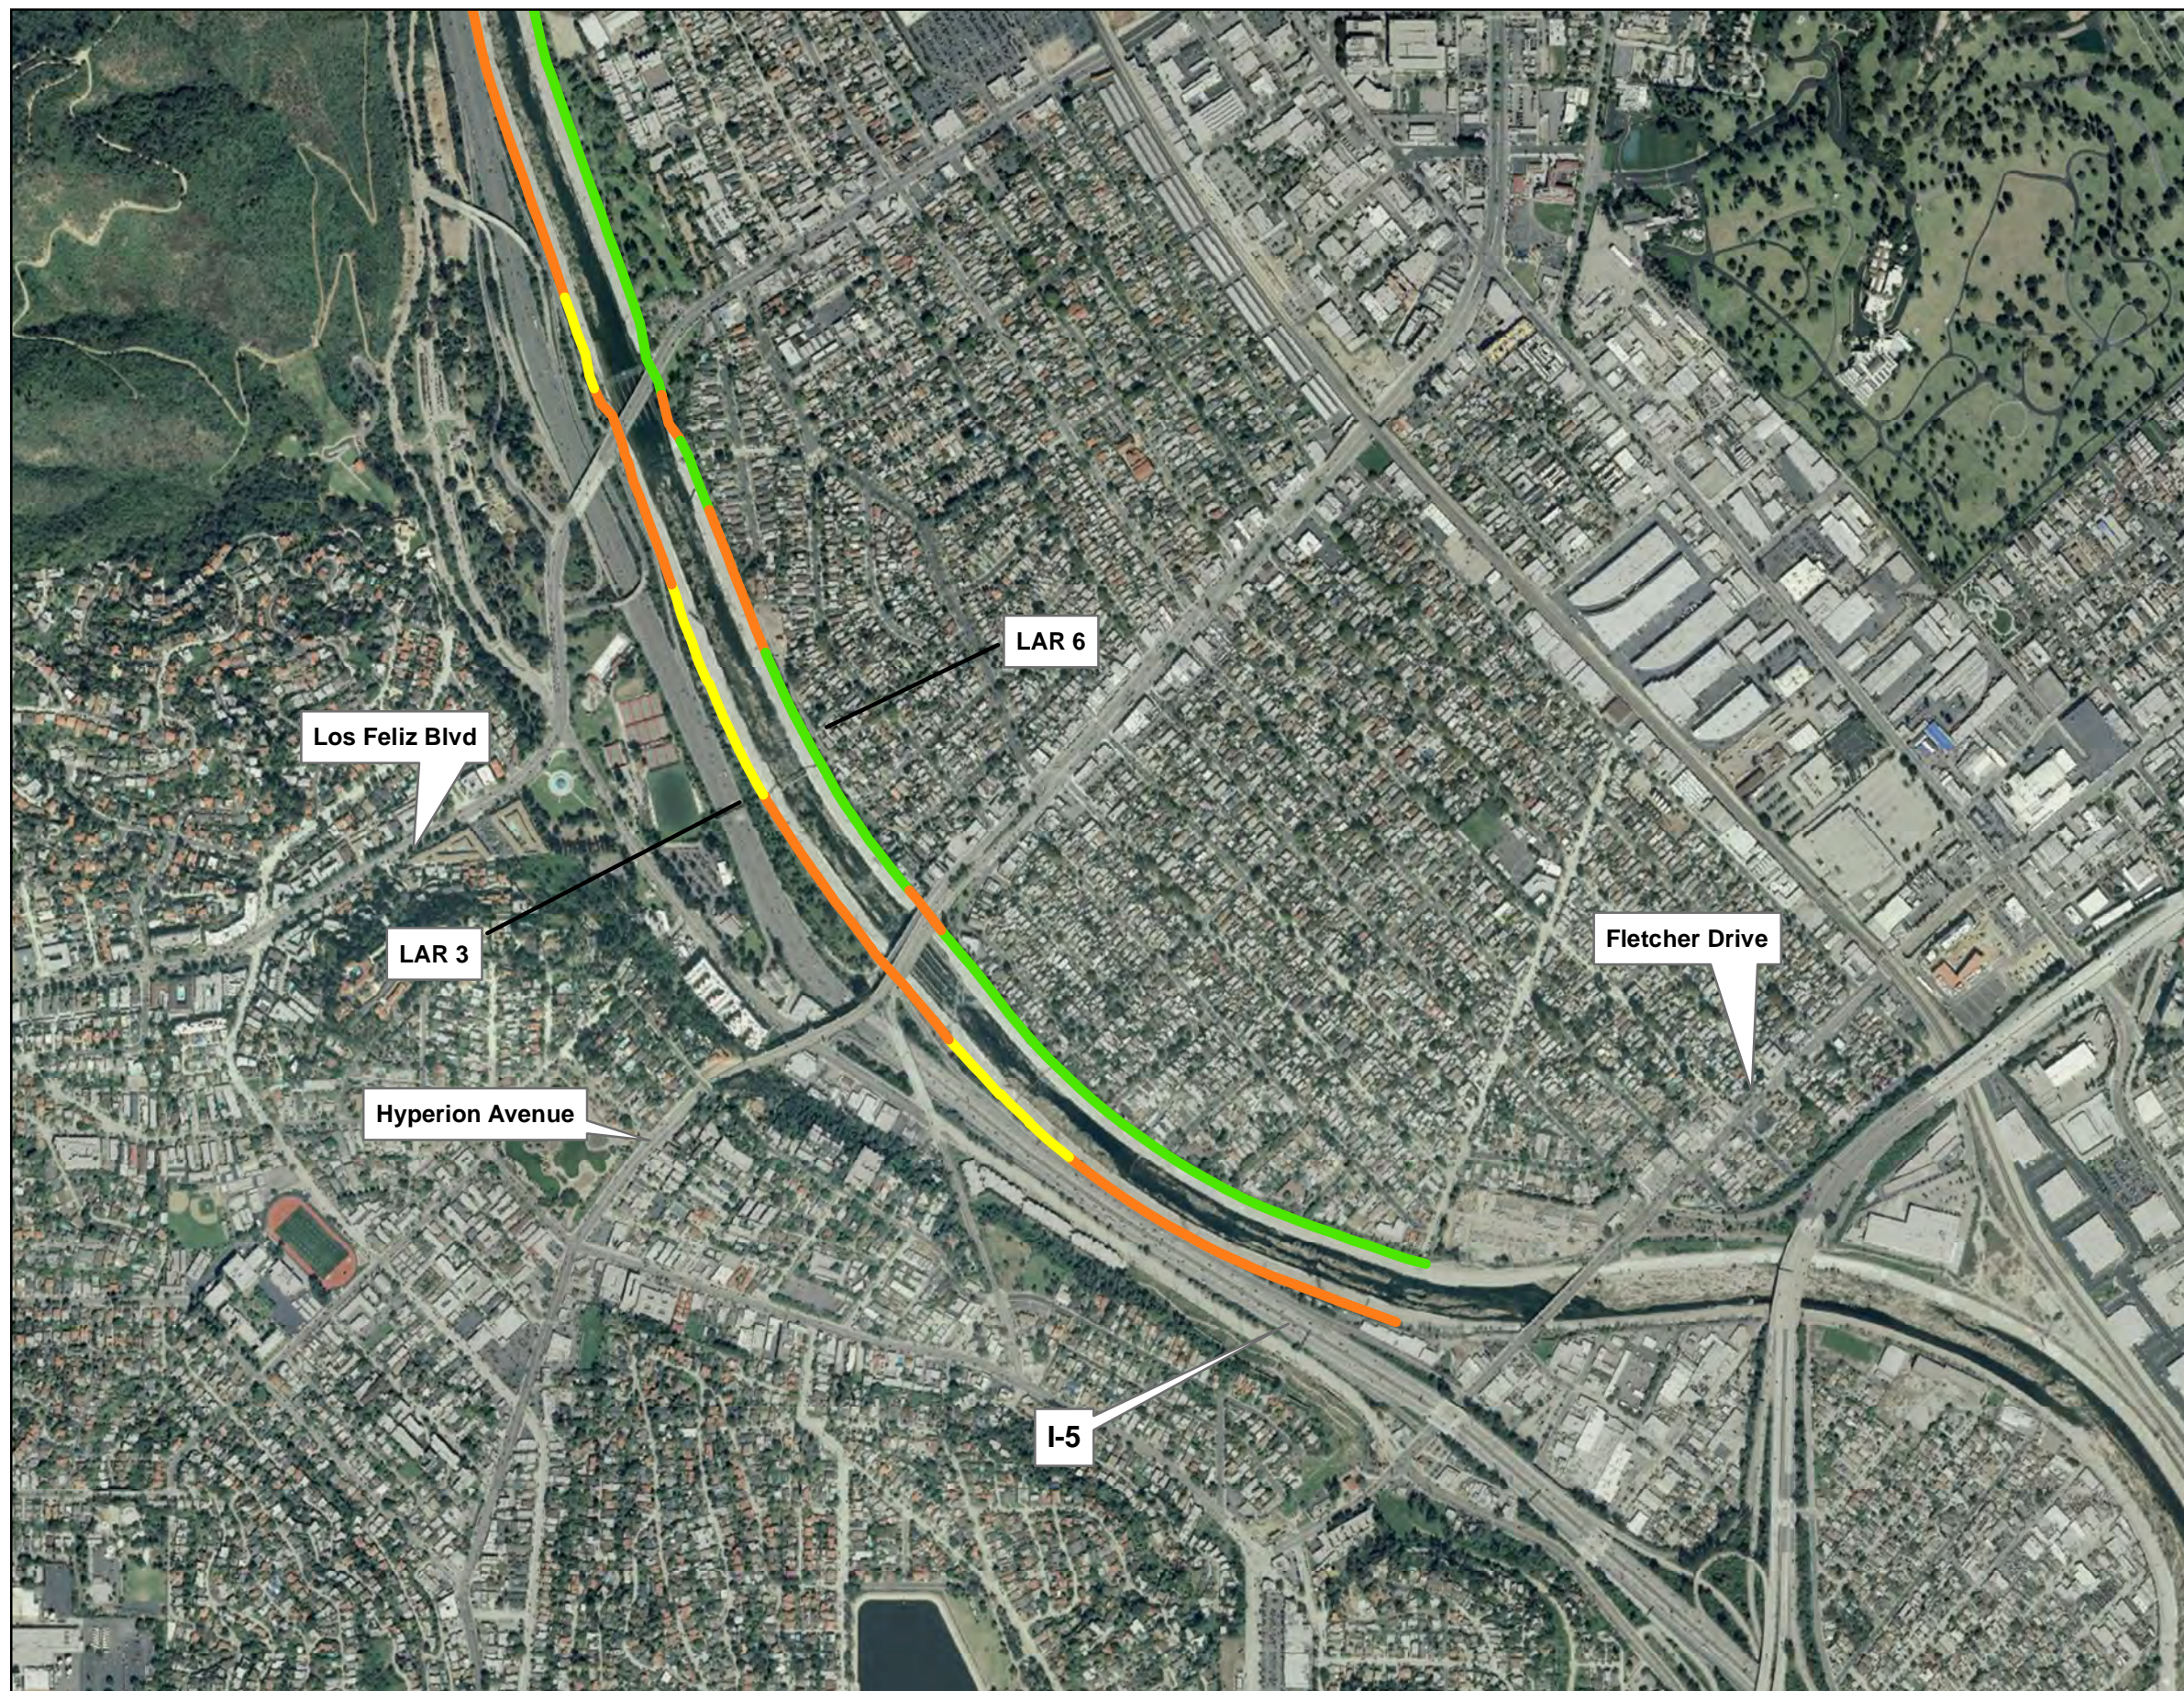
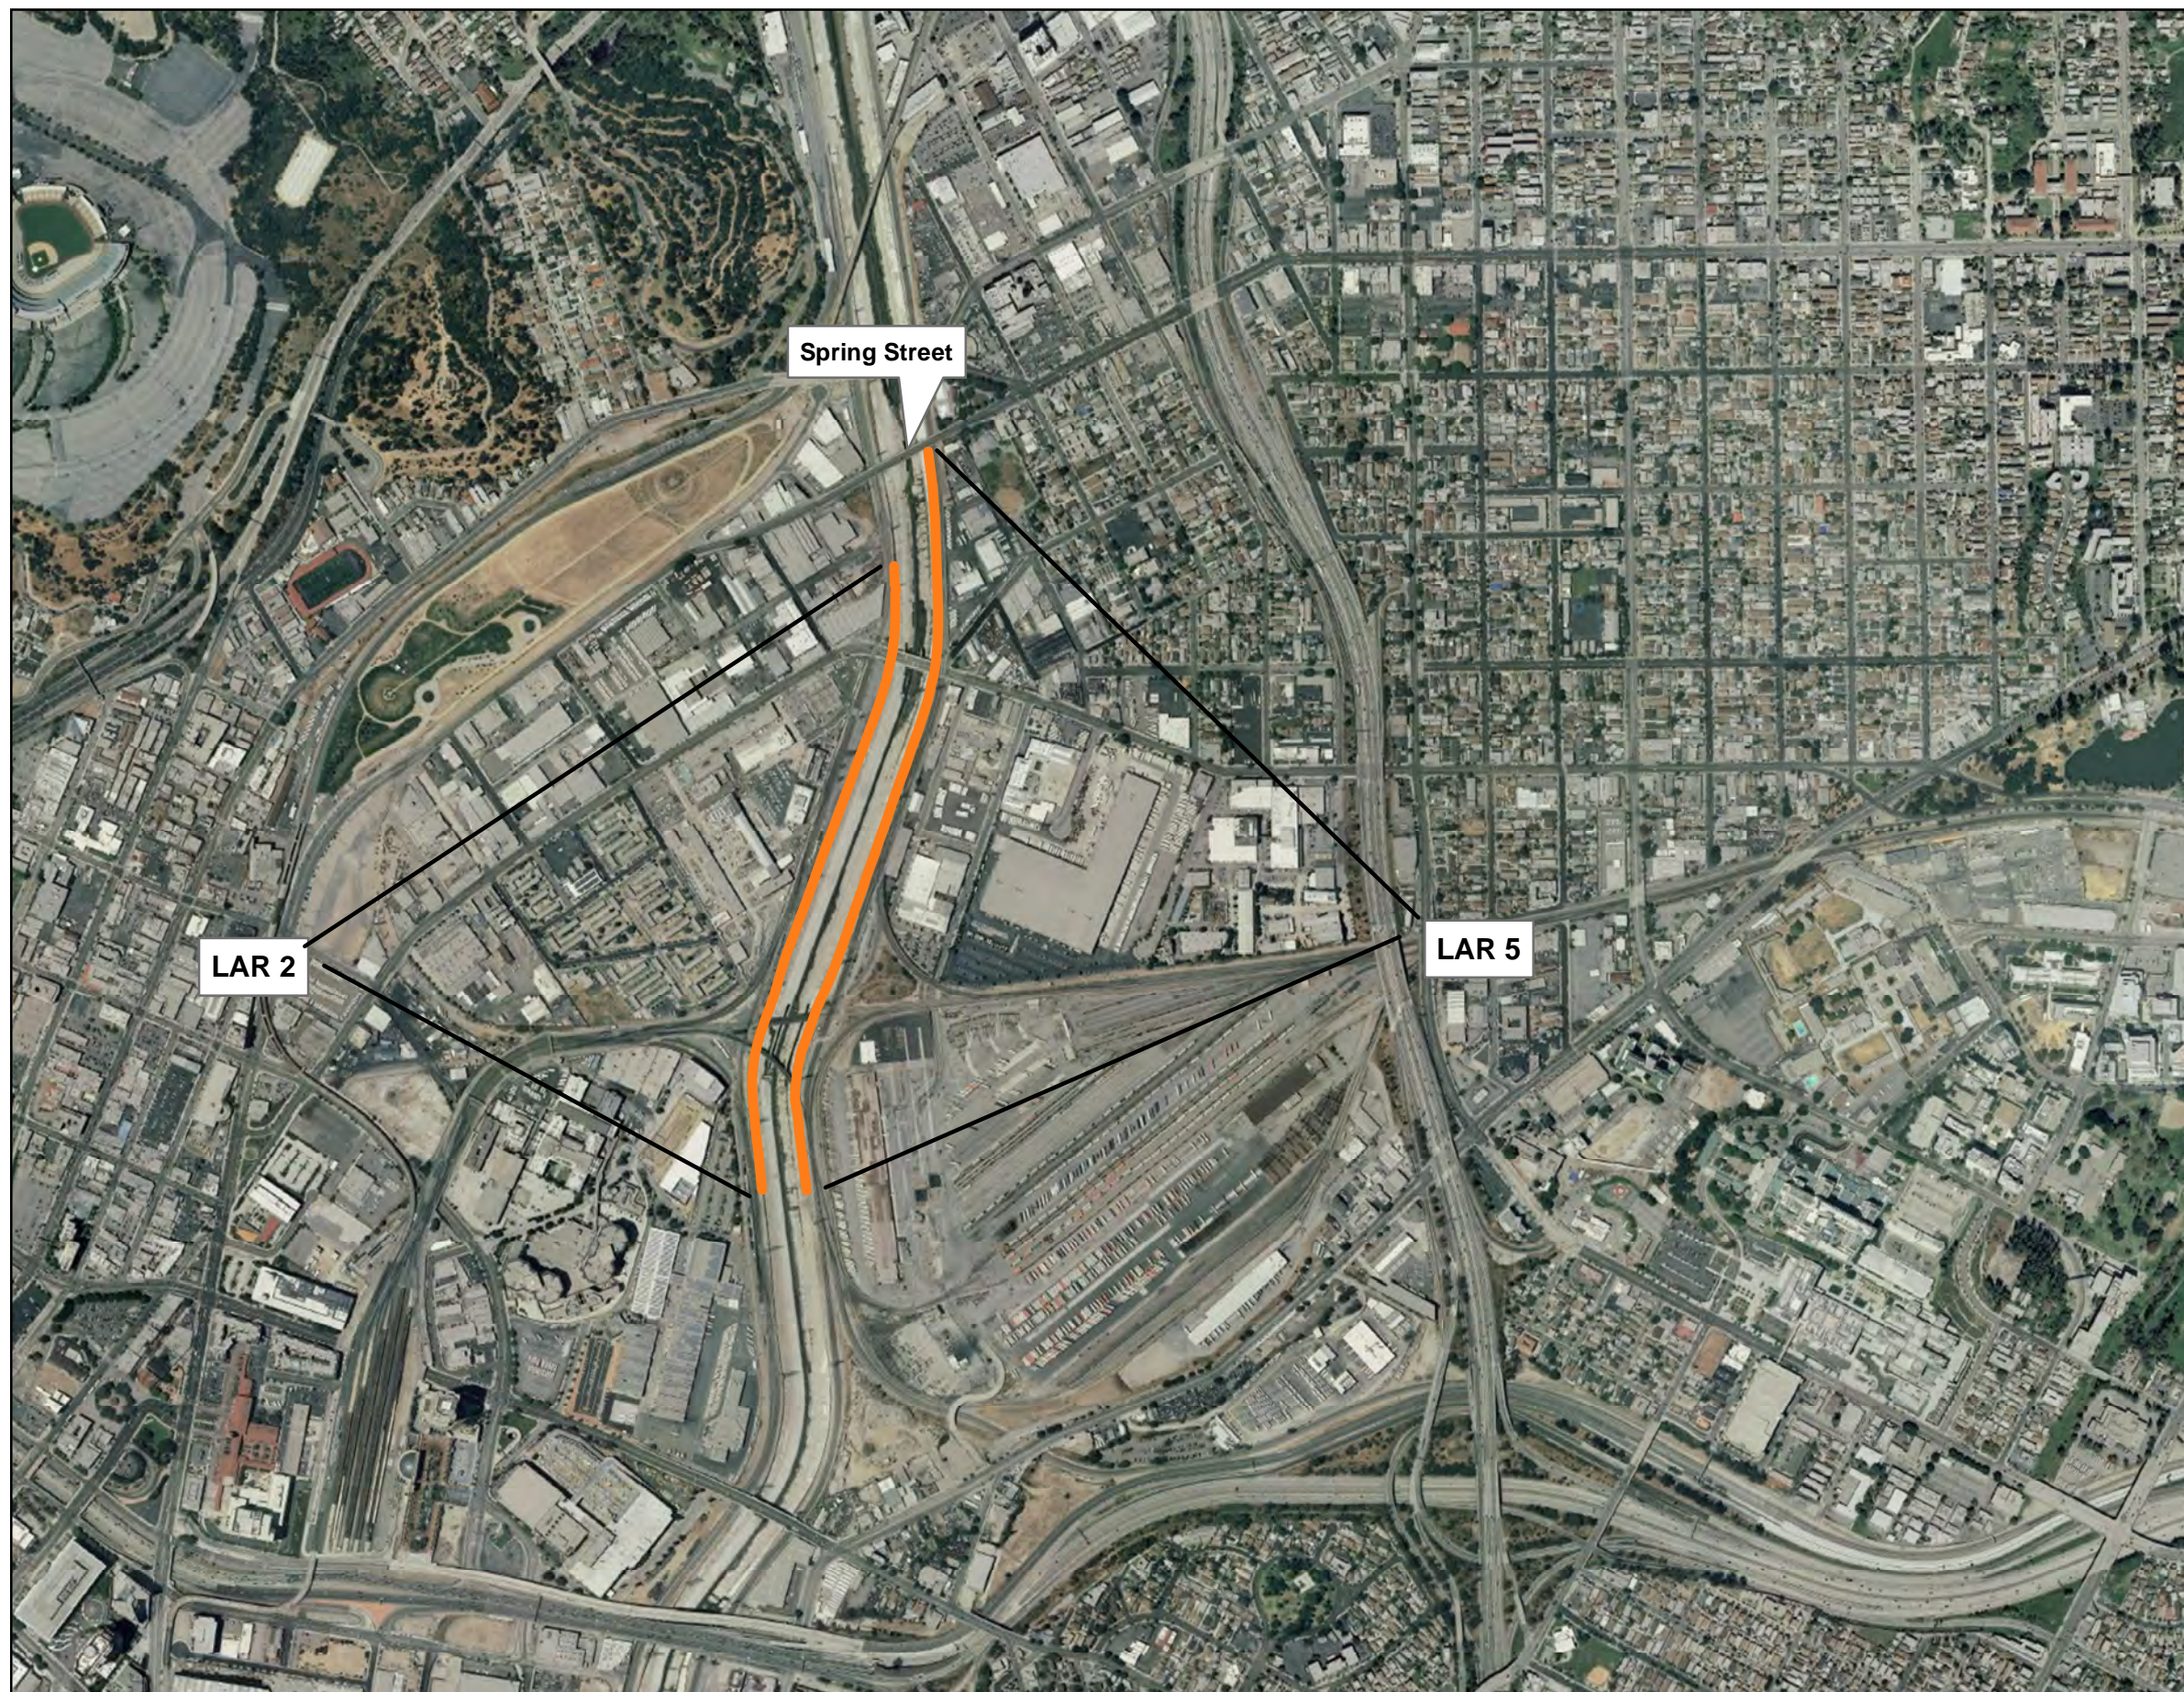
**Levees LAR 2, LAR 3, LAR 5,
LAR 6, and LAR 7
Field Levee Conditions**

- █ Levee as indicated on plan and in field
- █ Not levee. Landside backfilled.
- █ Levees with bathtub condition
