FLOOD PROOFING PERFORMANCE

Successes
&
Failures

US Army Corps
of Engineers

December 1998

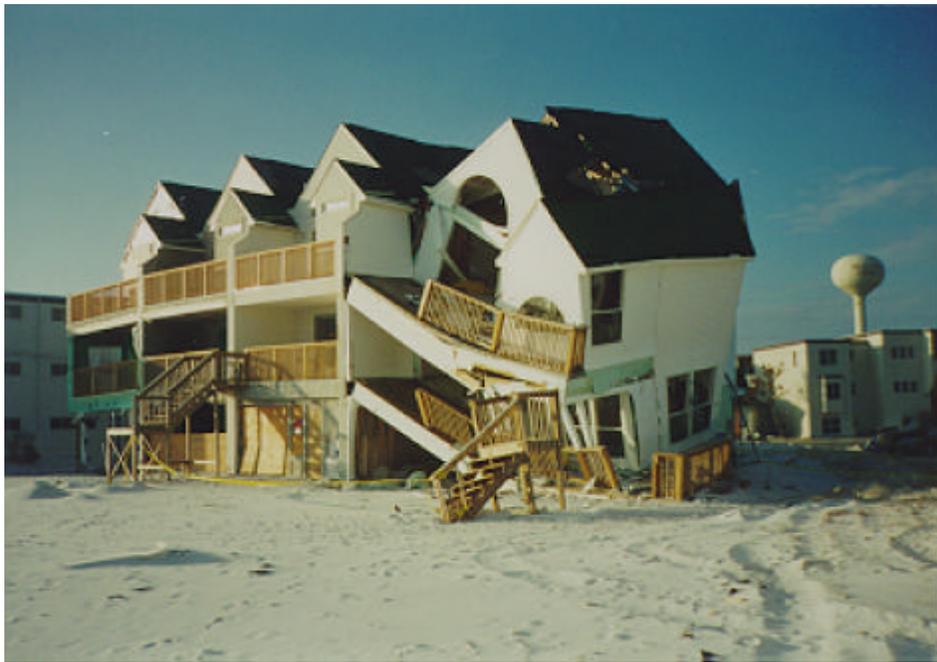
STRUCTURE 85. This structure, which was constructed on a barrier island, faced the beach. The structure was a three-story wood-frame building with the first floor elevated by wood-frame construction on shallow footings. Very high flood velocities were experienced in this area as floodwater flowed across the barrier island. Floodwater depths of about 4.5 feet were directly impinging on the structure. Localized scour occurred, which undermined the shallow foundation and caused one-fourth of the structure to collapse.

Lesson. Two basic factors caused the collapse of one-fourth of the structure. First, the construction on the barrier island placed the structure in jeopardy due to high-velocity floodwater, creating both a hydrodynamic force hazard and a scour hazard. Construction in areas such as this should be avoided. Second, the structure foundation that was situated in sand should have been much deeper to resist the forces of erosion caused by the high velocities and compounded by the obstructive nature of the structure.

Looking at the structure from the beach.

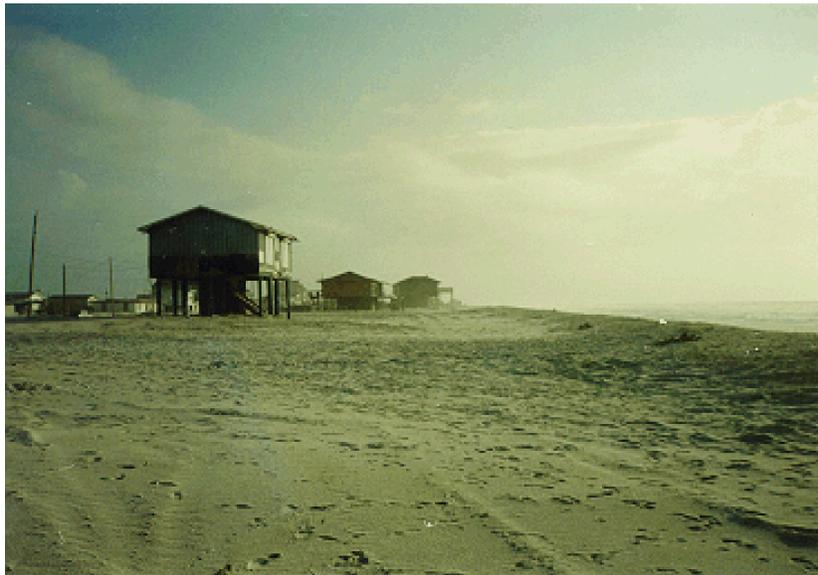
STRUCTURE 86. This structure, which directly fronted the beach, was a one-story, single-family wood-frame home elevated approximately 8 feet on wooden piles. It had an enclosed lower area for storage of utility items. Embedment of the wooden piles was adequate to withstand scour from this event. This structure survived well, as did other structures of this type similarly elevated.

Lesson. This structure survived well in this event. However, the enclosed lower area could have created a problem due to the obstructive effect of the floodwater creating hydrodynamic force against the enclosed area and higher localized velocities as floodwater flowed around the enclosed area. This effect could cause excessive localized scour to depths not anticipated in sand, undermining pile supports and causing failure. It is best in warm climates, such as occurs in Florida, to have lower level storage areas enclosed with “jail-type” spaced bar construction so floodwater can flow through, eliminating hydrodynamic force and scour potential.

Looking along the beach at the structure.

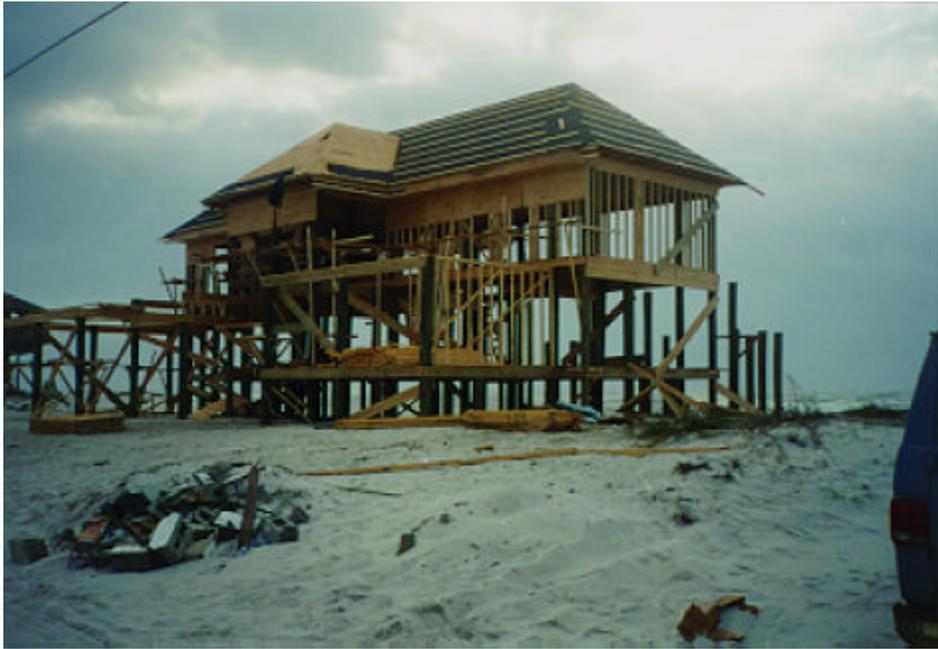
STRUCTURE 87. This was a two-story, single-family residential structure elevated on 12-inch-diameter wooden piles. The piles were of such length that they extended from embedment depth up to the roofline so the entire structure was tied together by means of the wooden piles. Hurricane-type steel fasteners were in place. The first floor was elevated 8 feet above grade, with the lower area entirely unobstructed. The structure was under construction at the time of the event.

Lesson. This structure was designed to accommodate hurricane hazards from wind,

flooding, and scour. One possible weakness was observed at the intersection of the main floor with the wooden piles. The wooden piles were notched to accommodate a resting place for the main floor sills to the extent that the 12-inch-diameter wooden piles were reduced in diameter to approximately 6 inches. This weakens the effectiveness of the piles' ability to bond the entire structure together in terms of the ability to withstand hurricane force winds.

Looking at the structure with the beach in the background.

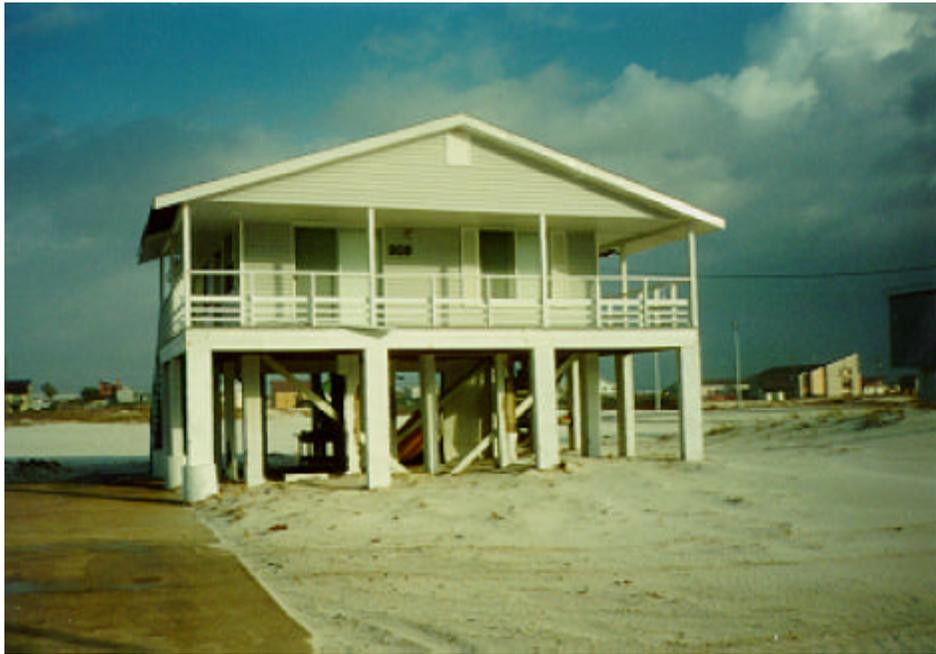
STRUCTURE 88. This structure was a single-family, wood-frame home elevated on columns made of concrete block with a one-half-inch rebar grouted into each hole of the concrete block. This made a reinforced concrete block column for use in elevating the structure about 8 feet above grade. The structure was about 300 feet from the beach on the landward side of a beachfront street. The structure survived the event well, except for the reinforced concrete block columns, which sustained severe cracking apparently from the torsion effect of the hurricane force wind against the structure. No “x” bracing was used between the columns. The columns appeared to be close to failure.

Lesson. Reinforced concrete block columns of this design are not appropriate in coastal areas where high wind forces occur against a structure. The concrete block columns should have contained more rebar in order to provide rigid strength against the hurricane force winds. The best alternative is to use piles that have the ability to resist this type of force without becoming damaged.

Looking at the structure.

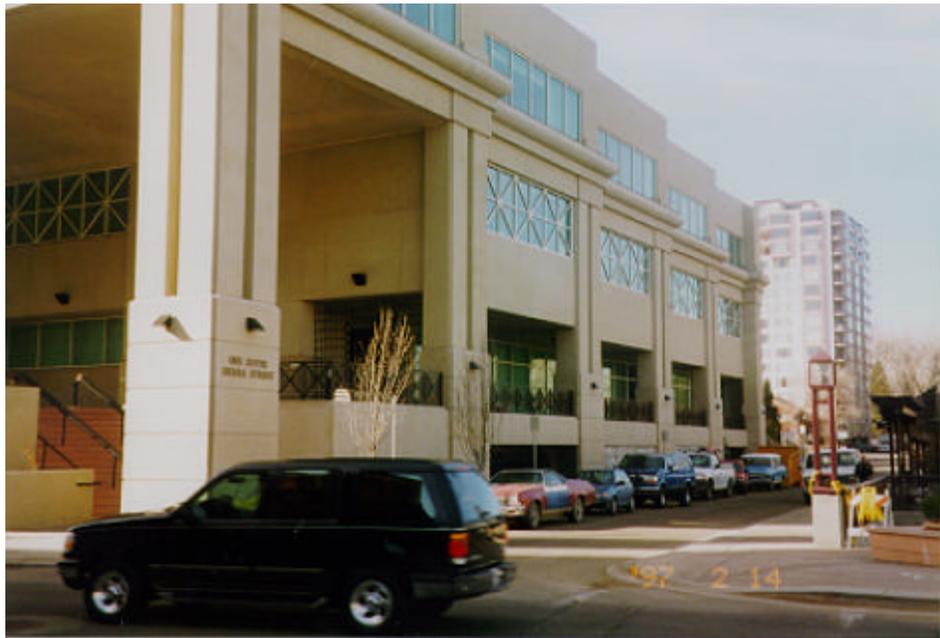
STRUCTURE 92. This structure was a multistory public building located within about 100 feet of the Truckee River. The building was constructed in 1996. The building walls were constructed of reinforced concrete. Ample warning time prior to flooding was present. The lower level was flood proofed by wet and dry flood proofing. The wet flood proofed area was used for building access and vehicle parking. The remainder of the lower level was dry flood proofed by using waterproofed reinforced concrete with a state-of-the-art closure panel consisting of metal construction with a pneumatic seal on all sides except the top, which left a gap in all closures of about 8 inches.

Lesson. The wet flood proofing measure functioned properly, with apparently little damage in this part of the lower level. The dry flood proofing measure however, failed. This measure was designed for 1 foot above the 100-year flood. The flood event of January 1997 exceeded that level. Floodwater overtopped the closure panel completely, inundating the protected area. Obviously, the closure panels and the reinforced concrete walls should have been designed for a higher level of flooding that would have completely closed all openings. The state-of-the-art metal panels with a pneumatic seal functioned as designed without damage. They were simply not high enough. In addition, it was reported that floodwater was already about 1 foot deep in the protected area before floodwater overtopped the closure panels, indicating water was leaking through the waterproofed reinforced concrete. The most reliable waterproofing method for reinforced concrete is to “sandwich” a nonpermeable membrane between the layers of concrete. No damage was apparent to the actual reinforced concrete wall due to hydrostatic force.

Looking at the structure. The Truckee River is immediately to the right.
The flood proofed floor is at the automobile level.

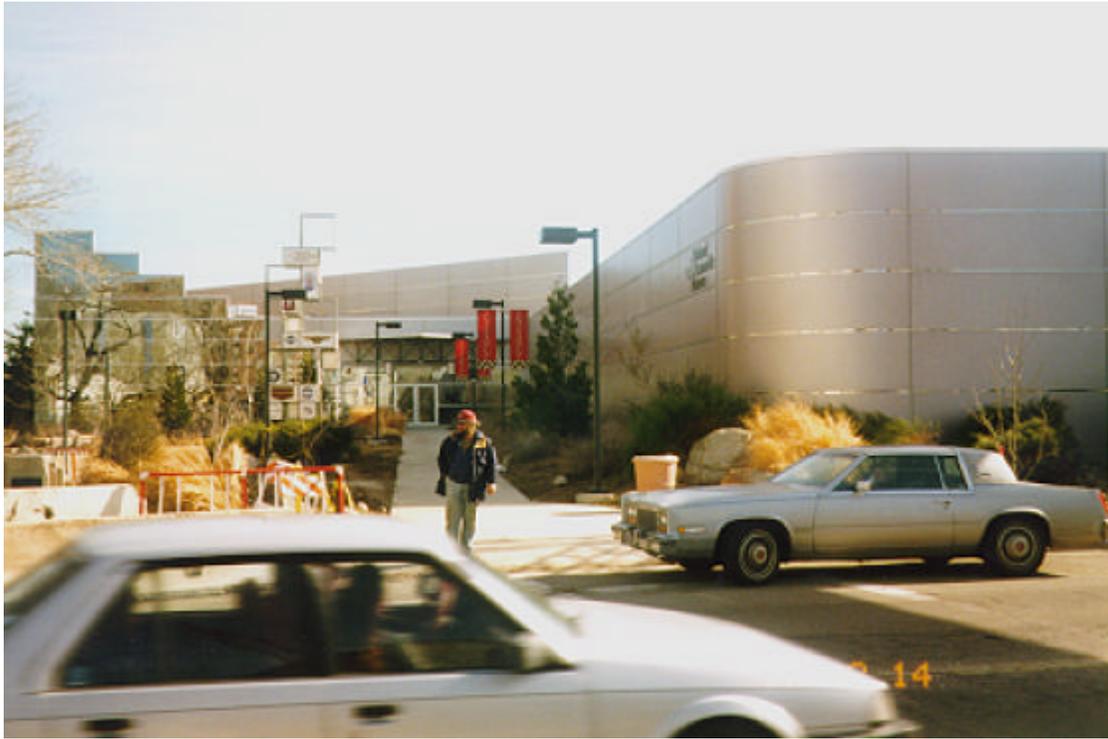
STRUCTURE 93. This structure was a single-story, slab-on-grade building located about 50 feet from the Truckee River. It was built in 1989 just downstream from a city bridge over the river. It was flood proofed by elevation on fill to a level 2 feet above the 100-year flood. A flood fight was waged with sandbags and plastic sheeting at openings on the upstream side of the building. The downstream side of the building was higher than the floodwater.

Lesson. This structure and its contents had minimal damage due to the flood proofing measure of elevation on fill and the flood fight. The lesson for this structure consists of four parts. First, the flood proofing measure enabled a flood fight to be successful. Second, a decision had to be made based on upstream flood information that a successful flood fight was possible while still keeping safety in mind for the flood fight personnel (since a basic parameter of flood proofing is to evacuate). Third, the impact of debris in the upstream bridge needed to be considered. This was evidently overlooked when the flood proofing elevation was selected. In the flood event, the upstream side of the bridge filled with debris to the extent that floodwater was forced out of the channel and onto the street just upstream from the structure at an elevation higher than the computed water surface elevation for a flood of this magnitude without the obstructive effect of the bridge. The fourth part of the lesson concerns the value of the contents in the structure. The contents consisted of \$25 million worth of nonreplaceable antique automobiles. Contents that are nonreplaceable should always be located in a flood-free location.

Looking from the upstream street downstream at the structure.
The doors in the background are one of the flood fight locations.

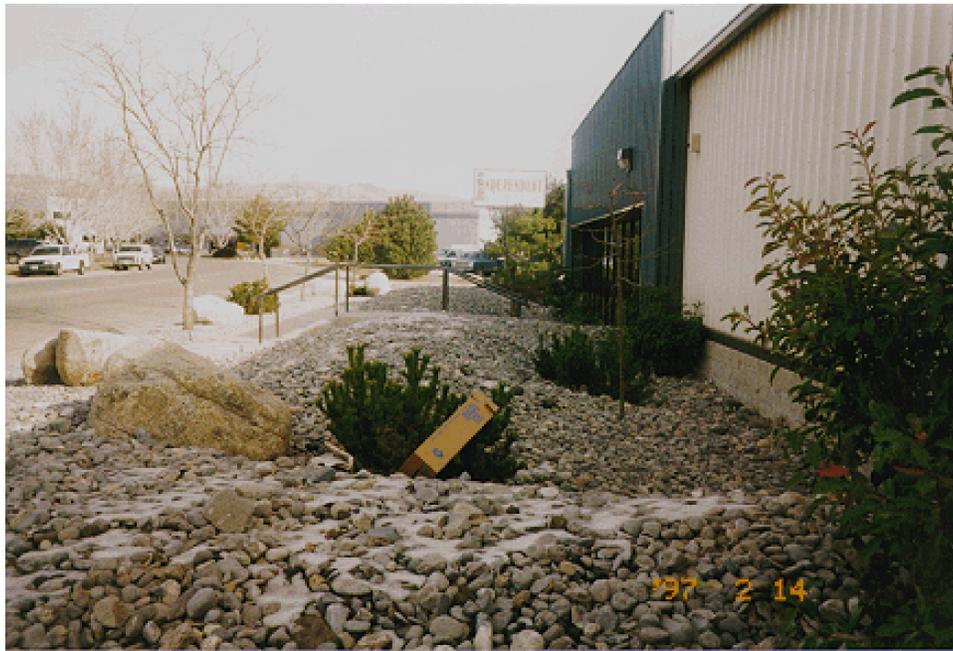
STRUCTURES 94, 95. These structures were both slab-on-grade commercial buildings located several hundred feet from the Truckee River. The area was subject to only shallow flooding. These structures are presented to illustrate a type of earthen embankment that can be very effective in flood proofing against relatively shallow, short- duration floods. Structure 94 had been landscaped well to blend into the surroundings and be aesthetically pleasing. This embankment was a permanent flood proofing measure. The embankment protecting Structure 95 had just been constructed. It could be removed after the flood event or remain as a permanent measure. Sandbag closures across vehicle access routes were necessary.

Lesson. These flood proofing measures were successful. Earthen embankments, especially in shallow-depth flood areas of short duration, can be quite effective if placed on a permanent or temporary basis. Obviously, all parts of an earthen embankment flood proofing measure such as interior drainage, closures, and so forth must be present and functional.

Looking along the earthen embankment with Structure 94 on the right. Note the raised handrail as the pedestrian entry to the building passes over the embankment.

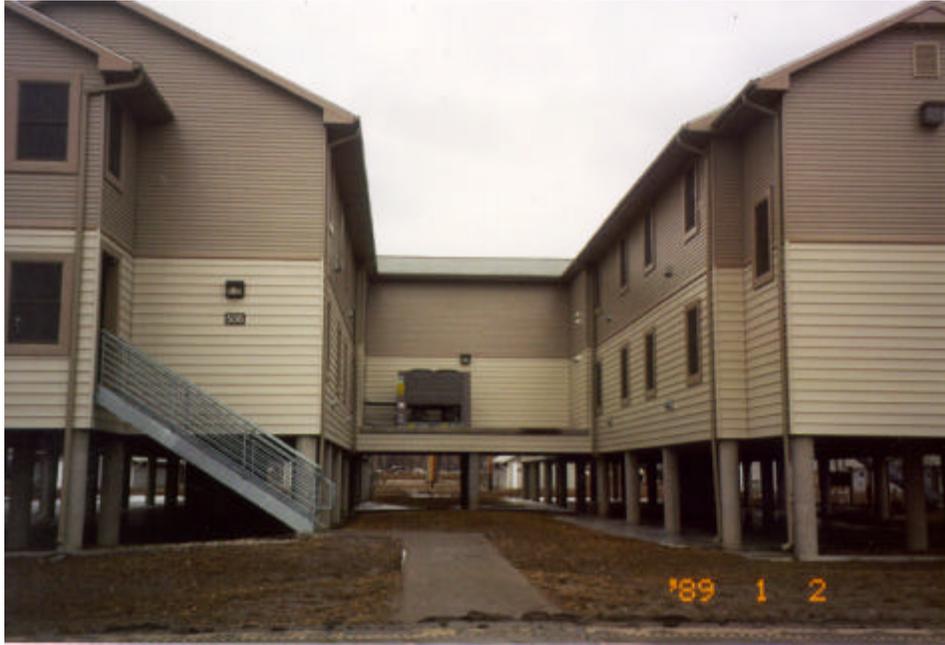
During the 1997 flood event, about 3 feet of floodwater inundated the area beneath the elevated buildings. Massive ice blocks also floated beneath the elevated buildings, directly impinging upon the posts. Floodflow velocity was moderate. No damage occurred due to either floodwater or the impact of the ice blocks.

Lesson. This flood proofing system performed very well in this flood event. The buildings were elevated enough to be above the flood elevation and the posts were strong enough to withstand the impact of floating ice blocks without damage. Erosion was not a factor for the event.

Looking at one of the elevated buildings.

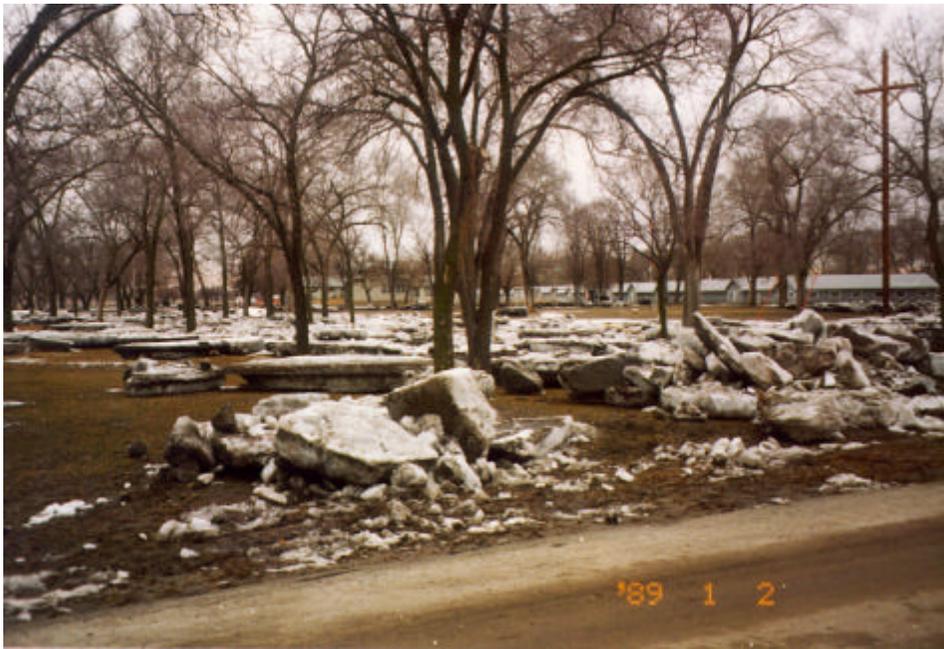
Looking at the massive ice blocks that passed through the area.
