APPENDIX B

FIELD IDENTIFICATION OF RAIL DEFECTS

B-1. Rail defects may be observed in track.

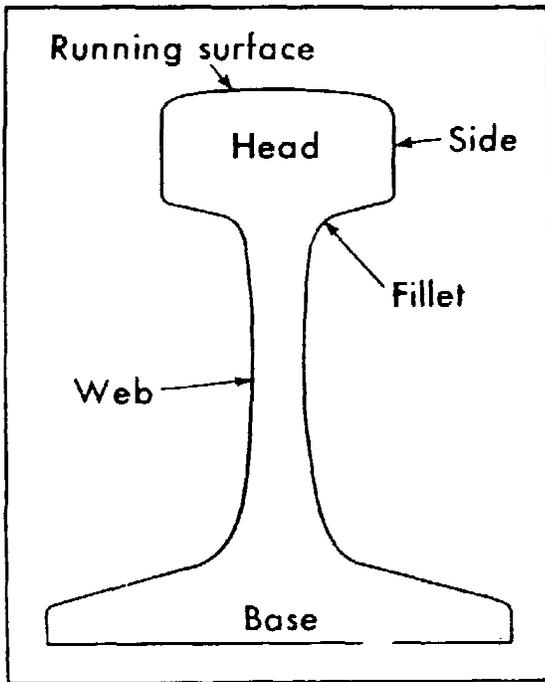
Figure B-1. Rail nomenclature.

This appendix presents definitions relating to rail and brief descriptions of the common rail defects observed in track. Figure B-1 presents common rail nomenclature, and figure B-2 shows the relative positions of planes through the rail.

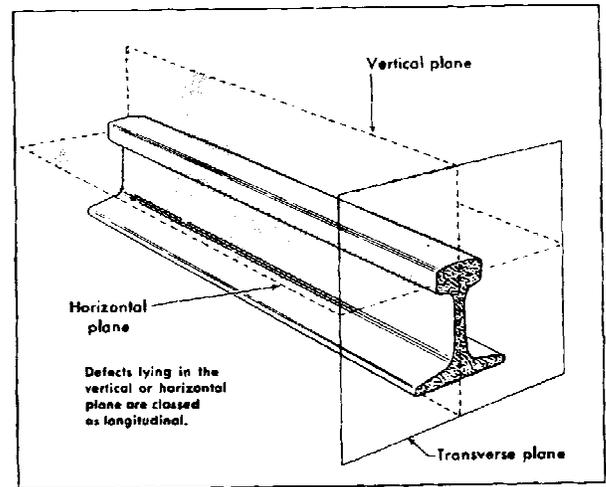
Figure B-2. Relative positions of planes through a rail.

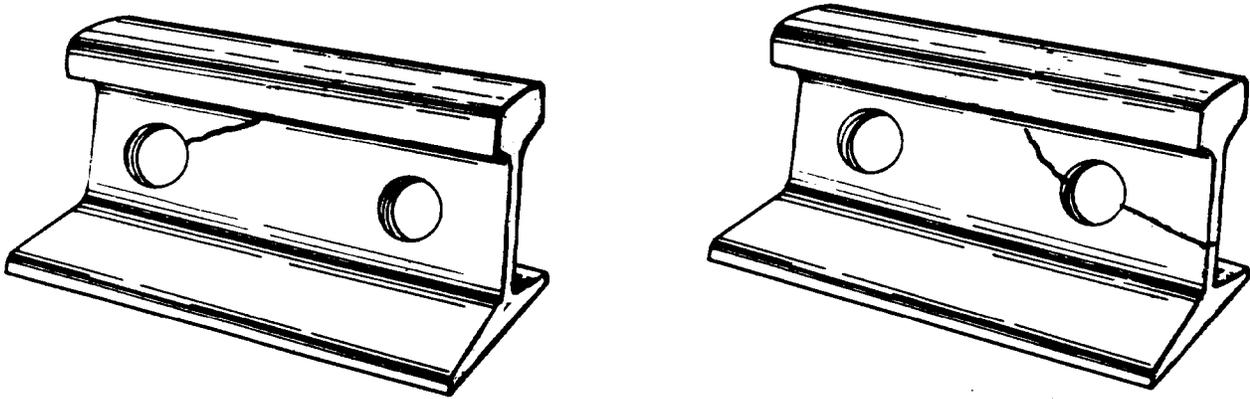
(1) *Description.* A progressive fracture originating at a bolt hole.

(2) *Appearance in track.* Bolt hole cracks are not visible until a bolt or a joint bar has been removed unless the defect has progressed beyond the bar. They may be recognized by a hairline crack extending from the bolt hole (fig B-3).

Figure B-3. General appearance of bolt hole cracks.

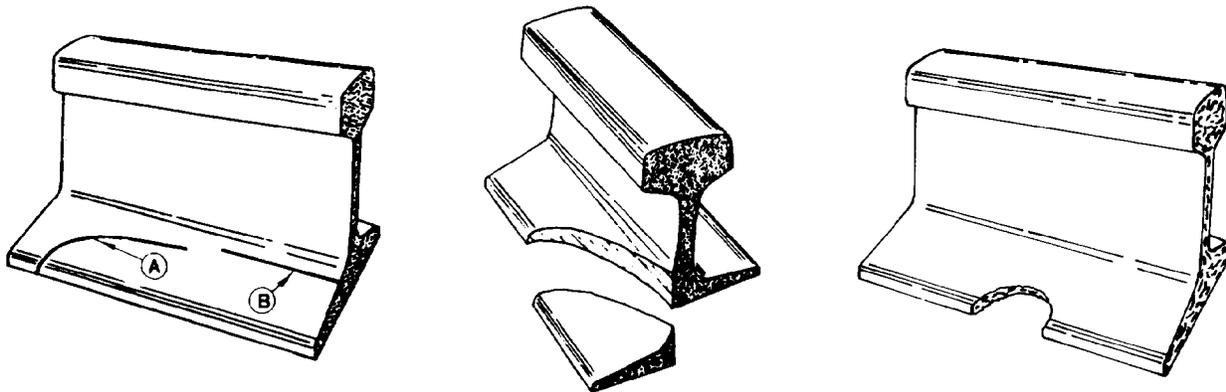
(1) Description. Any break in the base of the rail.

(2) Appearance in track. Generally appears as a half-moon crack break in the rail base. Figure B-4 illustrates three different appearances of broken bases.

Figure B-4. General appearance of broken base.

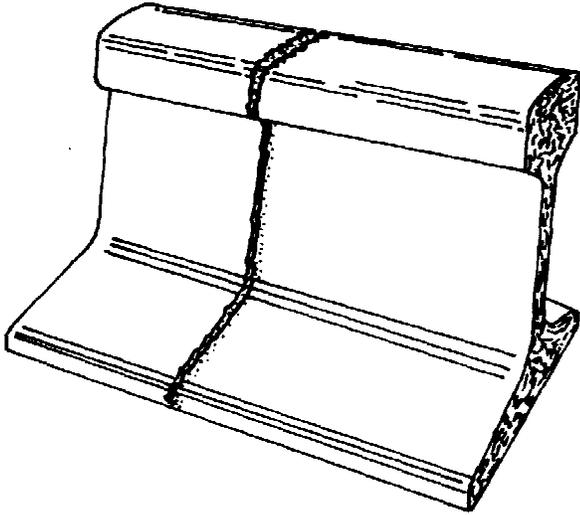
(1) *Description.* A complete transverse separation of the head, web, and base of the rail.

(2) *Appearance in track.* May appear as a hairline crack running completely around the rail, usually accompanied by bleeding or a separation of the rail at the break with one or both of the broken ends battered down (see fig B-5).

Figure B-5. General appearance of broken rail.

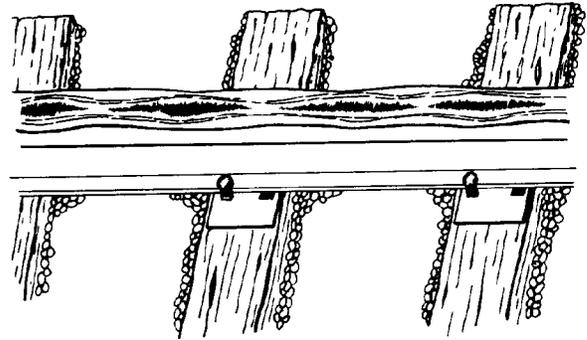
(1) *Description.* A repeated wavelike pattern on the running surface of the rail. Corrugations develop over a long period of time. A number of factors contribute to the development of corrugations with the actual cause dependent on the track and operating conditions. Corrugations are not a critical defect.

(2) *Appearance in track.* Small, hard, bright, short-pitch ridges along the running surface

of the rail varying anywhere from 2 to 18 inches apart and usually less than $\frac{1}{16}$ (0.0625) inch deep. Although the individual waves (ridges) are usually only a short distance apart, the corrugations may extend over a considerable distance (see fig B-6).

Figure B-6. General appearance of corrugation.

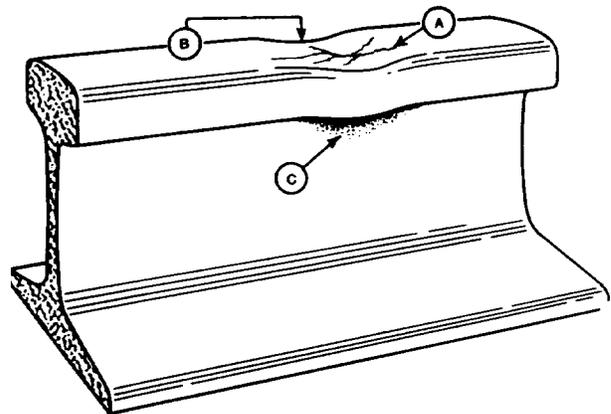
(1) *Description.* The flattening of several inches of the rail head, usually accompanied by a crushing down of the metal but with no signs of cracking in the fillet under the head.

(2) *Appearance in track.* Generally appears as:

(a) Flattening and widening of the head for several inches with the entire head sagging.

(b) Small cracks in a depression on the running surface.

(c) In advanced stages, a bleeding crack may be present at the fillet under the head (fig B-7).

Figure B-7. General appearance of crushed head.

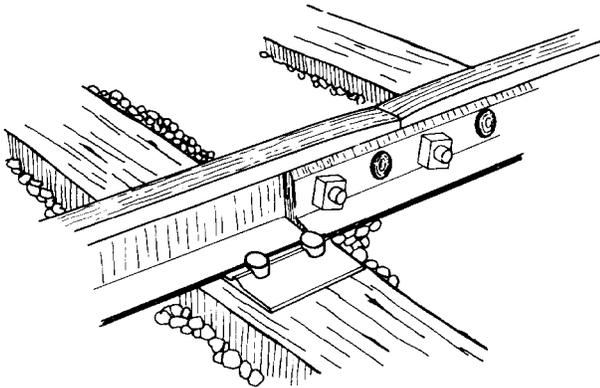
(1) *Description.* Damage caused by wheels striking the rail ends.

(2) *Appearance in track.* Appears as damage to or a depression in the top surface of the rail head at the ends of the rail (fig B-8).

Figure B-8. Rail end batter.

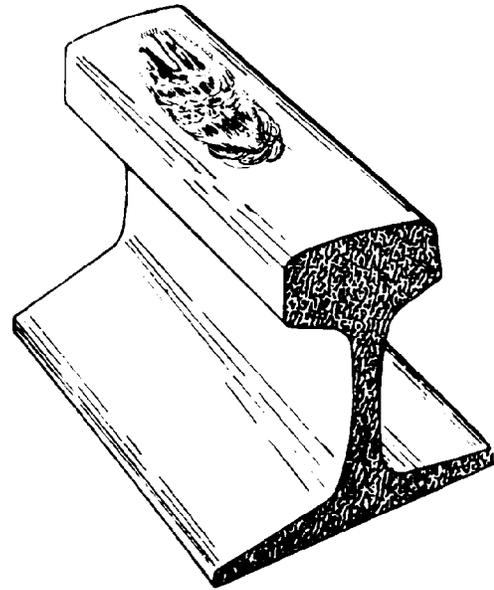
(1) *Description.* Rail that has been scarred on the running surface by the friction of slipping locomotive wheels. An engine burn is not a critical defect; however, an engine burn may lead to an engine burn fracture.

(2) *Appearance in track.* Round or oval rough spots or holes on the tread of the running surface. Often the source of engine burn fractures. Engine burns may be deep (fig B-9).

Figure B-9. Typical appearance of an engine burn.

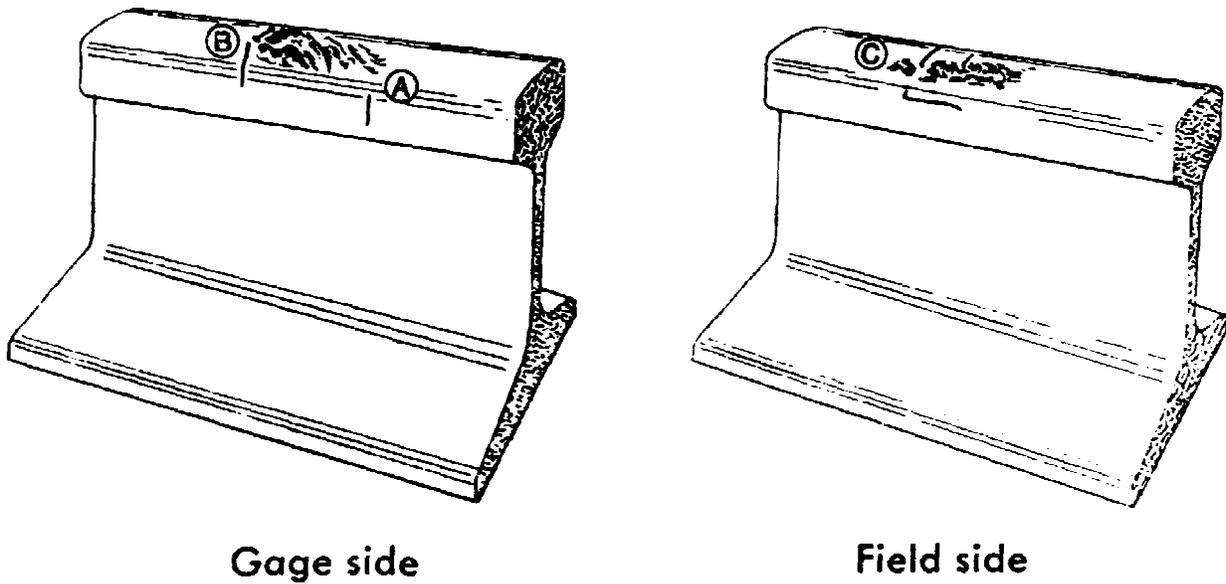
(1) *Description.* A progressive fracture in the rail head starting from a point where engine wheels have slipped and burned the rail.

(2) *Appearance in track.* No sign of transverse separation is visible until the defect reaches the rail surface (cracks out). An engine burn fracture may then be recognized by one or more of the following characteristics.

(a) A hairline crack on the side of the head in the immediate vicinity of an engine burn and at right angles to the running surface. The crack may be visible on either the field or gage side of the head.

(b) Transverse thermal cracks extending from the burn to the gage corner and down the side of the head for at least $\frac{1}{8}$ (0.125) inch.

(c) A cracked out horizontal separation on the field side of the rail head under the burned area often accompanied by one or more thermal cracks extending transversely to the gage corner (fig B-10).

Figure B-10. General appearance of an engine burn fracture.

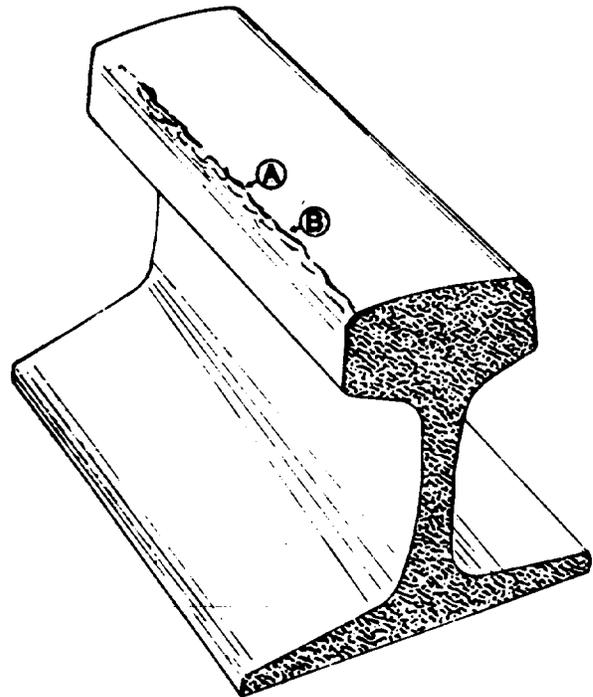
(1) *Description.* A progressive horizontal separation on the running surface near the gage corner often accompanied by scaling or chipping. Flaking should not be confused with shelling as flaking occurs only on the running surface near the gage corner and is not as deep as shelling. Flaking is not a critical defect.

(a) Shallow depressions with irregular edges occurring on the running surface near the gage corner. Generally flaking will occur within $\frac{1}{4}$ (0.25) inch of the corner of the rail.

(b) Horizontal hairline cracks along the running surface near the gage corner of the rail head, resembling small slivers (fig B-11).

Figure B-11. General appearance of flaking.

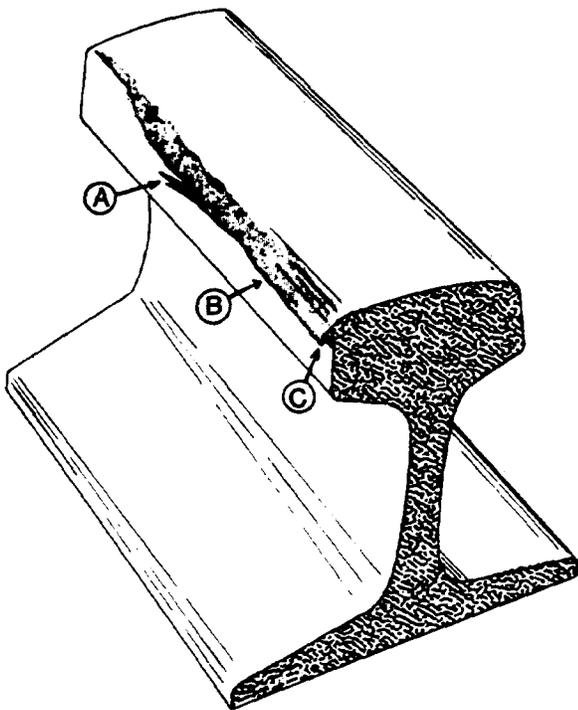
(1) *Description.* A rolling out of the tread metal beyond the field corner with no breaking down of the underside of the head. Flow is not a critical defect.

Figure B-12. General appearance of flow.

(a) Surface metal on the head flowed toward the field side giving a creased appearance on the running surface near the field corner.

(b) A protruding lip extending along the length of the rail.

(c) In the advanced stage, flow becomes bladelike, jagged, or nonuniform and may hang down or separate from the rail head (fig B-12).

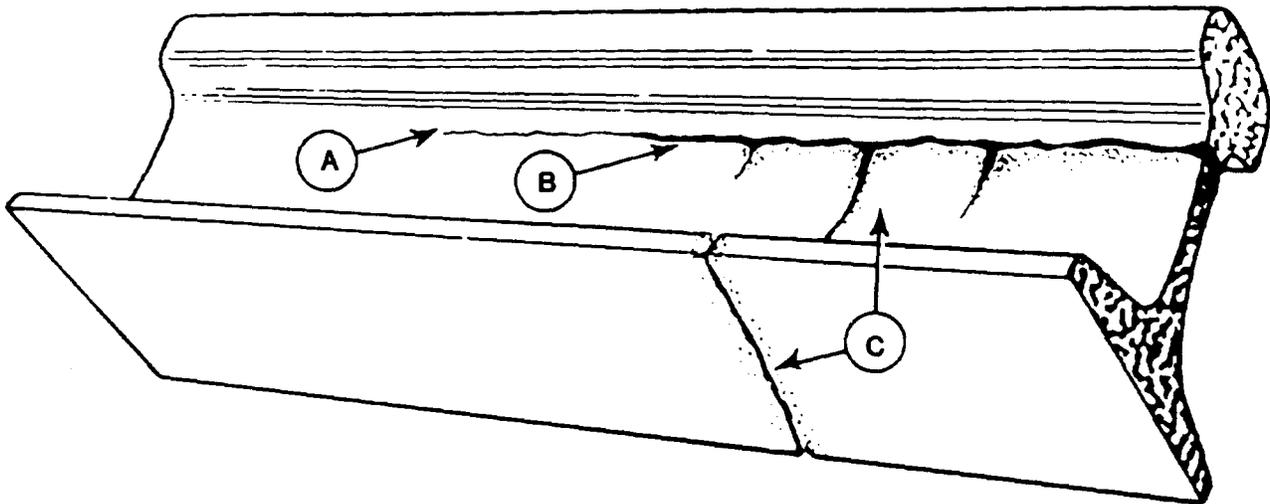
(1) *Description.* A progressive fracture separating the head and web of the rail.

(a) In earlier stages, wavy lines appearing along the fillet under the head.

(b) As the condition develops, a small crack will appear along the fillet on either side progressing longitudinally with slight irregular turns upward and downward.

(c) In advanced stages, bleeding cracks will extend downward from the longitudinal separation through the web and may extend through the base (fig B-13).

Figure B-13. General appearance of head/web separation.

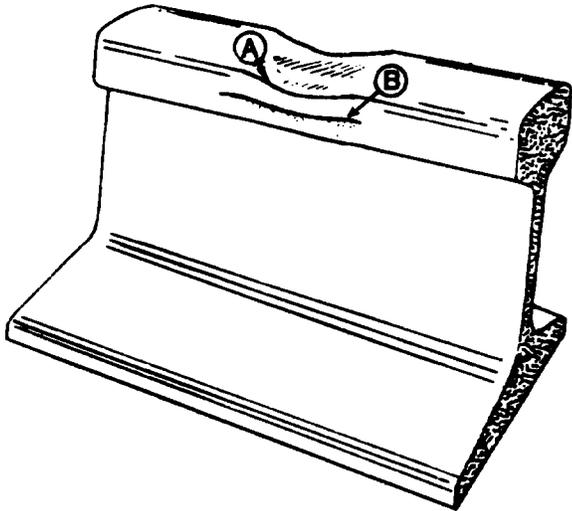
(1) *Description.* A progressive longitudinal fracture in the rail head parallel to the running surface.

(a) Before cracking out, a moderate size horizontal split head will appear as a flat spot on the running surface often accompanied by a slight widening or dropping of the rail head. The flat spot will be visible as a dark spot on the bright running surface.

(b) After cracking out, the horizontal split head will appear as a hairline crack in either side or both sides of the rail head usually $\frac{1}{4}$ (0.25) inch or more below the top of the rail head (fig B-14).

Figure B-14. General appearance of horizontal split head.

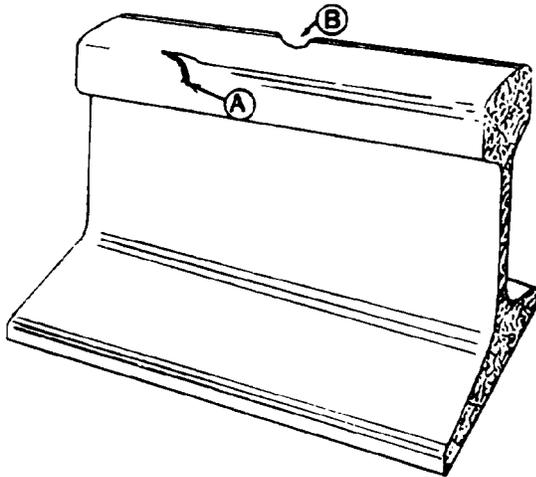
(1) *Description.* Deformations, cavities, seams, or foreign material found in the head, web, or base of the rail. Mill defects are not critical defects.

(2) *Appearance in track.* Any deformation in the rail, broken out area, or inclusion (fig B-15).

Figure B-15. General appearance of mill defects.

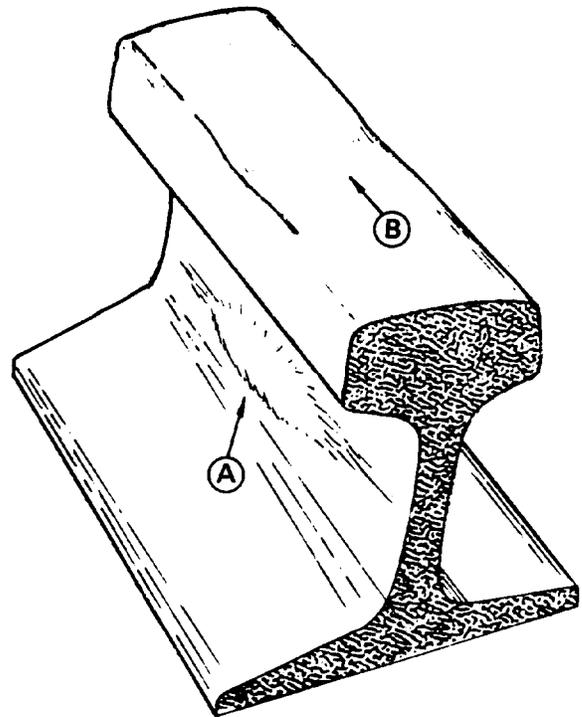
(1) *Description.* A progressive longitudinal fracture in the web of the rail with a vertical separation or seam, forming a cavity in the advanced states of development.

(a) A bulging of the web on either or both sides. Shallow cracks due to distortion may be found in the bulging surface.

(b) A slight sinking of the rail head may exist above the pipe (figs B-16 and B-17).

Figure B-16. General appearance of piped rail.

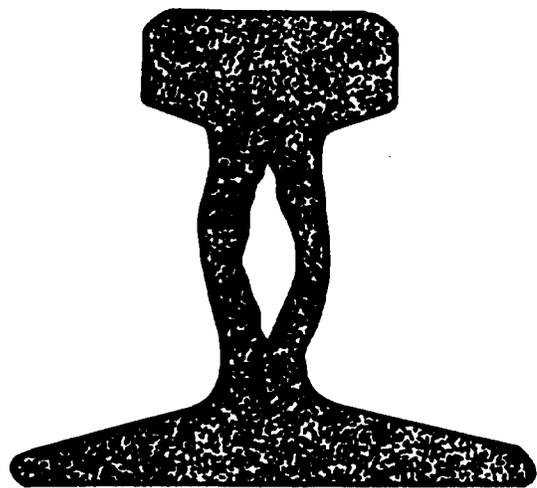
Figure B-17. Cross-sectional view of piped rail.

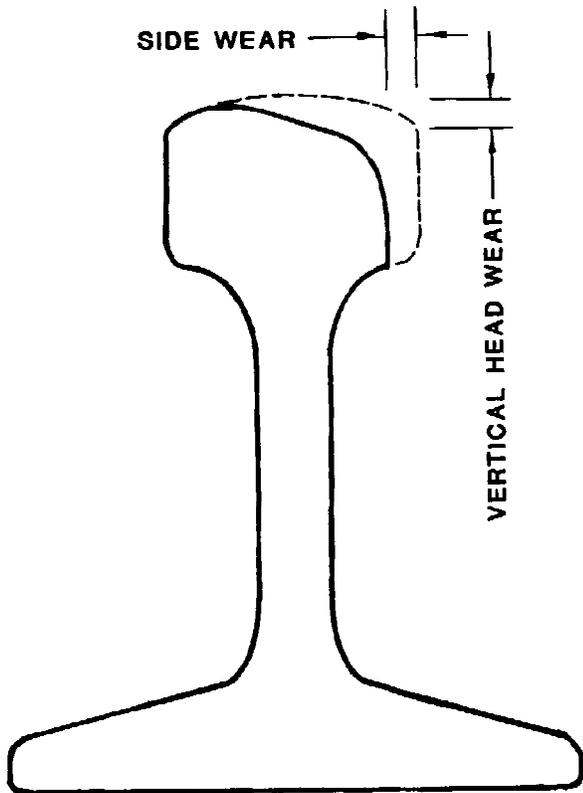
(1) *Description.* The loss of material from the running surface and side of the rail head due to the passage of wheels over the rail.

(2) *Appearance in track.* Rail wear appears as a rounding of the running surface of the rail head, particularly on the gage side (fig B-18).

Figure B-18. General appearance of vertical head and side wear.

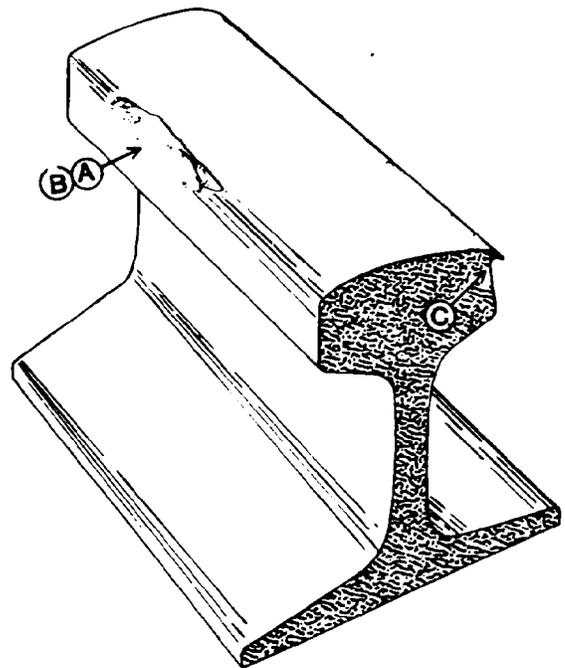
(1) *Description.* A progressive horizontal separation which may crack out at any level on the gage side but generally at the gage corner. It extends longitudinally not as a true horizontal or vertical crack, but at an angle related to the amount of rail wear. Shelling is not a critical defect.

(a) Dark spots irregularly spaced on the gage side of the running surface.

(b) Longitudinal separation at one or several levels in the upper gage corner with discoloration from bleeding.

(c) If the rail has been turned, the shelly spots will appear on the field side with an irregular overhanging lip of metal similar to flowed rail (fig B-19).

Figure B-19. General appearance of shelling.

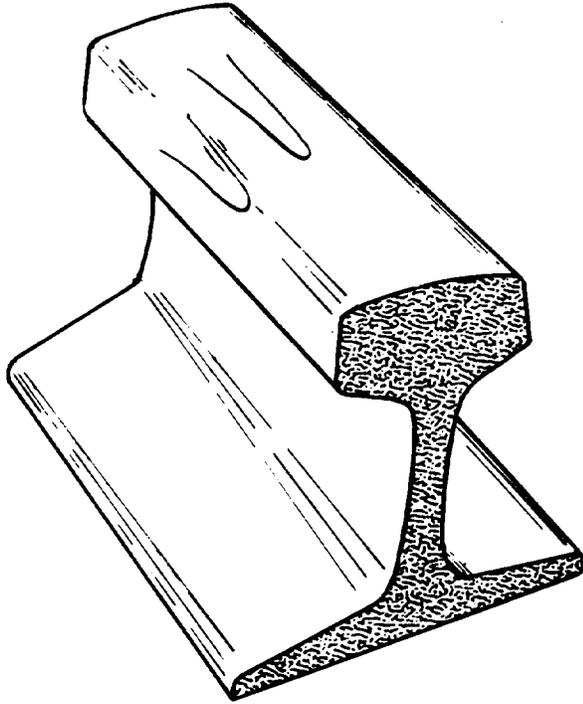
(1) *Description.* A sliver is the separation of a thin, tapered mass of metal from the surface of the head, web, or base of a rail. Slivers are not critical defects.

(2) *Appearance in track.* Thin slivers on the surface of the rail head and parallel to the rail length similar to wood slivers (fig B-20).

Figure B-20. General appearance of slivers.

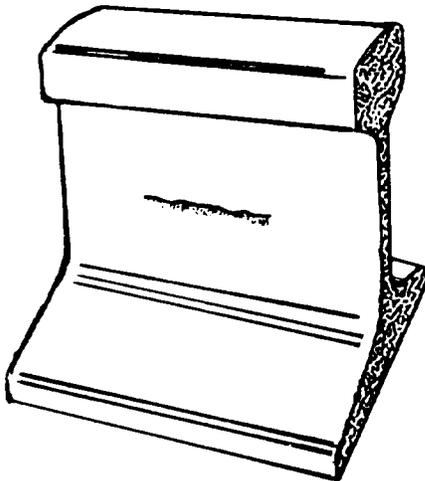
(1) *Description.* A progressive fracture through the web in a longitudinal or transverse direction, or both.

(2) *Appearance in track.* Horizontal and/or vertical bleeding cracks in the web (fig B-21).

Figure B-21 General appearance of split web.

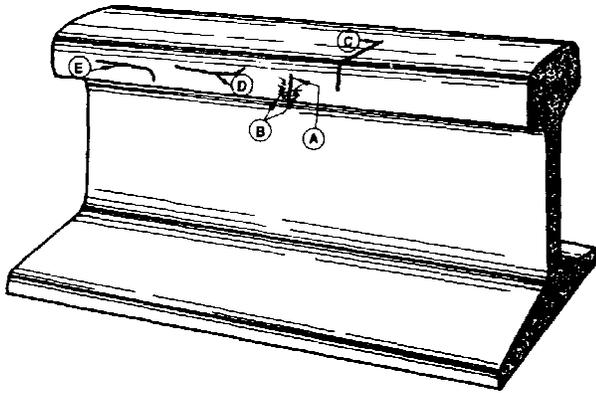
(1) *Description.* Any progressive fracture occurring in the rail head having a transverse separation, however slight. The exact type of transverse defect cannot be determined until after the rail is broken for examination.

(a) A hairline crack on the side of the head at right angles to the running surface, at the fillet under the head, and occasionally on the running surface.

(b) Bleeding at the crack.

(c) A hairline crack at the gage corner of the rail head. On turned rail, this condition may occur at the field corner. Numerous small gage cracks or head checks are often present but should not cause suspicion unless a single crack extends

(d) A horizontal hairline crack in the side of the rail head turning upward or downward at one or both ends usually accompanied by bleeding. Under such conditions a flat spot will generally be present on the running surface.

(e) A hairline crack extending downward at right angles from a horizontal crack caused by shelling of the upper gage corner of the rail head (fig B-23).

Figure B-23. General appearance of transverse defects.

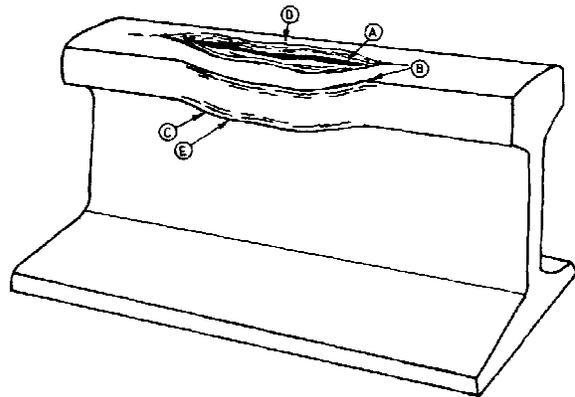
(1) Description. A progressive longitudinal fracture in the head of the rail perpendicular to the running surface.

(a) A dark streak on the running surface.

(b) Widening of the head for the length of the split. The cracked side of the head may show signs of sagging.

(c) Sagging of the head causing a rust streak to appear on the fillet under the head.

(d) A hairline crack near the middle of the rail head.

(e) In advanced stages, a bleeding crack is apparent on the rail surface and in the fillet under the head (fig B-24).

Figure B-24. General appearance of vertical split head.
