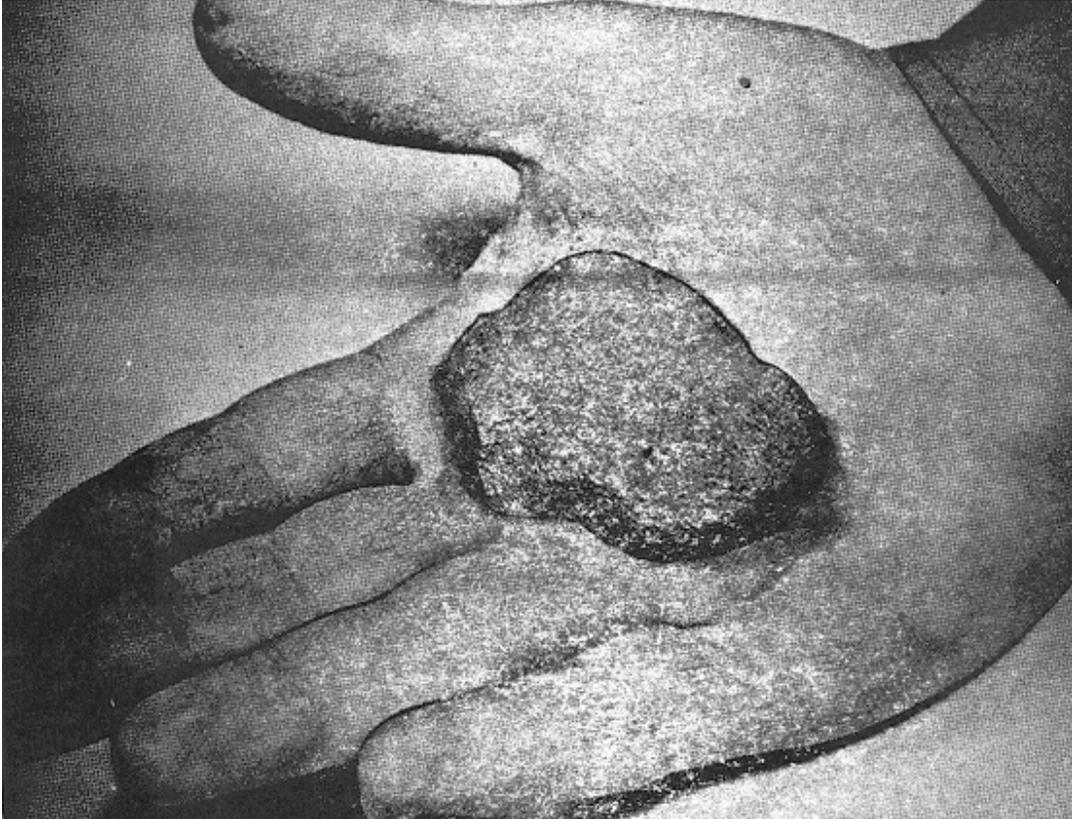
Figure E-4. Appearance of a sample of moist, fine-grained soil prior to conducting the dilatancy test.

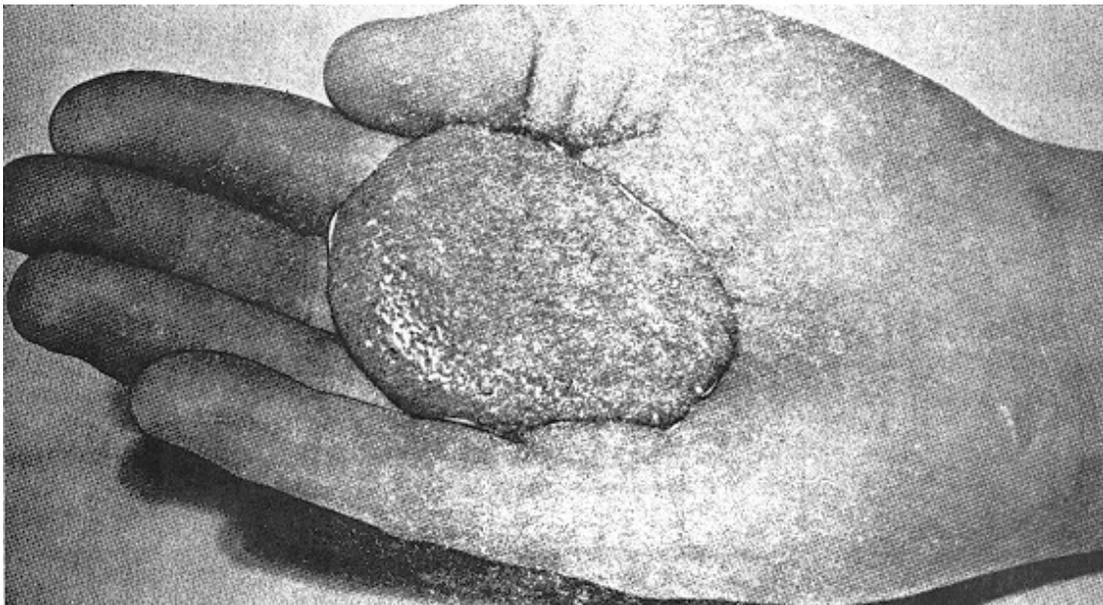
Figure E-5. Livery appearance of a sample of a moist, fine-grained soil which occurred as a result of shaking during the dilatancy test
