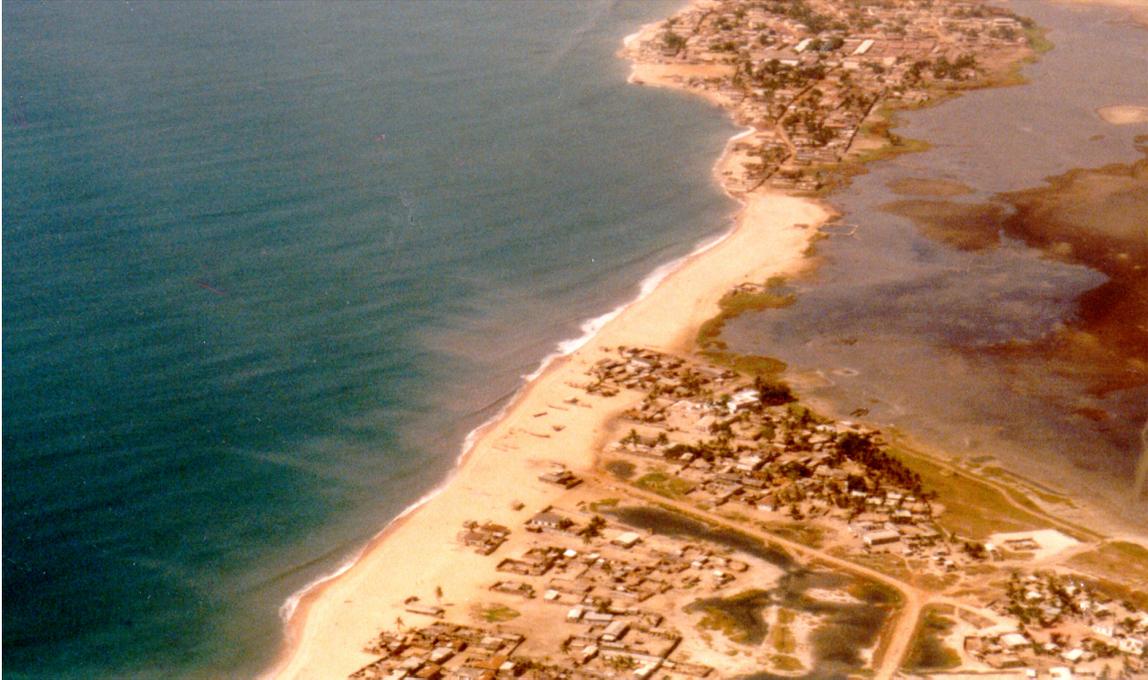
**Figure III-5-5. Discolored water from erosion of exposed cohesive sediment along the Keta shoreline in Ghana, West Africa, July 1996**

(6) At the site in Ghana, subsequent to the initial visual observations of evidence of the presence of underlying cohesive sediments, a series of subsurface investigations was completed to define these conditions. These included augers, boreholes, vibracores and sub-bottom profiling. Use of more detailed subsurface investigations to confirm visual observations and provide more detailed information is discussed in Part III-5-6.
