IV-2-9. Marine Deposition Coasts - Barriers

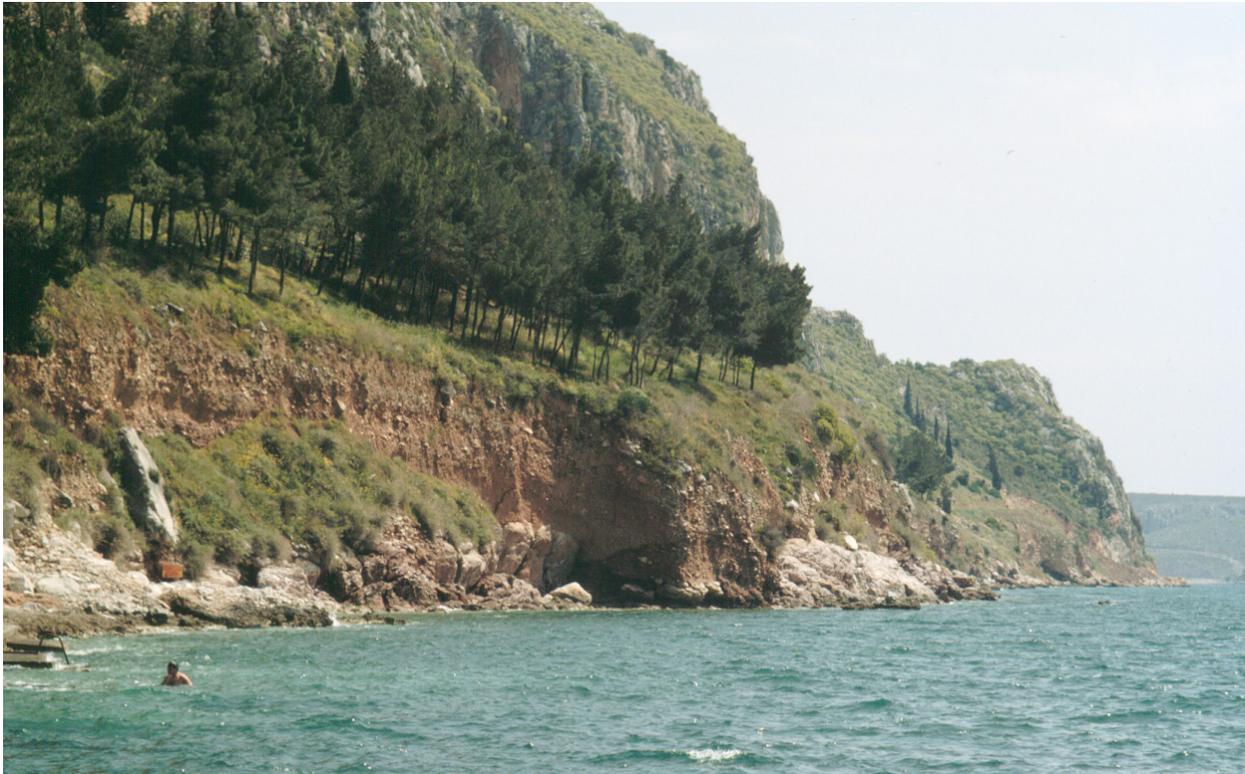
Figure IV-2-21. A section of cliff, projecting out from the shore, is likely to collapse soon. To the left, rubble at sea level marks the location of a previous slump. The lower cliffs are poorly cemented conglomerate while the higher, vertical cliffs (above the trees), are limestone (near Nauplió, Greece, April 1992)

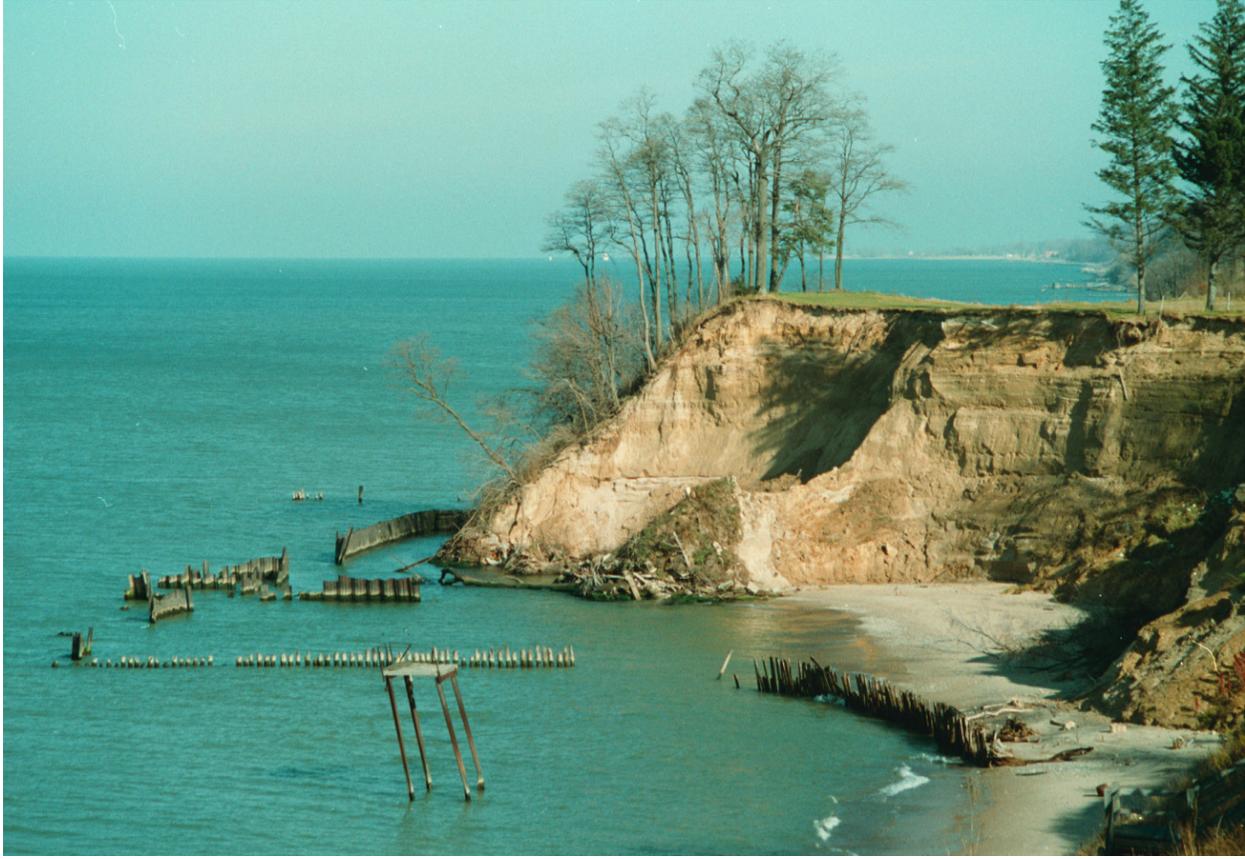
Figure IV-2-22. Lake Michigan shore south of St. Joseph, Michigan (November 1993). A triangle-shaped wedge of the bluff has recently slumped. The bluffs in this area have suffered rapid retreat, and many homes have been destroyed. At least three factors account for the erosion: (a) offshore downcutting of the till lake bottom; (b) wave attack on the bluffs; (c) ice expansion and lubrication of bedding planes caused by groundwater

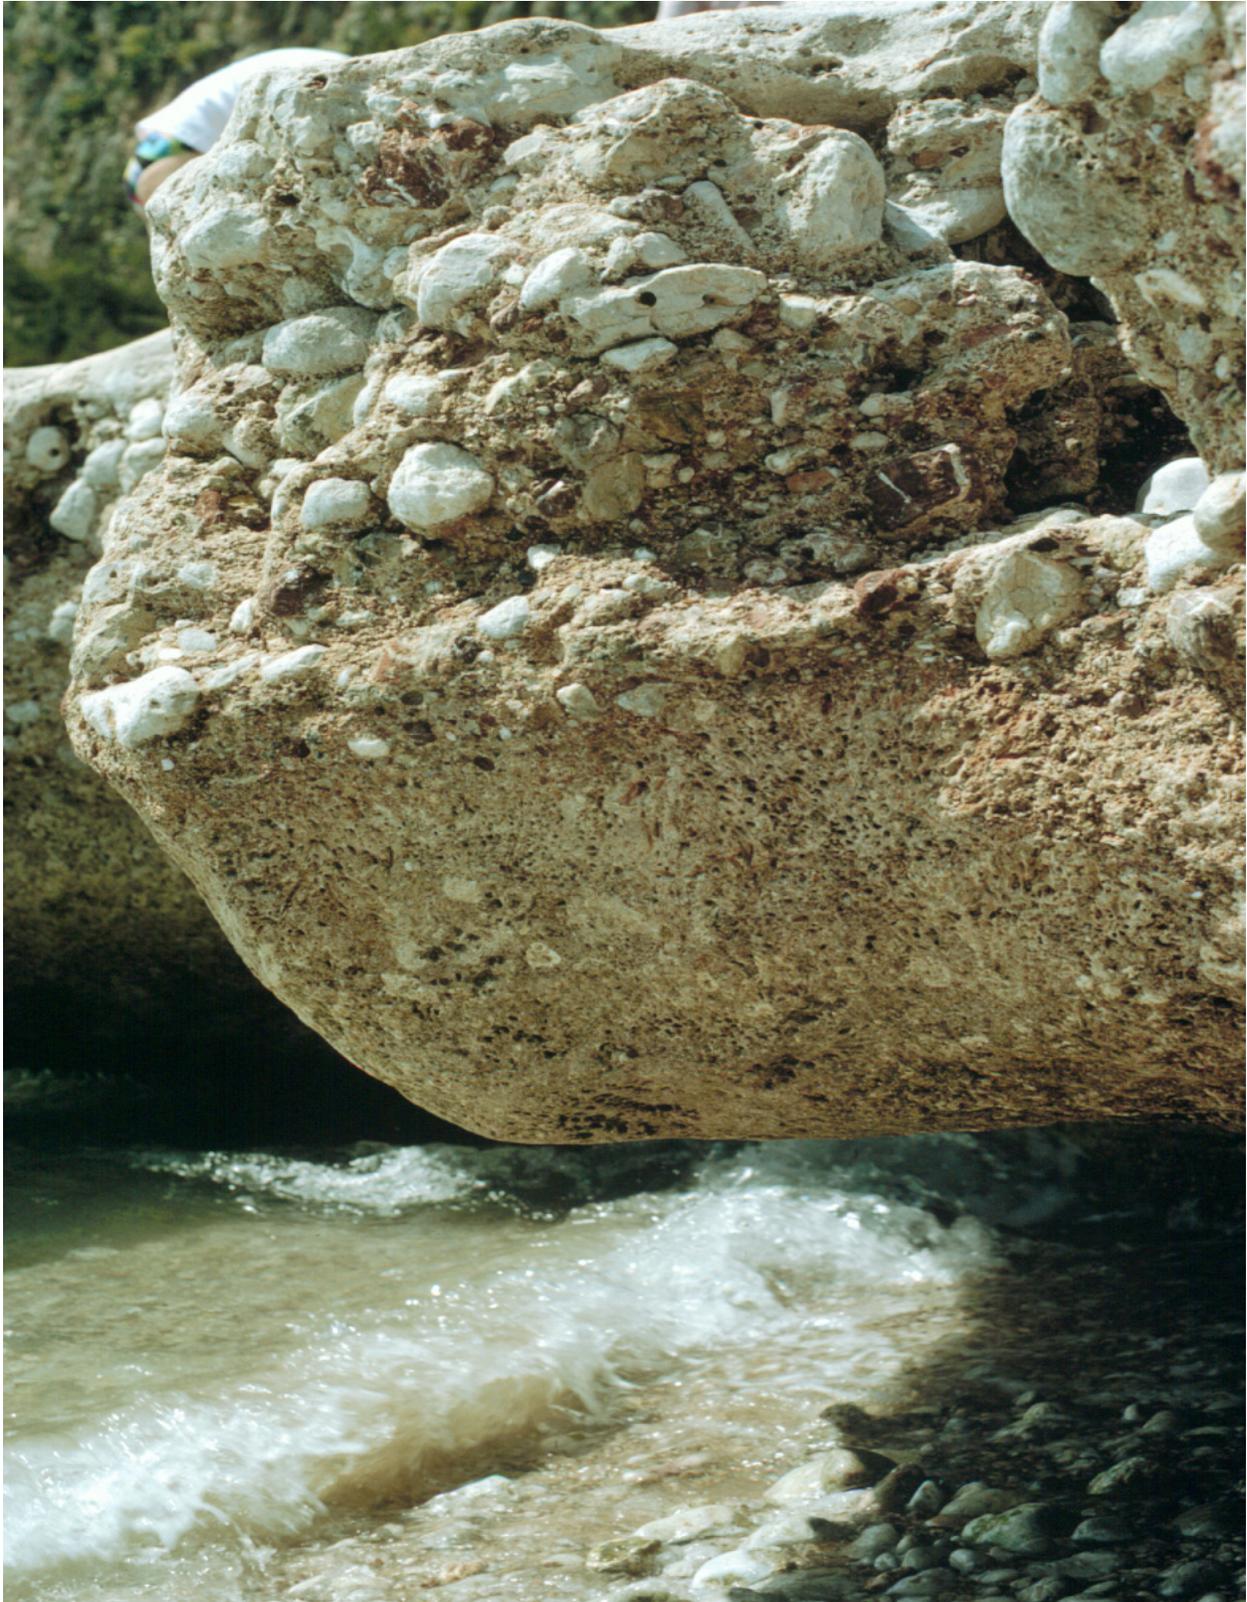
Figure IV-2-23. Cemented conglomerate with many pits and cavities shows evidence of dissolution. The rock mass has been undercut over 1 m (near Nauplió, Greece). Note that the conglomerate is distinctly graded, with fine grains near the bottom and cobble near the top
